# **LM6000PD Hot Section Removal/Installation Technical Report**

**Site den Haag  
Unit #  
ESN 192-229**

**GE Oracle Project: I01-051443  
GE Aero Houston Service Shop PO: 7302270  
GE Aero Houston Service Shop WO nb. Z6JVNL1866283\_JV**

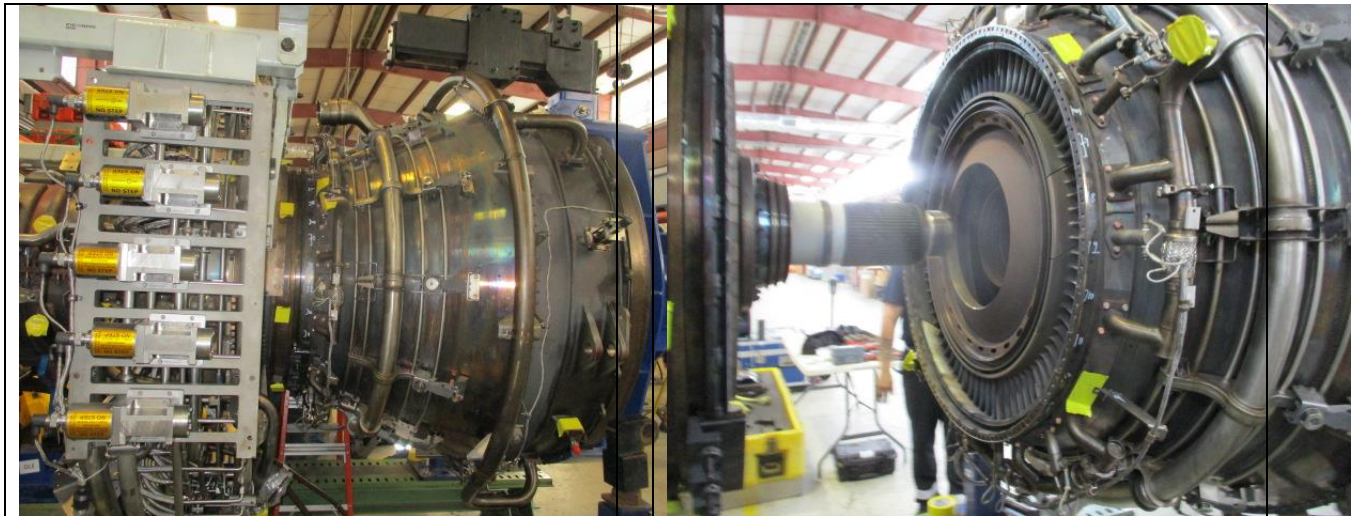
LPT removal

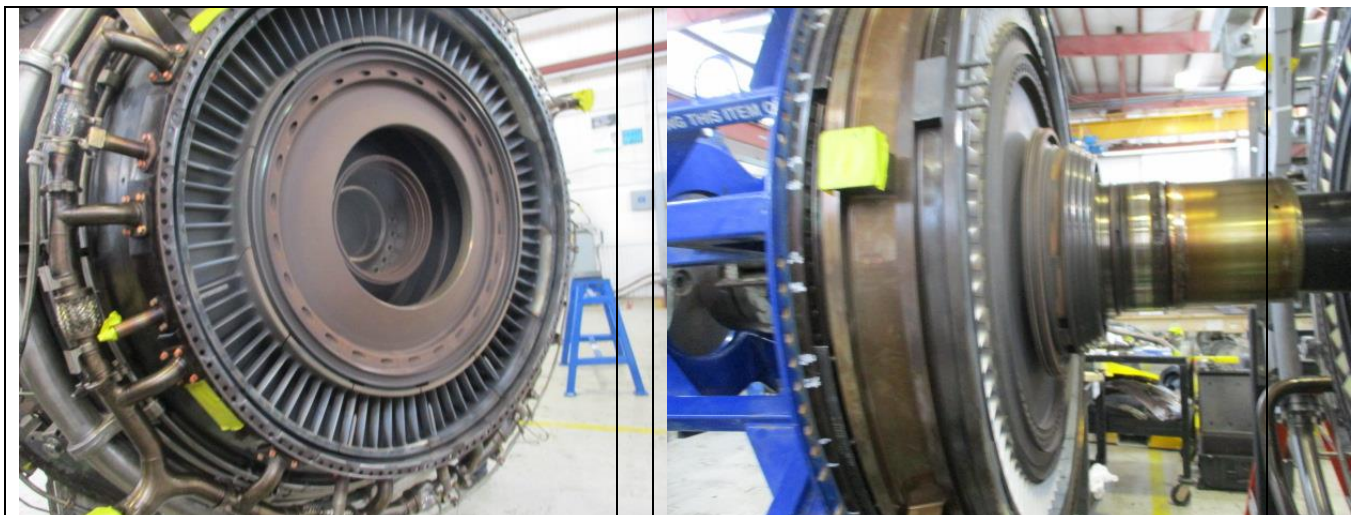
LPT removal

HPT removal

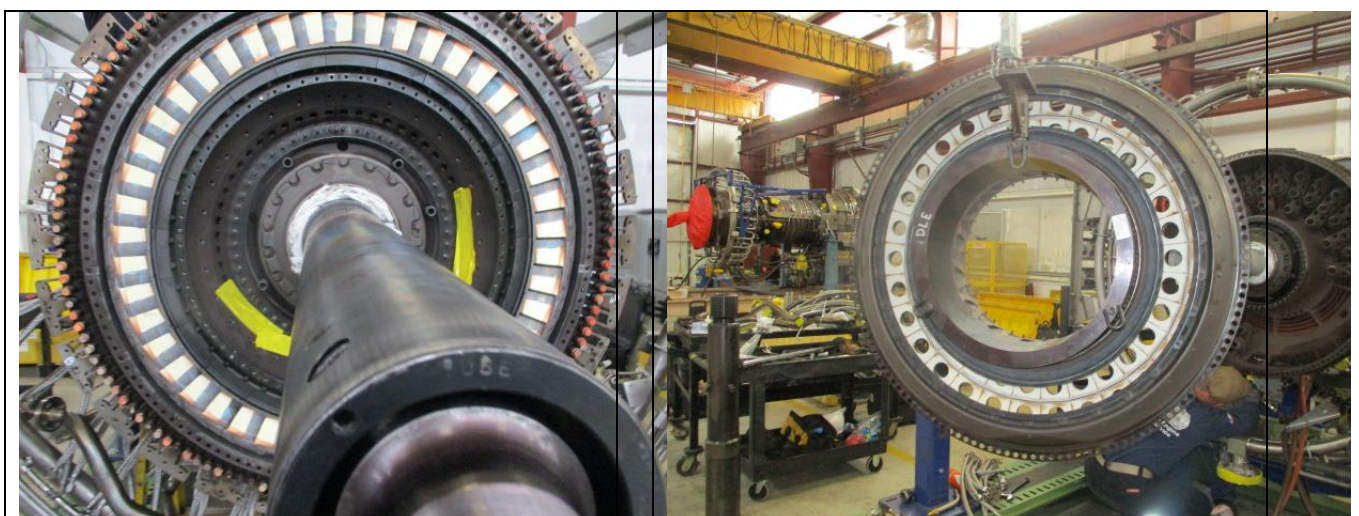
S1N removal

Combustor removal

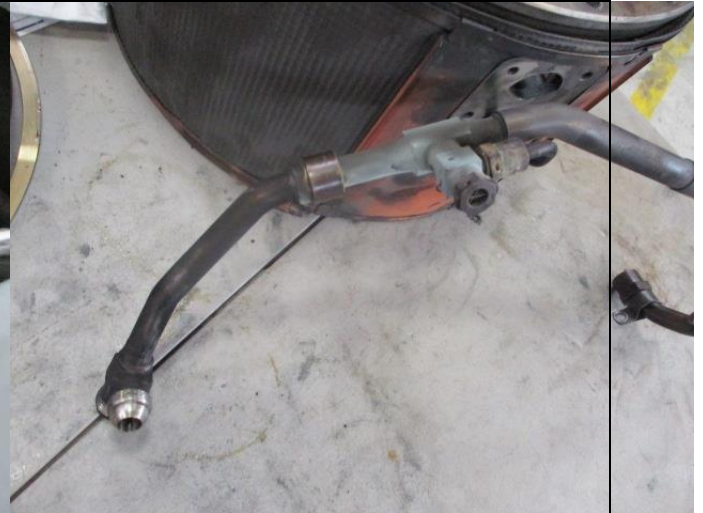
CRF oil manifold removal per SB 308

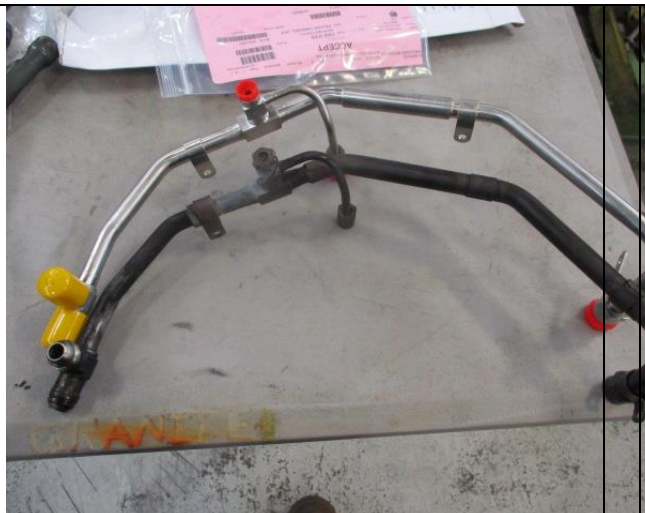
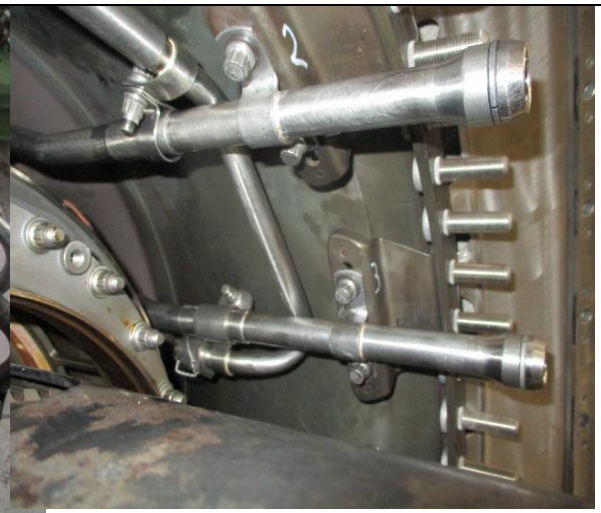
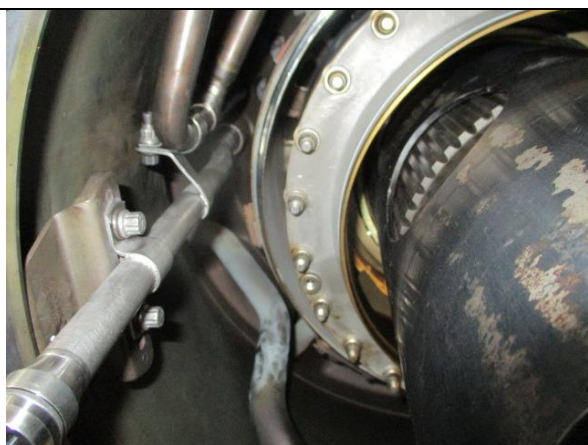
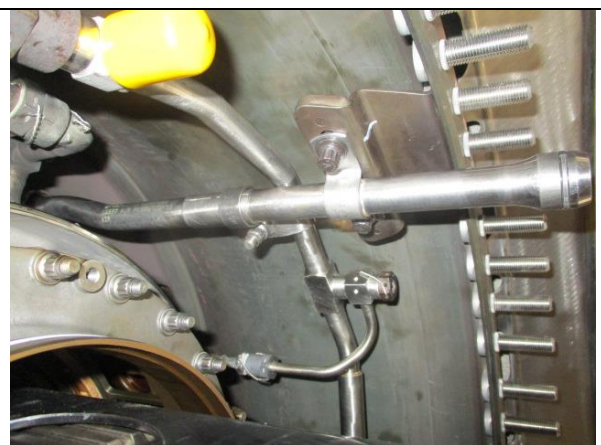
CRF oil manifold install per SB 308

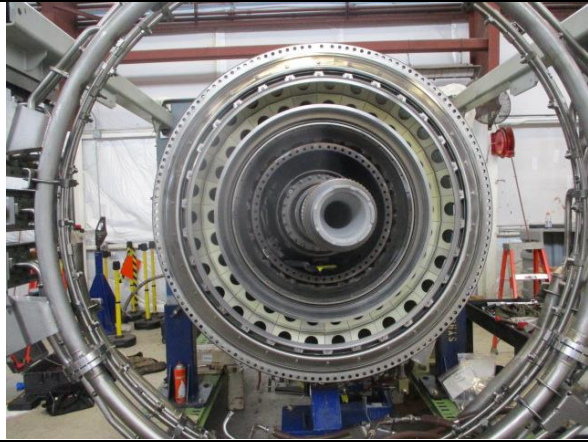
Rotable Combustor install

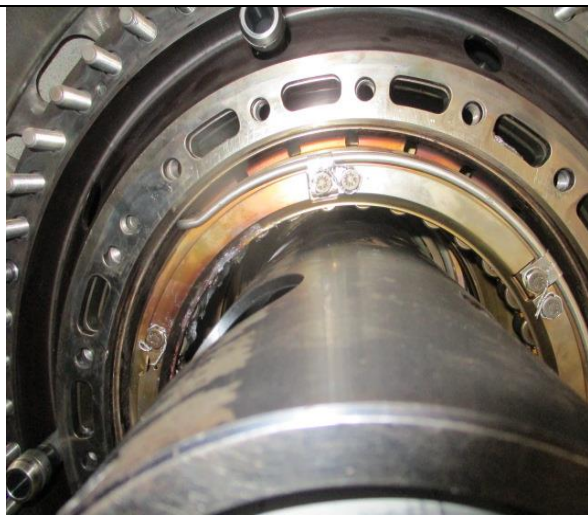
#5 bearing housing install

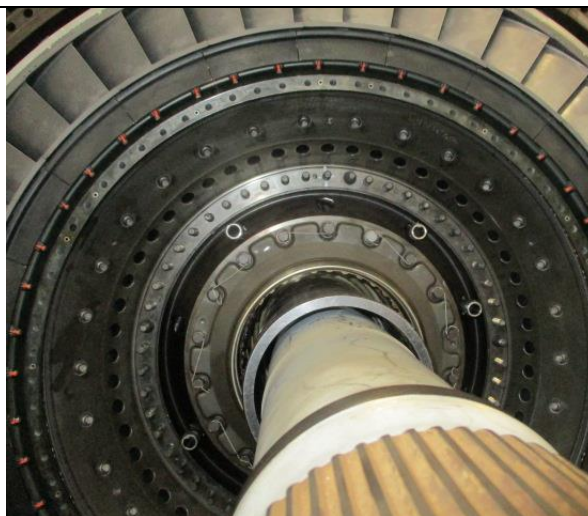
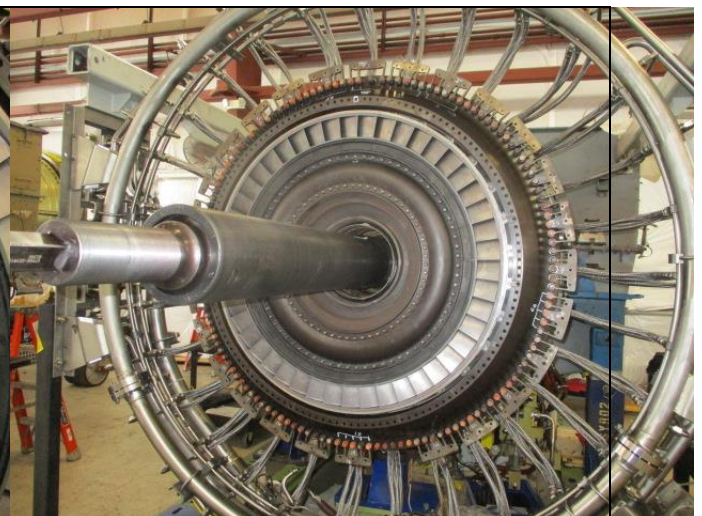
Rotable S1N install

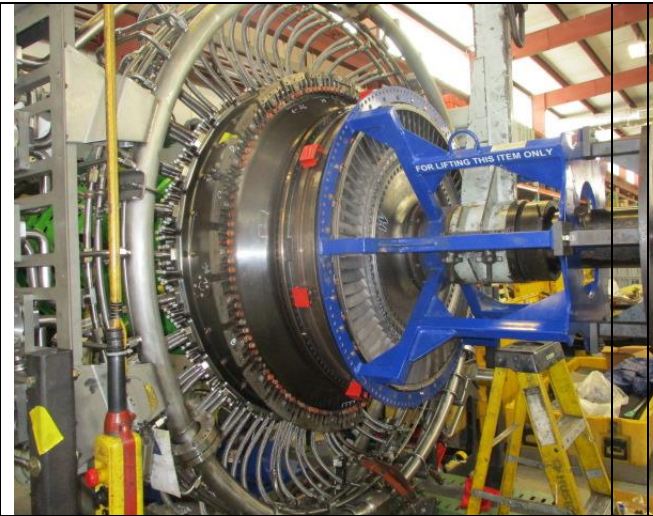
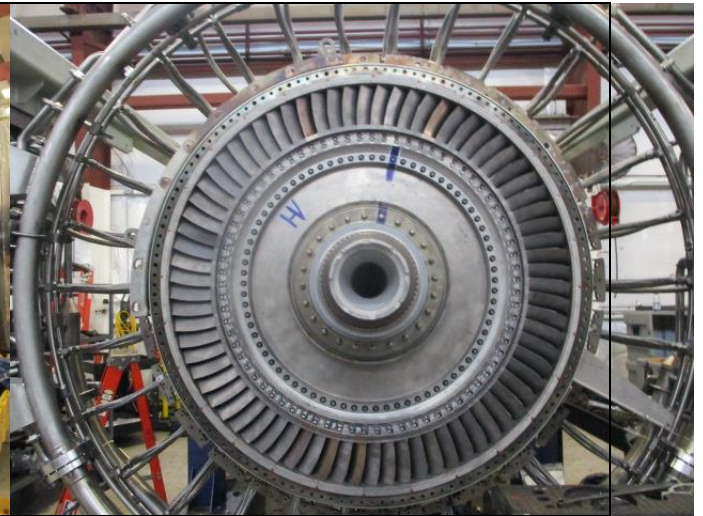
Rotable HPT install

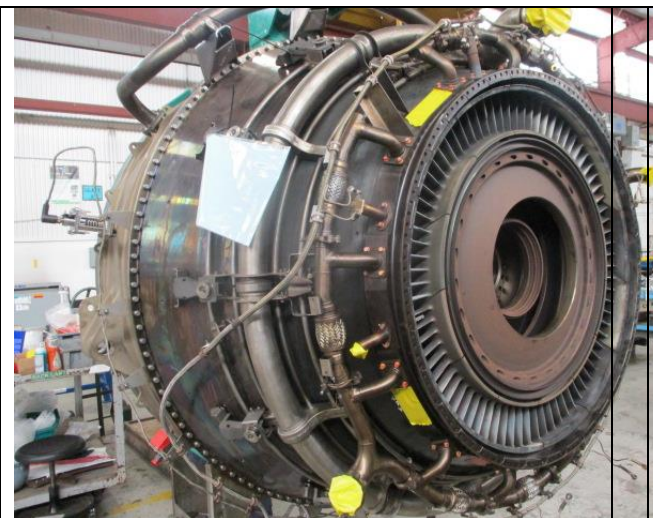
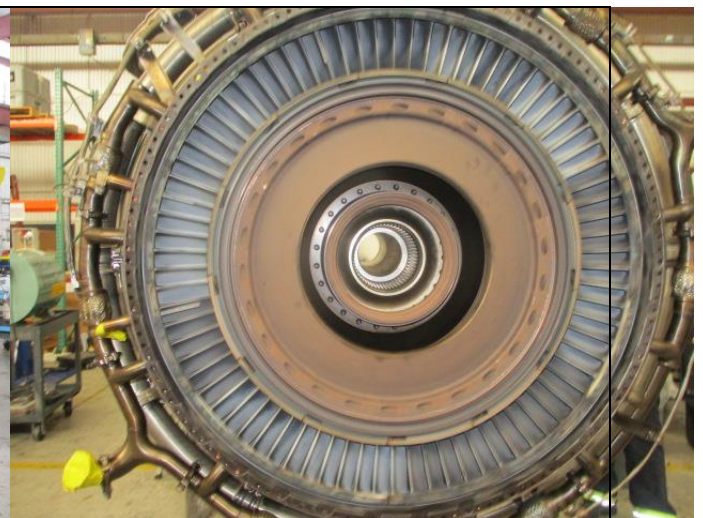
LPT with TRF Rotable install

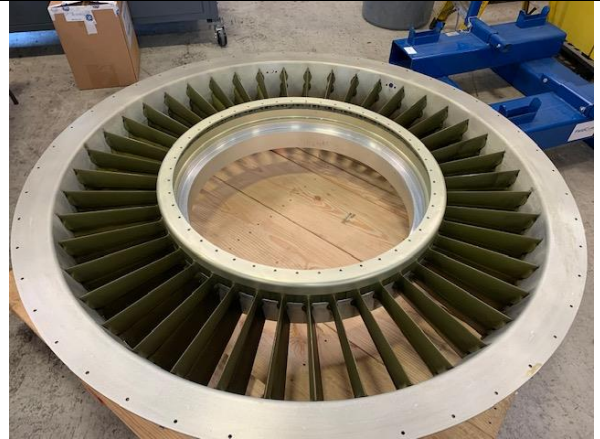
VIGV sent to depot for cleaning

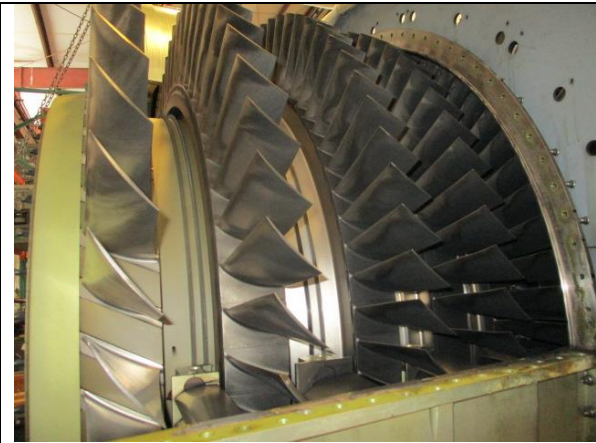
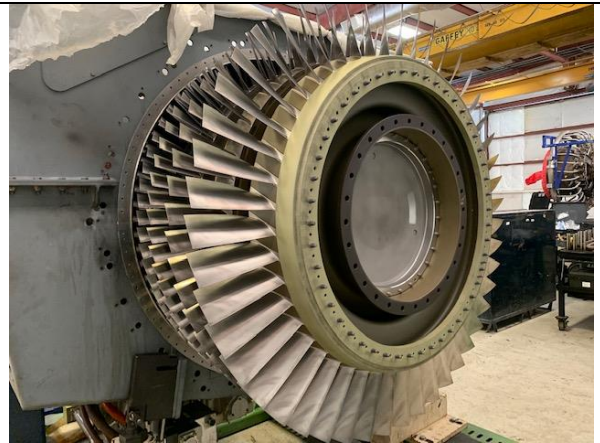
LPC rotor where dry ice cleaned

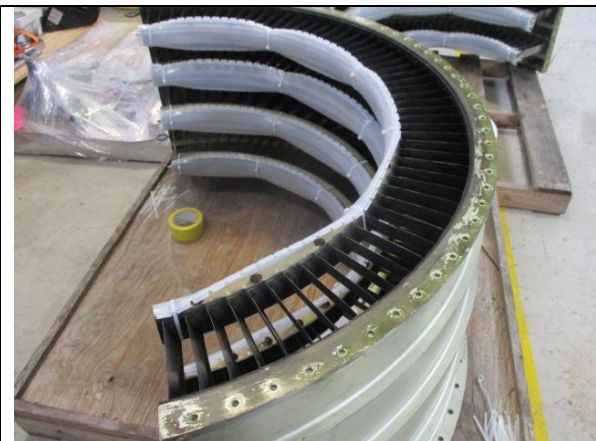
LPC cases sent to depot for cleaning

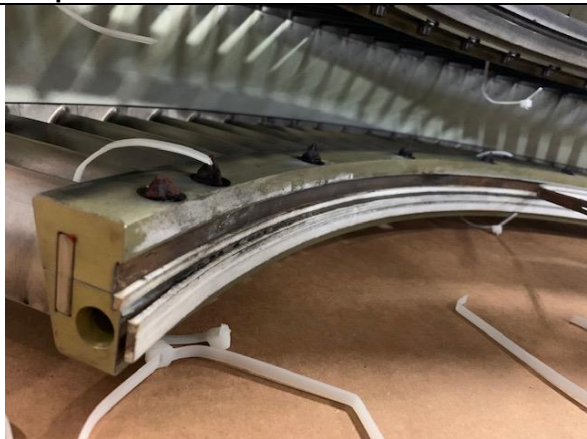
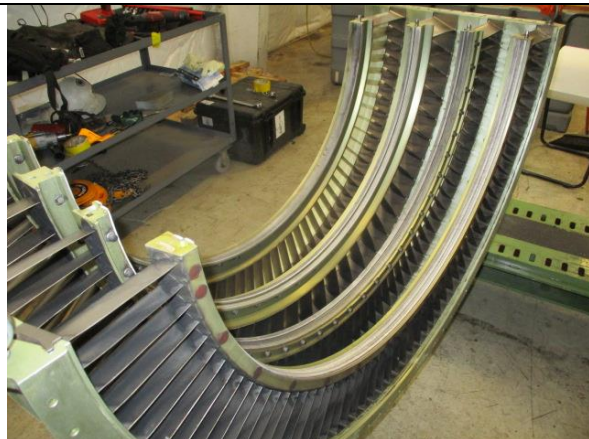
STG 3 shroud replaced on upper case

Technical Inspection, VIGV was removed and sent to depot for cleaning. LPC cases were removed and sent to depot for cleaning. STG 3 shroud was replaced on LPC upper case due to worn delaminated Teflon seal. LPC and HPC rotors blades were dry ice clean. HPC cases were also dry ice clean. New VBV doors were installed. VIGV rigging was performed, adjustment was made to the shims. All premixers were replaced as a set.

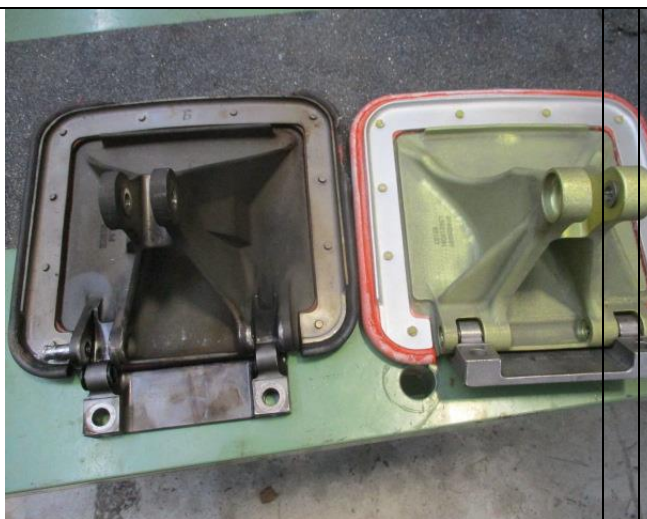
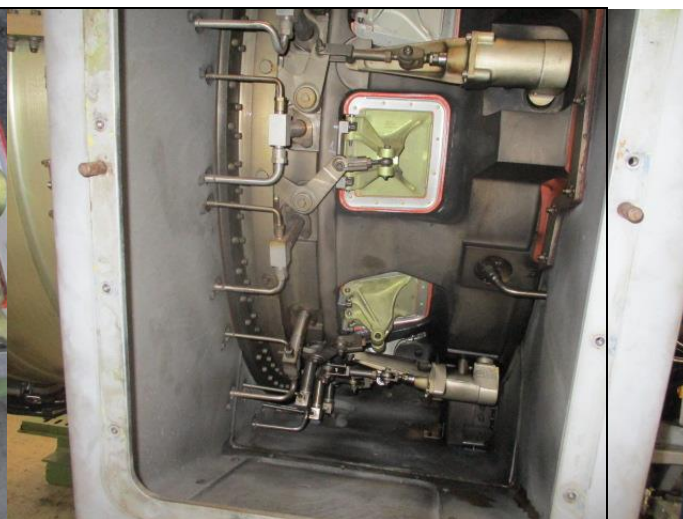
VBV doors replaced with new

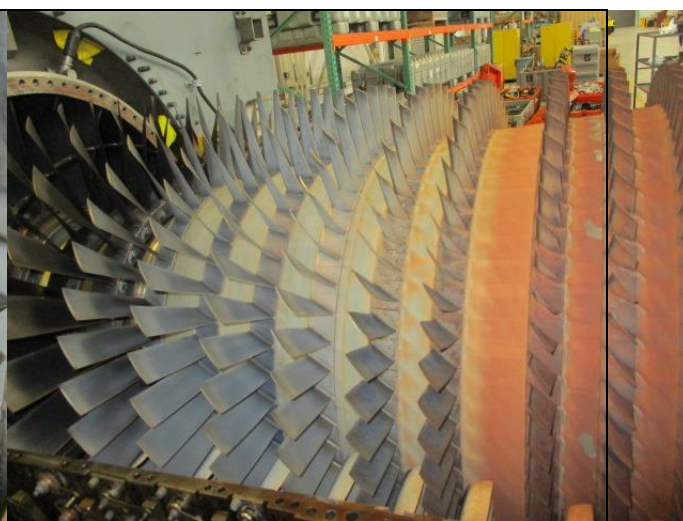
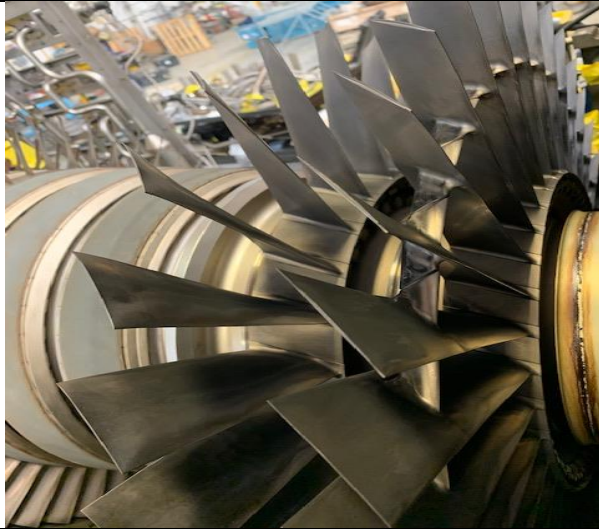
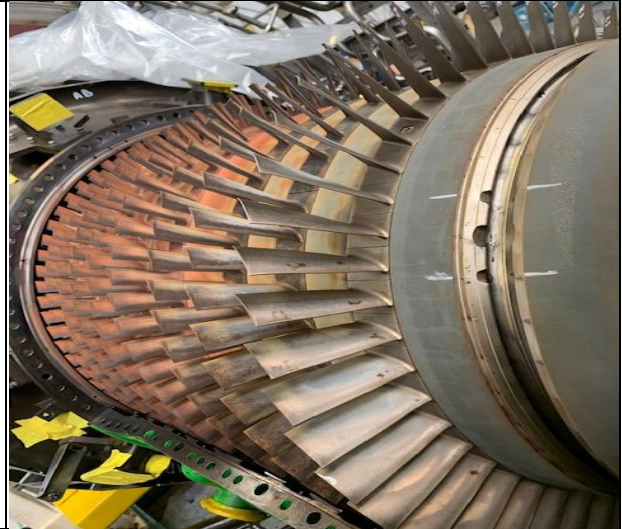
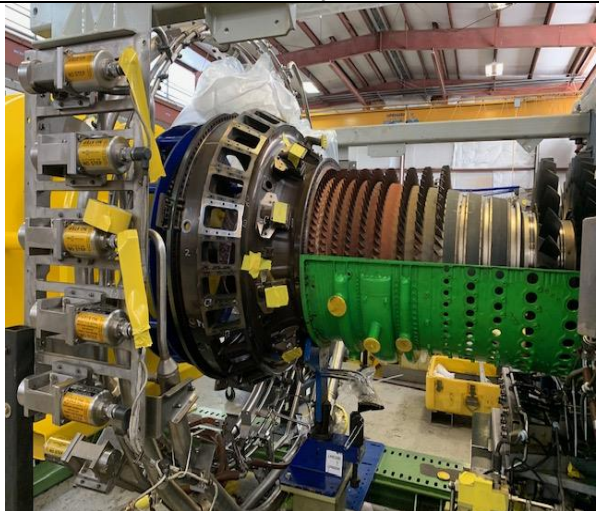
HPC rotor blades where dry ice cleaned

HPC blades and vanes are exposed and were found heavily polluted with black deposit and requires Ice Blasting Cleaning.

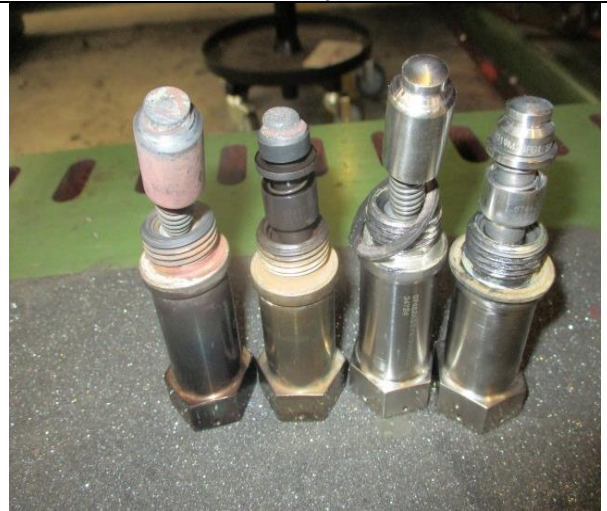
STG 1 and STG 2 plugs replaced due to wear on tip

Continue with heat shield install. Air piping install. STG 1 and STG 2 borescope plugs where order. Borescope plugs will be replaced due to wear at tip. Also, one bracket for heat shield was placed on order. HPC vane work will continue once vane are delivered.

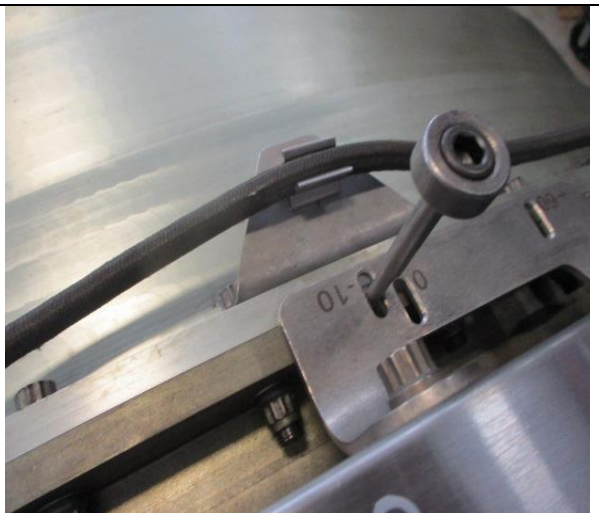
VIGV pinned at closed position

VIGV rig check is performed minor adjustments were made to the Actuator brackets to set insert pin at 10dgr further all in serviceable condition.

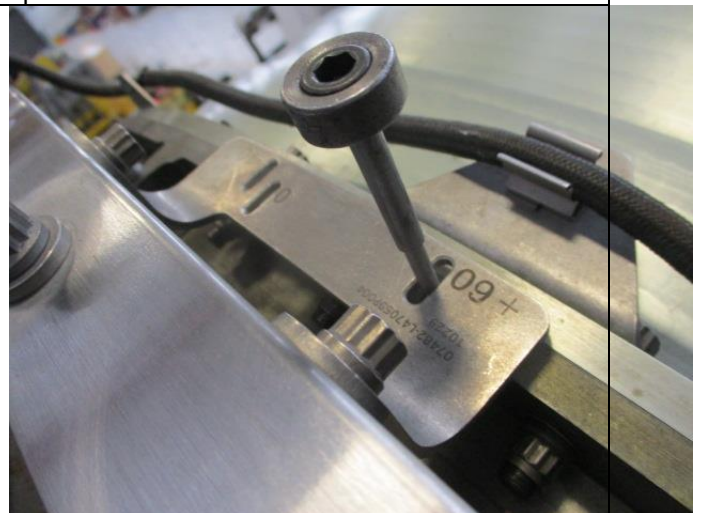
VIGV pinned at open position

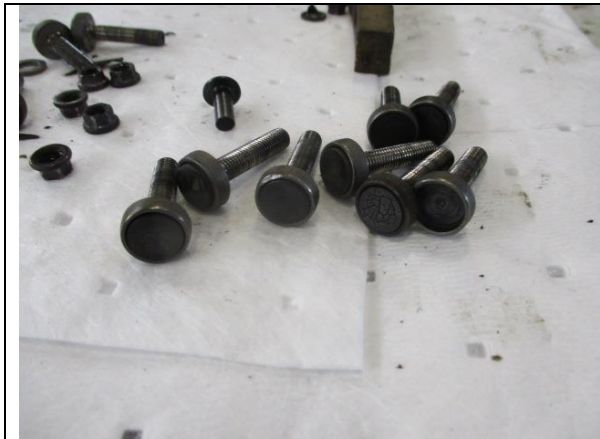
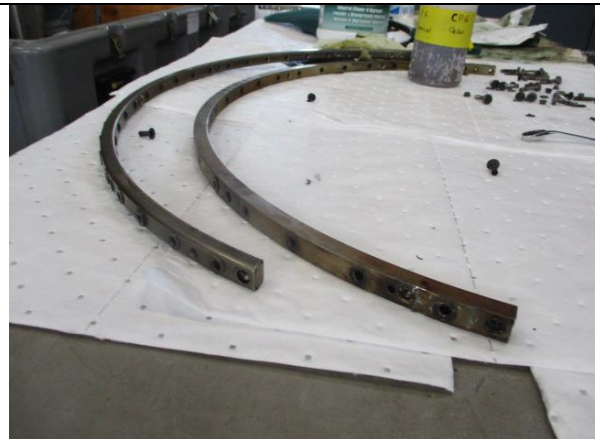
STG 3-5 rub button replaced with new

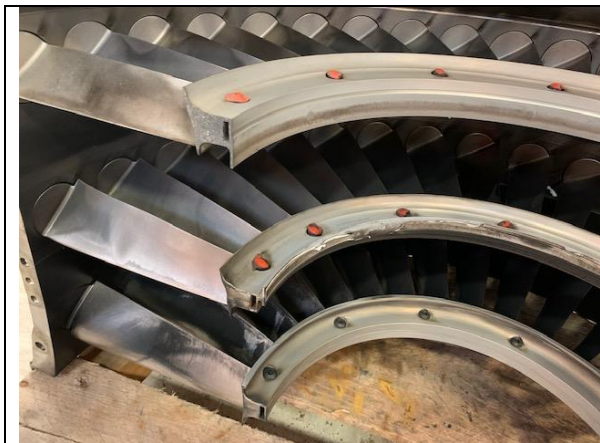
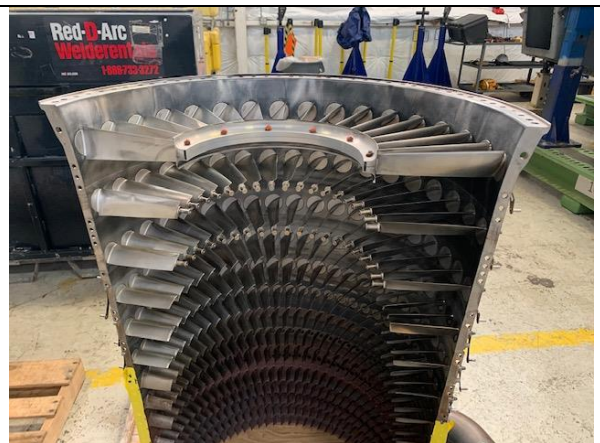
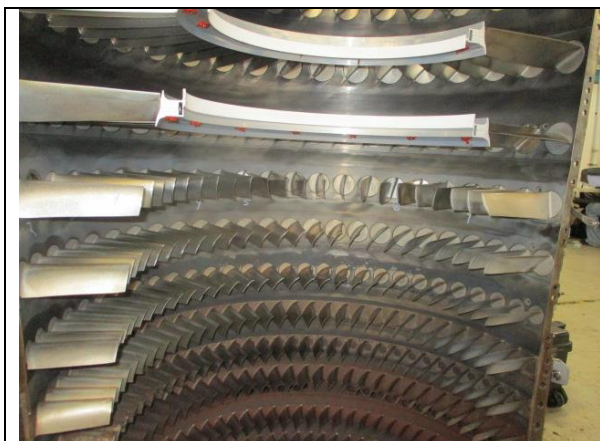
STG 2 and STG 2 shrouds replaced with new

Shrouds on STG 1 and STG 2 would need to be replace on both cases, Teflon seal is eroded.

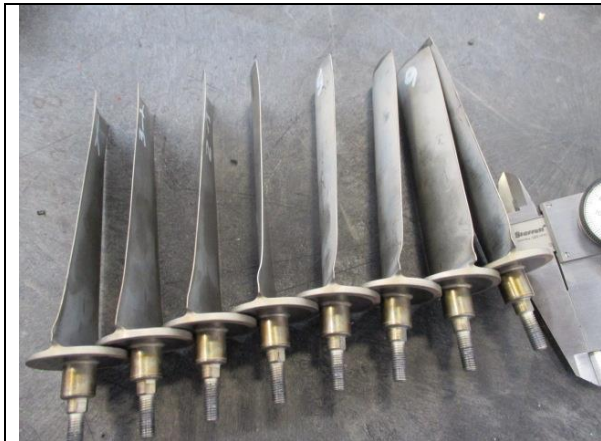
Replaced a total of 15 vanes on STG 3 upper and lower cases

15 HPC Vane Stage 3 found damaged in upper casing and requires replacement for new.

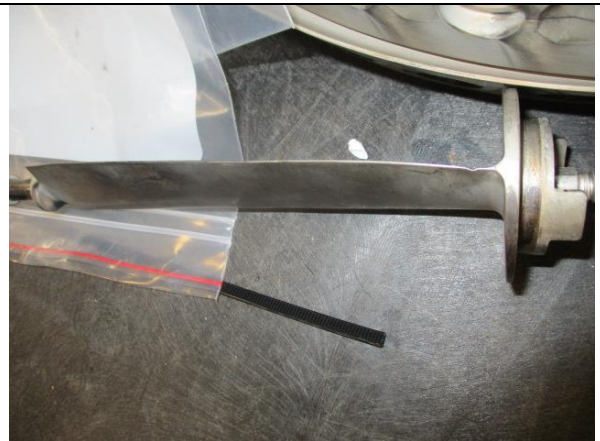
Replace one vane on STG 2

01 HPC Vane Stage 2 found damaged in lower casing and requires replacement for new.

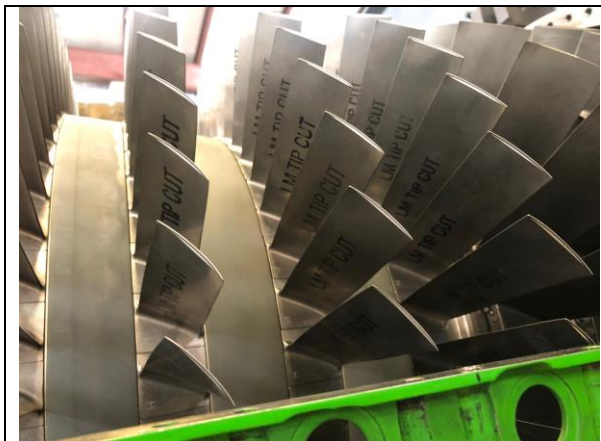
Replaced STG 3-5 blades per SB 310

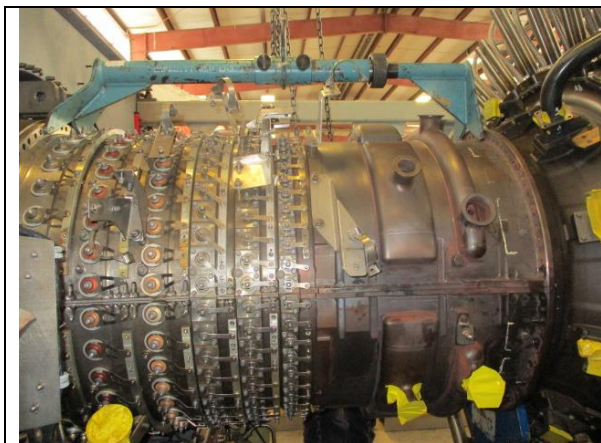
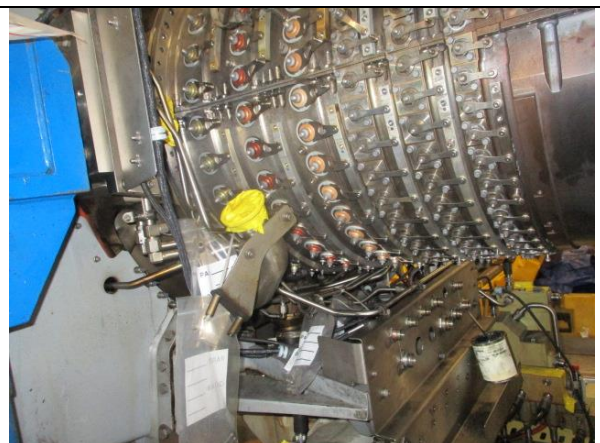
HPC cases installed

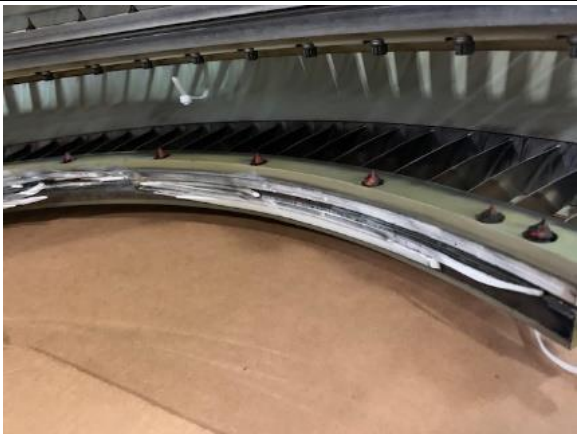
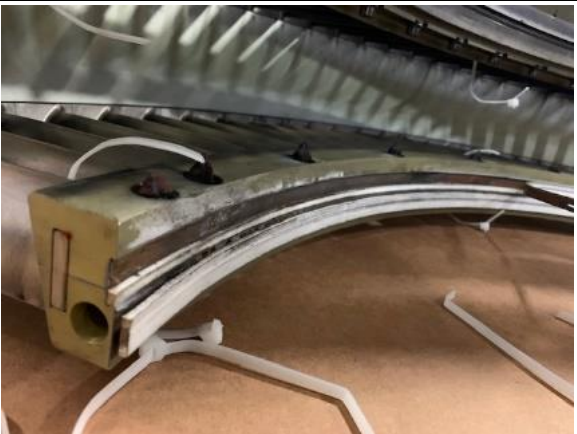
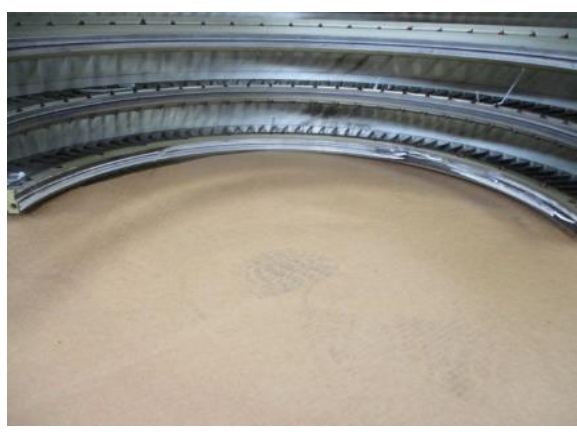
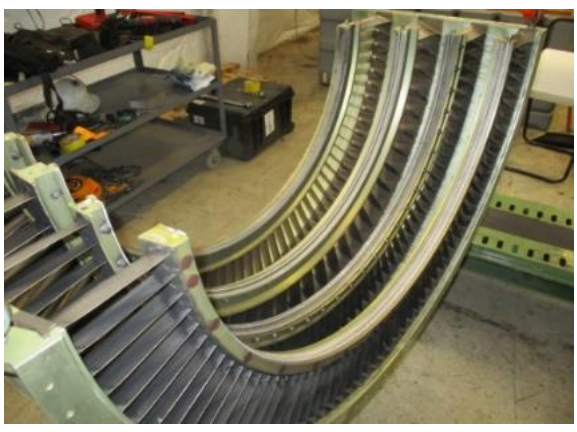
| Damaged LPC Shroud stg3 Upper-Lower Case | |

| Missing Teflon and seal delamination | Missing Teflon and seal delamination |

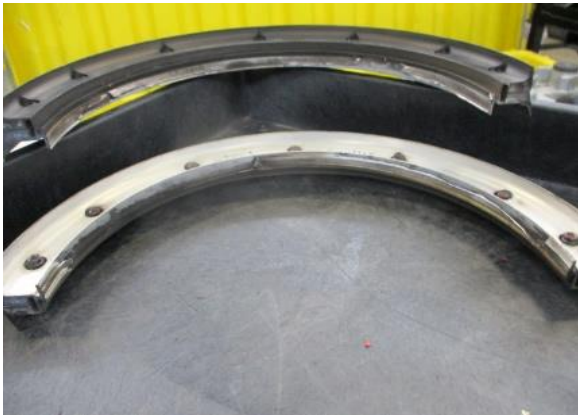
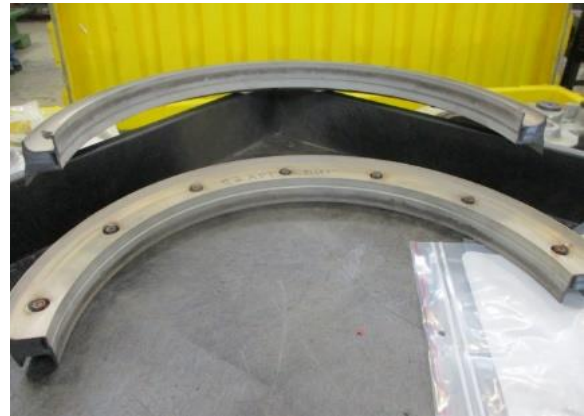
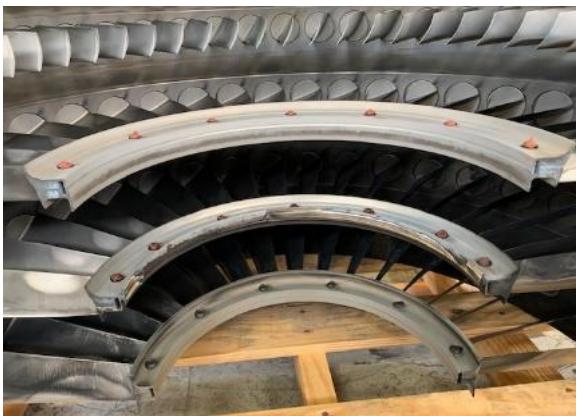
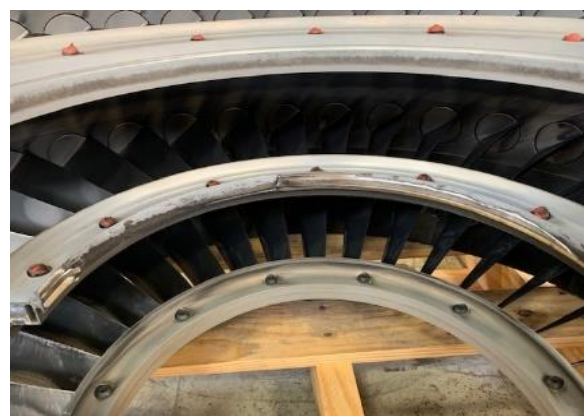
| Damaged HPC Shroud stg1/2 Upper-Lower Case | |

Missing Teflon and seal delamination

The purpose of this visit was to perform HPC top case. STG 3- 5 blades where replaced. Stg 3-5 bushing where replaced. Stg 1 and Stg 2 shrouds where replaced due to damage. Stg 3 to Stg 5 rub buttons where replaced. HPC rotor blades and cases where dry ice cleaned.

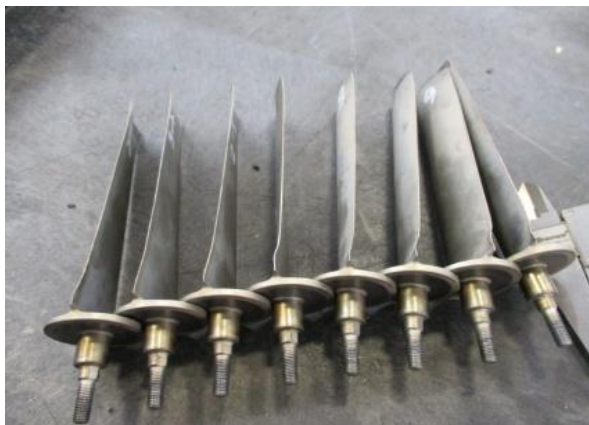
Damaged HPC Vanes stg3 Upper/Lower Case

HPC Vanes stg3

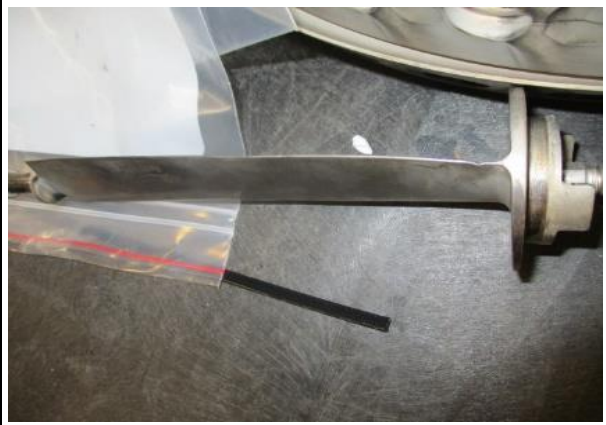
Damaged HPC Vane Lower Case stg2

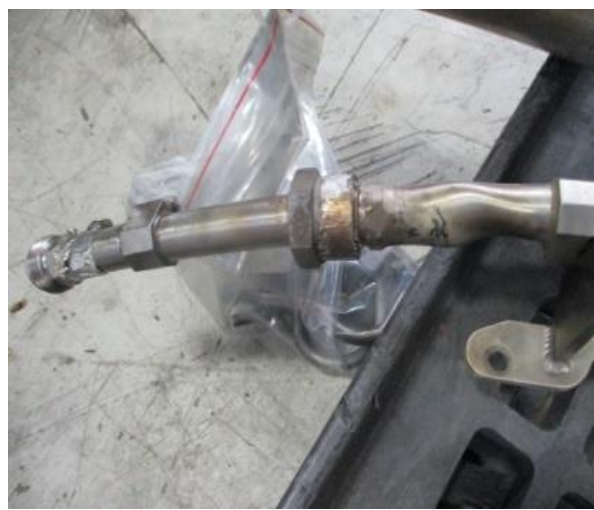
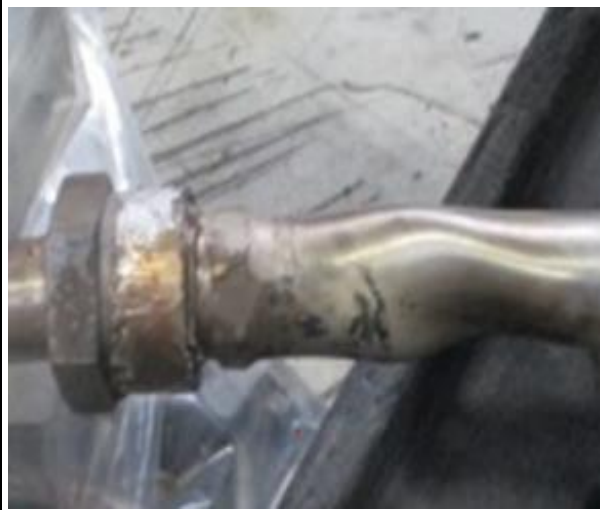
Damaged Water Manifold

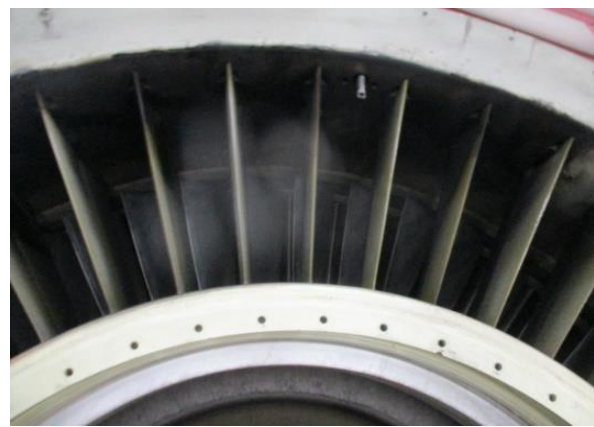
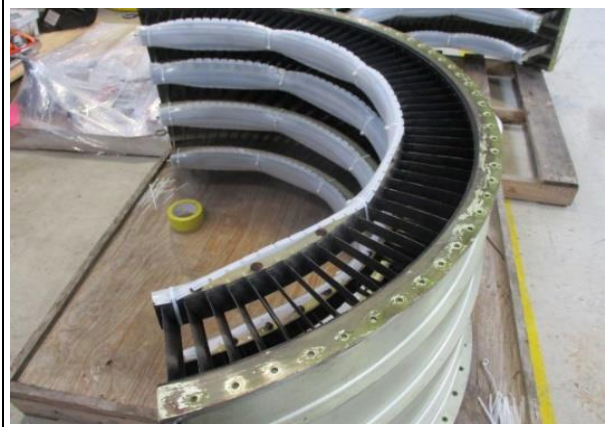
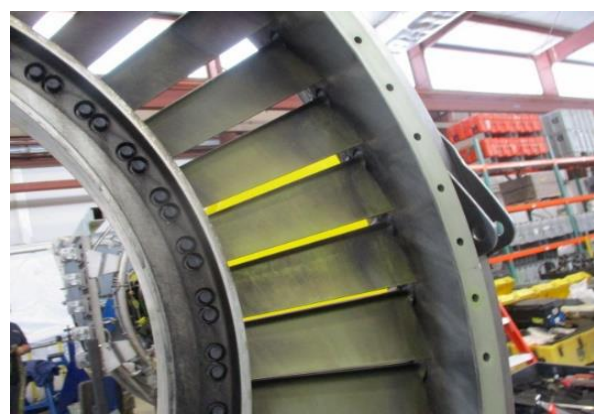
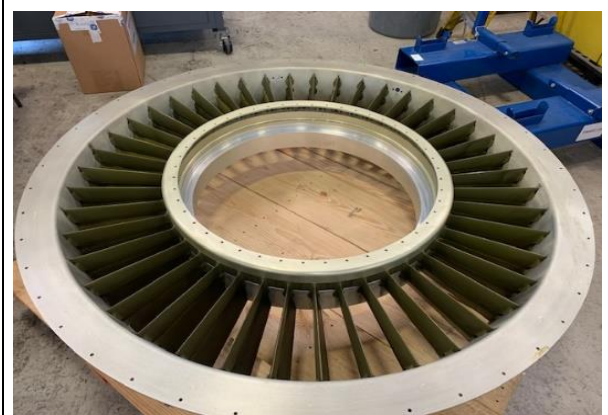
LPC, HPC, and VIGV before and after Ice / Steam cleaning

Note: There is heavy black pollution on vanes which requires Steam and Ice Cleaning to remove it.  
VIGV – LPC - HPC Rotors were dry ice cleaned, Cases where first steam cleaned and HPC Cases had additional dry ice clean after steam cleaning, VIGV and # 5 race is also steam cleaned.

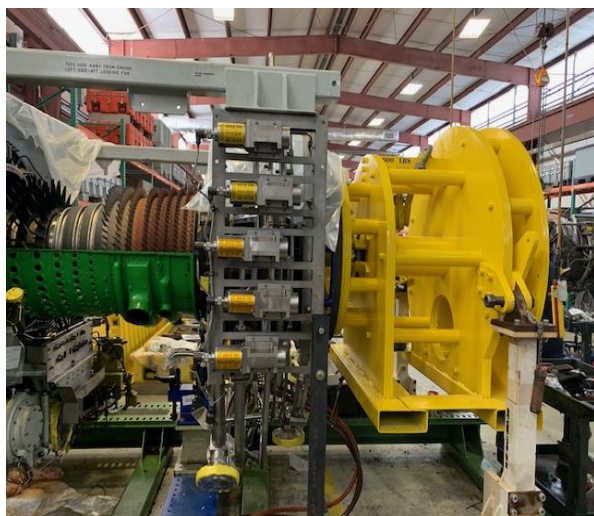
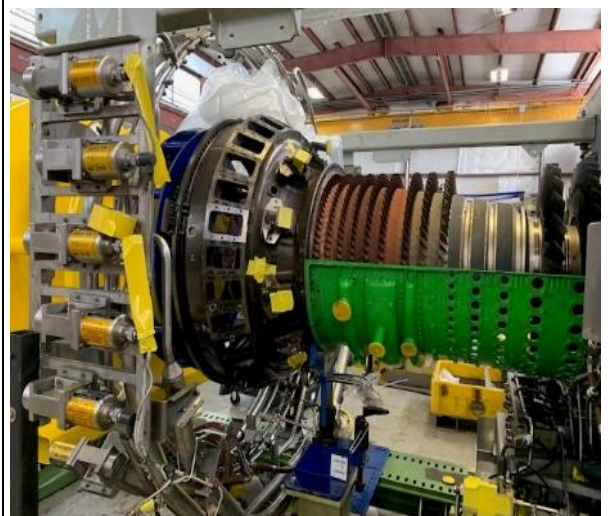
LPC, HPC Rotors with Dummy Cases and Dummy LPT:

LPC, HPC Cases were removed to perform Ice Cleaning and replacing the damages Vanes / Shrouds

LPT was removed to remove and exchange TRF rotatable and installation of new seals

VIGV was removed to perform Cleaning
