# RAPID ASSESSMENT OF ZALUN BANK EROSION (DRAFT)

field inspection, diagnosis and first recommendations

RVO in collaboration with DWIR

8 FEBRUARY 2020

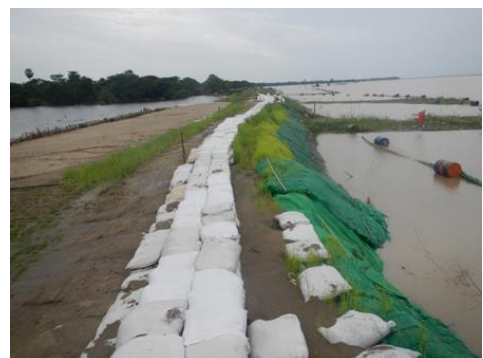
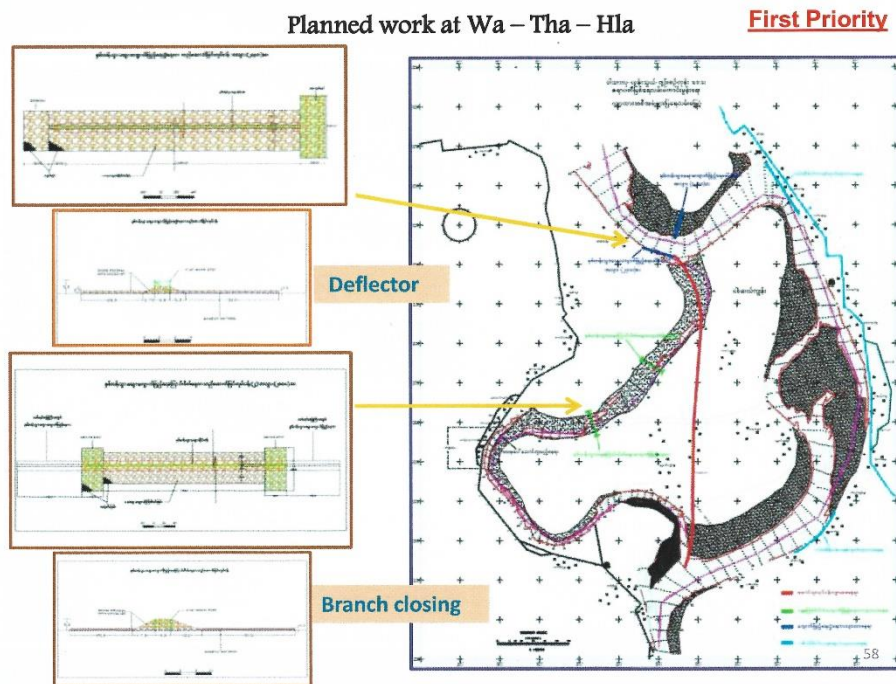
*Figure 2 Planned and executed river work north of Zalun (2017)*

The strategy in Myanmar to deal with meandering channels is as follows. Once the moving river channel approaches the embankment within 30 m, a secondary embankment is constructed at some (inland) distance from the primary embankment. This was also the situation in 2015 at Du Ya, and many attempts were made to stop the ongoing erosion, including the placement of flow diversion screens, and the placement of sandbags (see photo taken by the author in September 2015). By the time, it appeared difficult to maintain the new embankment and the local bank erosion continued. To better control it, DWIR dredged a meander cut-off channel in 2016/2017. The plan for this system intervention was discussed during the DRR mission in 2015 when author advised to first analyse the hydro-morphological response before opening such new channel. However, proper tools to do so were not available at the time and the works were carried out according to plan, which comprised the construction of training walls, closing of branches and the excavation of an approximately 14 km long, 35 m wide and 2 m deep (below low water level) channel in a straight line through the centrally located sand bar (see Figure 2 below obtained from DWIR in 2015 - the work has been carried out in 2016/2017).

The morphological response of the river to these interventions was intense: the new cut-off channel quickly deepened and widened, started to meander itself and extended southwards, resulting in significant erosion of the floodplain downstream. Intense erosion was also observed along the primary west embankment, around mileage 22.0 (some 8 km north of Zalun) – see right two photos taken from the boat during the field inspection on 27 January 2020. Today, the erosion has reached the city of Zalun, where the existing revetment is already undermined and damaged (left photo below in Figure 3).

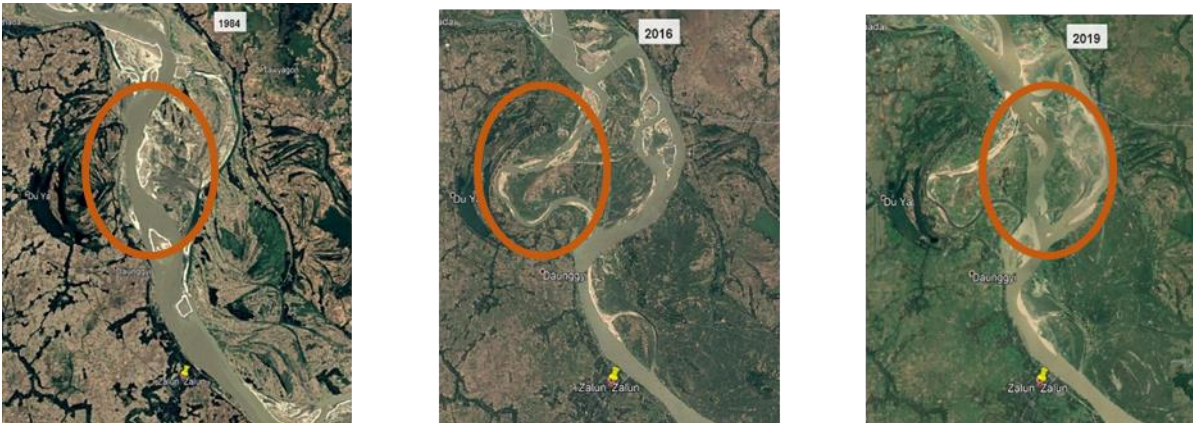
Figure 4 Satellite images 1984, 2016 and 2019

Figure 4 shows the situation north of Zalun, which city is marked with the yellow pinpoint, in 1984, 2016 and 2019. By comparing 1984 and 2016 it can be seen how the main channel split up in two channels with the smaller one meandering far westwards. This smaller channel caused the severe erosion problems near Du Ya, which was the motivation to excavate the cut-off channel visible in 2019. Note that the situation in 2019 is much different than shortly after the excavation in 2017 when the channel was initially straight and narrower.

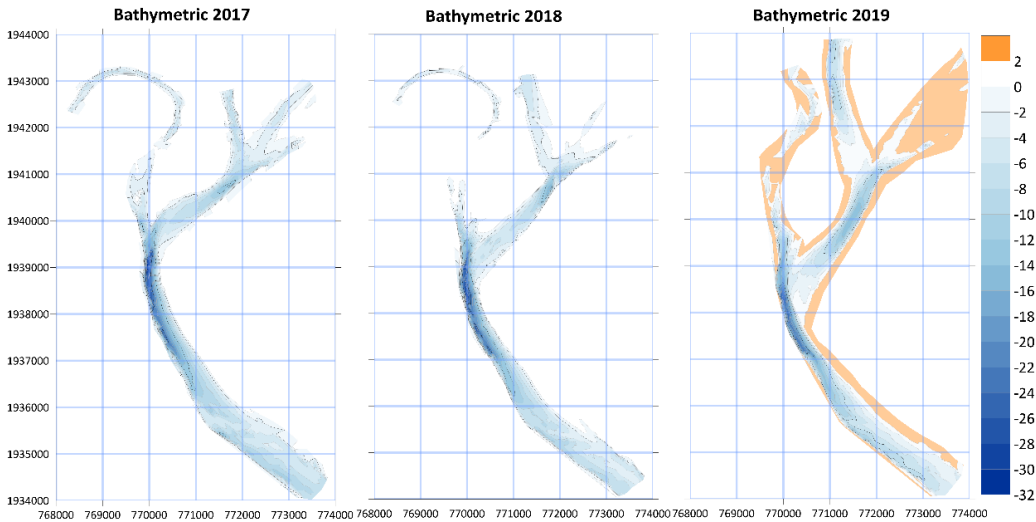
Figure 6 Bathymetry maps 2017, 2018 and 2019

DWIR has carried out bathymetric surveys in November 2017, November 2018 and November 2019, which data provides the opportunity for a more detailed analysis of the morphological changes. The original measured depths were interpolated using Triangular Irregular Network method (TIN) using 0,5 m gridding distance, resulting in the bathymetry maps shown in Figure 6 below.

It is recommended that quarterly single-beam surveying of the full river channel and lower-economic critical sections surrounding Zalun is done (same area as in Figure 6). In addition, monthly multi-beam monitoring of the riverbed of the specific locations where measures are implemented is required. For example, the multi-beam bathymetry would allow to detect before, during and after the wet season how the barrels are positioned on the slope and whether they are changing position over time. In addition to bathymetric data, it is helpful if ADCP data is collected as it will allow to relate any bathymetric changes to specific current flow patterns. These two types of monitoring, if done consistently, will yield a better understanding of the annual river morphology and will allow to better capture the effectivity of current and to-be implemented measures.

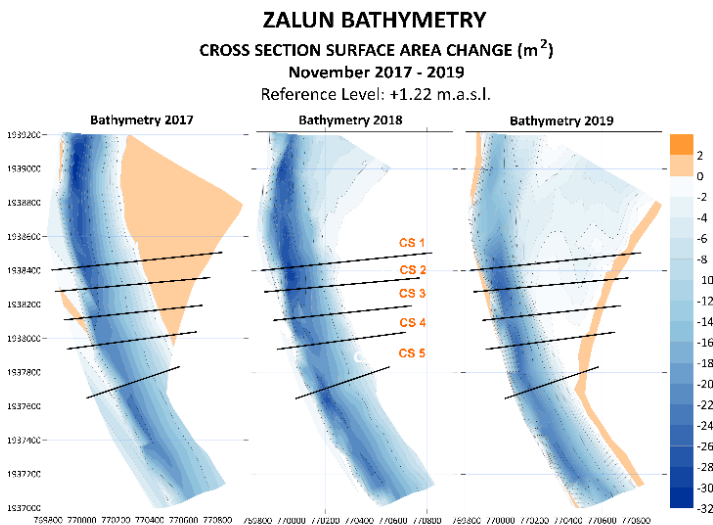
Figure 10 Locations of five cross-sections for calculation of cross-sectional flow area

The so-called “cross-sectional flow area” (in m<sup>2</sup>) almost linearly depends on the discharge that flows through that cross-section. This means that if twice as much water flows through a cross-section, that the total surface area will also double. Five cross-sections were selected (see Figure 10) and for each of them, the cross-sectional flow area below the local reference datum (0.00 m) was calculated. The results are given in the table below:

What follows from this analysis is that in 2017, when the morphological changes near Zalun were not as manifest as in 2019, the cross-sectional flow area varies maximum 4 percent between the five cross-sections. This suggest a relatively stable situation. In 2018 not much changed, but in 2019 the five cross-sectional areas reduce with some ten percent with smaller flow areas going from north (cross-section “1”) to south (cross-section “5”). Although year to year differences in river discharge will also have an impact, this may suggest that the flow velocities towards the south, so towards Zalun, increases (roughly with some 10 %). After all, the same volume of water that goes through cross-section “1” also needs to pass cross-section “5”. If the riverbed would entirely consist of erodible sediments such as sand, this increase in flow velocity

would lead to bed erosion, which, however, is probably prevented due to the presence of less- or non-erodable clay layers at the river bed.

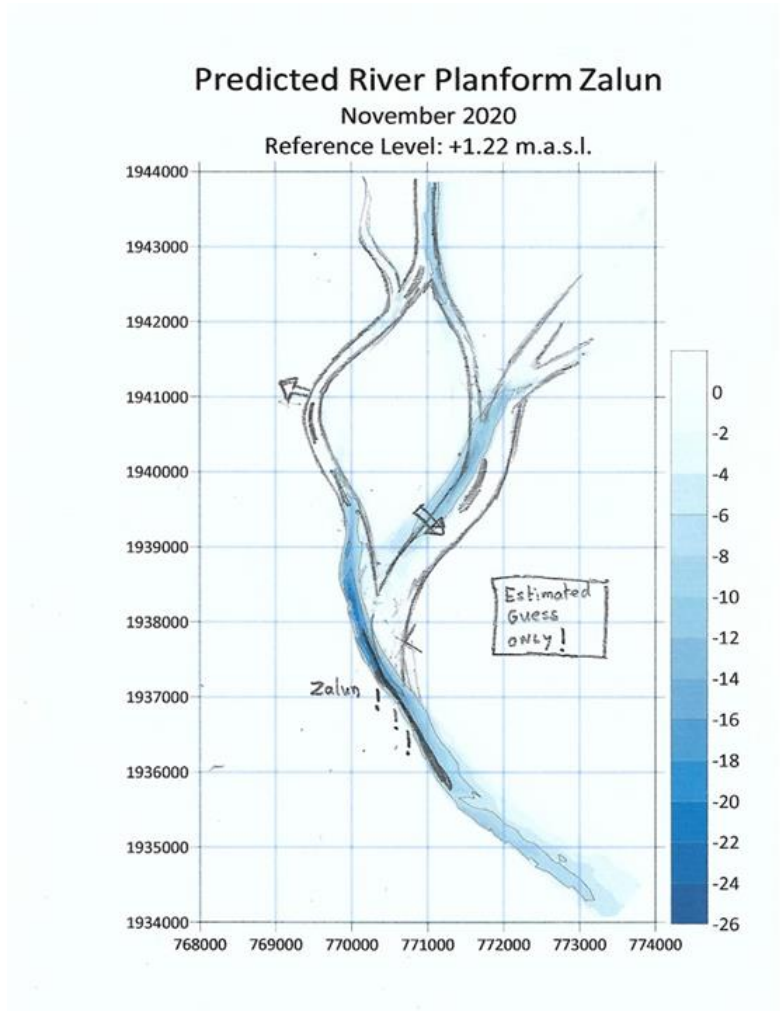
Figure 11 Estimated guess of bathymetry November 2020

channel. It is possible that this new side-channel may further grow and develop into a major river branch which may meander towards the west as this has occurred for many decades in the past. Figure 11 shows how this may look like in November 2020. It would give some relief to the erosion along the west bank because the direction of the flow then becomes more parallel to the river axis instead of under an angle to it.

Although this possible development seems promising, it will not give immediate relief to the erosion situation at Zalun. Thanks to the presence of poorly-erodable clay layers, the erosion will be limited, but can at some place still be several meters. However, the safety situation is already urgent today because the revetment has already been damaged, and because landslides can occur due to unstable riverbank (underwater and above water profile).

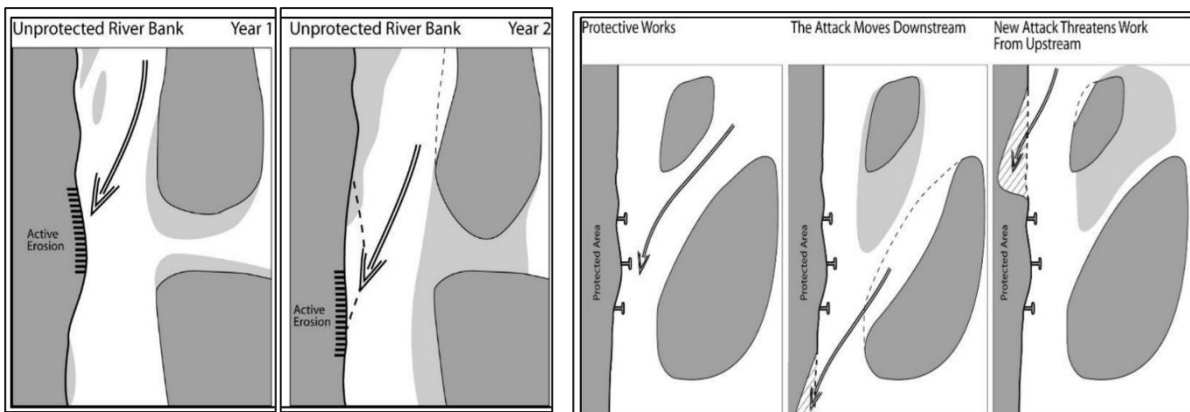
Figure 15: Major rivers are characterized by permanently shifting locations of erosive attack on riverbanks (left); Frequent problems with too short riverbank protection (right).

In addition to the possible problems following the construction method of the barrel measure, it is argued that more is required than post-erosion attack mitigation measures (emergency adaptation). This is especially pivotal as major rivers, such as the Ayeyarwady, are characterized by continuously shifting location of erosive attack (Figure 15, left).

In addition to these inherent characteristics of erosion behavior in major rivers, the actual erosion prevention/mitigation measures should also be sufficiently long so that the measure itself does not lead to a direct shifting of the erosive attack as illustrated in Figure 15 (right).

Therefore, the Zalun riverbank erosion prevention requires - apart from careful preparation and implementation - extensive and effective monitoring and surveying so to keep track of whether the barrel construction remain in place throughout the wet season. This could be realized by multi-beam surveying. Effective surveying and bathymetric analysis will allow DWIR to better cope with the unpredictability inherent to major river systems. This is especially relevant as in monsoon dominated river systems, where the difference between dry season and wet season flows is significant, designs and planning can only be realized one year at a time, i.e. what is built in year one, will change the river morphology in year two. Hence the design for riverbank protection in year two can only be made once the response to the year one construction is visible, measured and presented. This asks for a more adaptive approach towards river engineering works.
