| General info | | | |
|---|---|---|---|
| Subject: | Boroscoop inspection Gasturbine 3 (GT3) | Inspection Date: | 30-06-2020 |
| Manufacturec: | General Electric | Inspection done by: | R. van Dongen |
| Type: | Frame 9E (MS9001E) | Report by: | J. Sassenburg |
| KKS: | EFR31-MB | Report no: | 21-1332 |

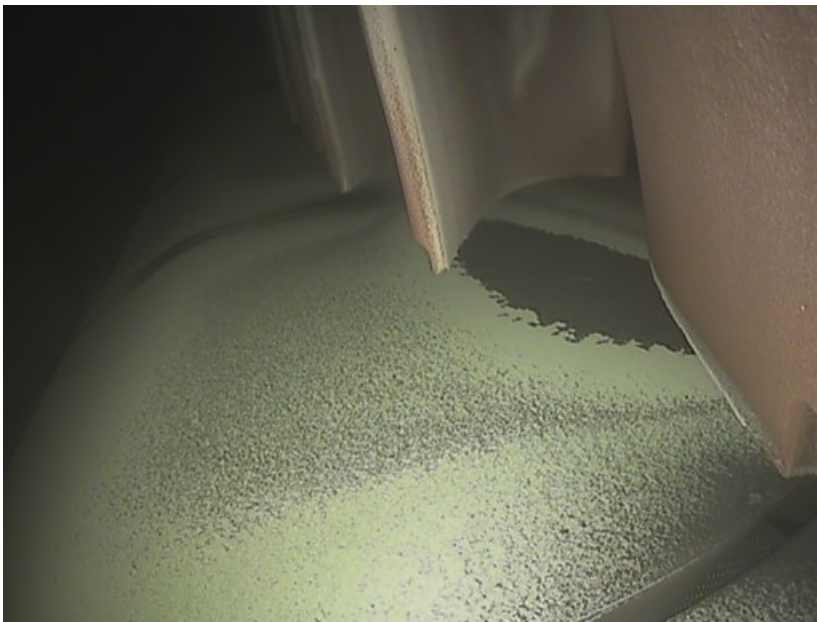
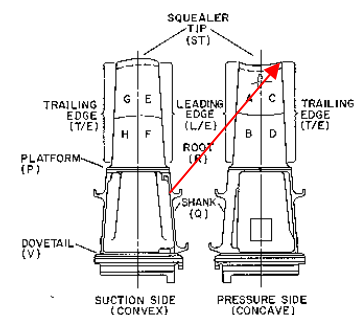
Foot of bucket T/E pressure side

- At the Leading Edge no particularities of the blade
- At the Trailing Edge no particularities of the blade
- TBC Coating applied in 2015 some places coating cracked or moved
- Furthermore nothing special.

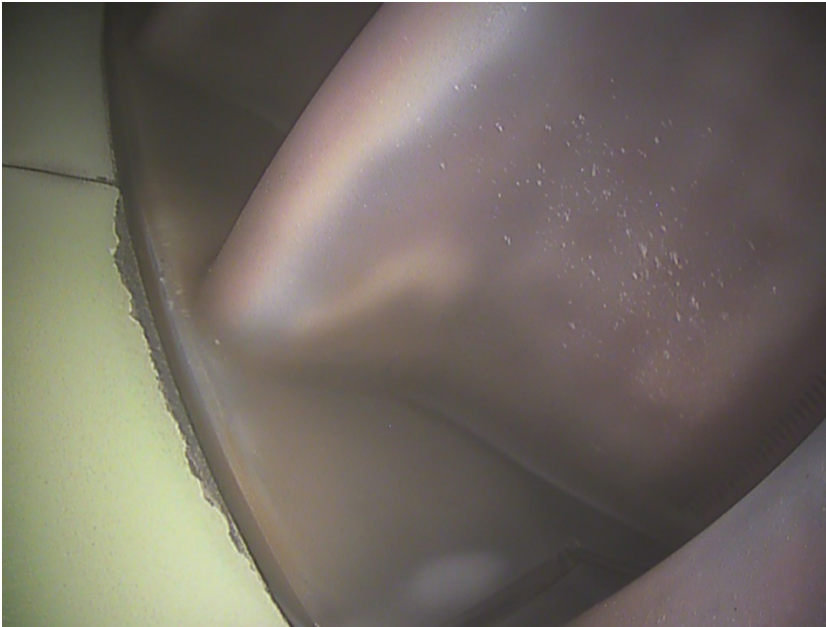
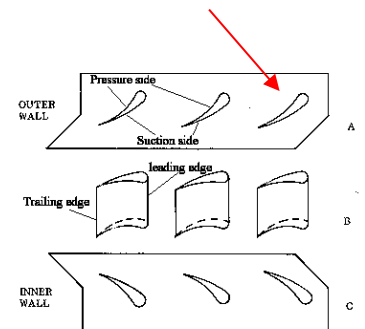
Top of nozzle L/E outer wall pressure side

- No cracks were found in the inner and outer wall of the nozzle
- No closed cooling holes detected.
- No curved walls of the outflow side detected.
- Furthermore nothing special
