GAS TURBINE INSPECTION REPORT

**EON ROTTERDAM HOT  
GAS PATH INSPECTION  
AND COMPRESSOR  
INSPECTION**

EON BENELUX NV

ROTTERDAM, Unit 3

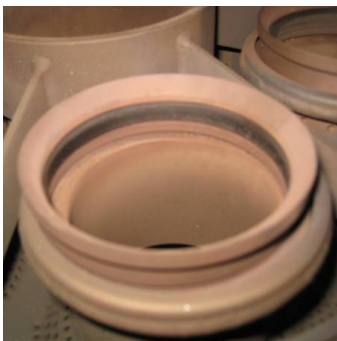
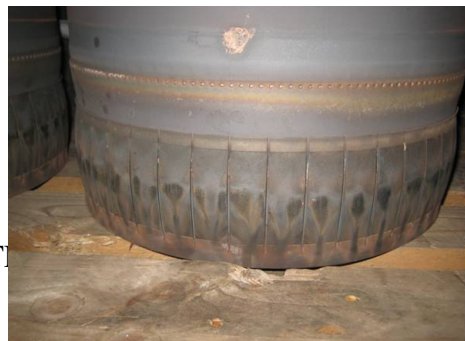
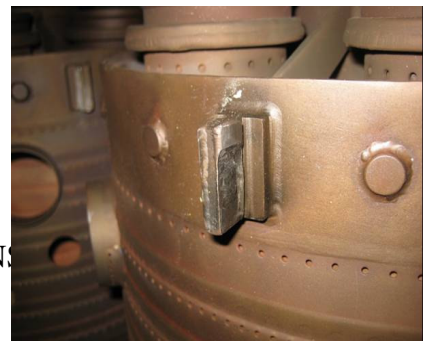
Fuel nozzle collar light wear

liner hula seal in medium condition

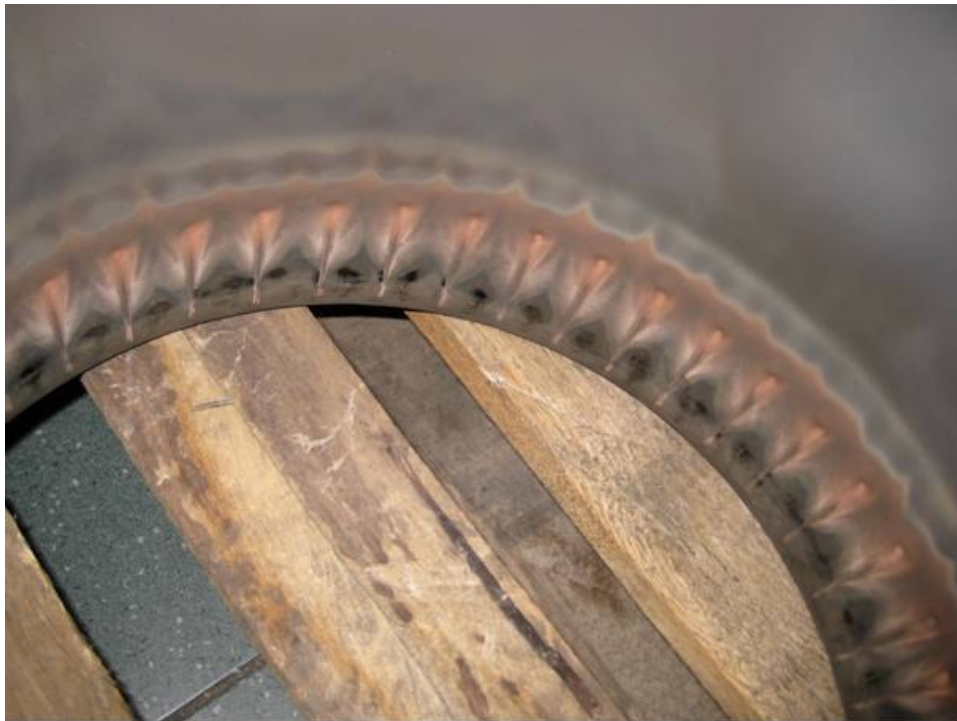
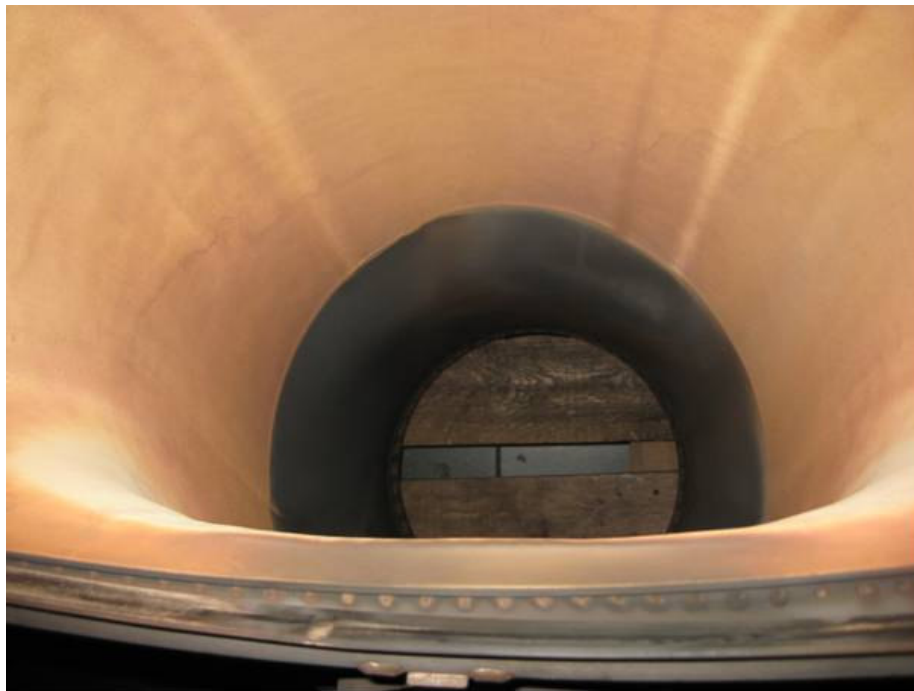
GT3055xfire tube&retainer gen cond(a)

Retainers whole set have been found worn medium while all cross fire tube collar were severely worn and body discoloration was showing evidence of hot spot.

TCB GENERAL GOOD CONDITION EXPECTED DISCOLORATION IN ACCORDANCE WITH UNIT TOTAL FIRED HOURS

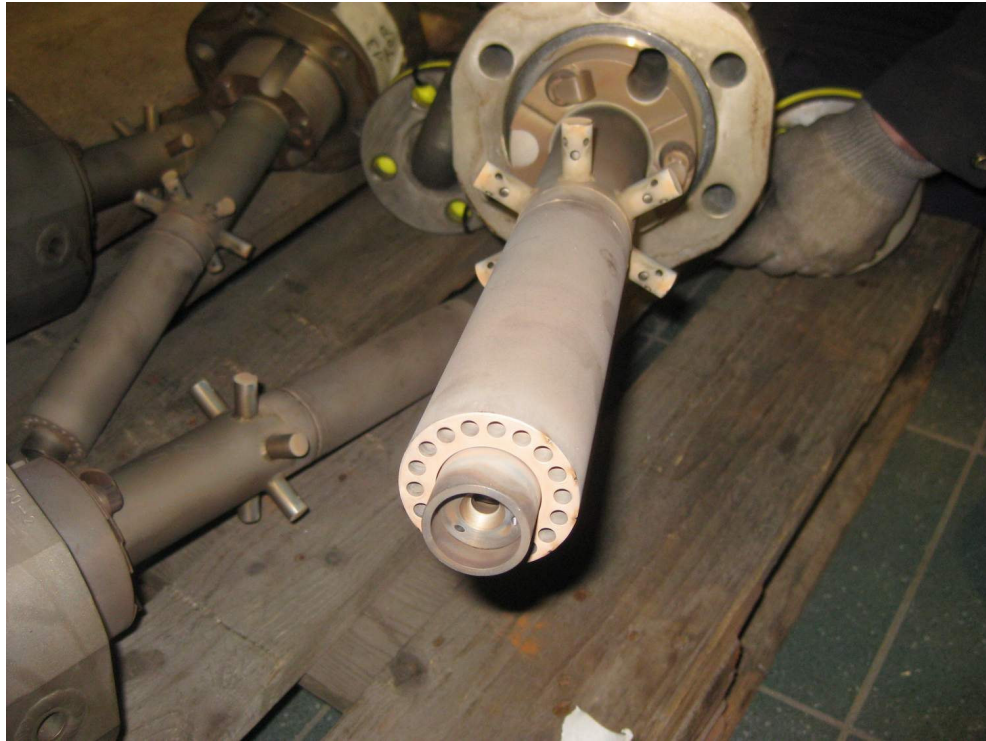
SECONDARY GAS FUEL NOZZLE WITH LIGHT CARBON DEPOSIT AND DISCOLORATION ON ITS TERTIARY TIP

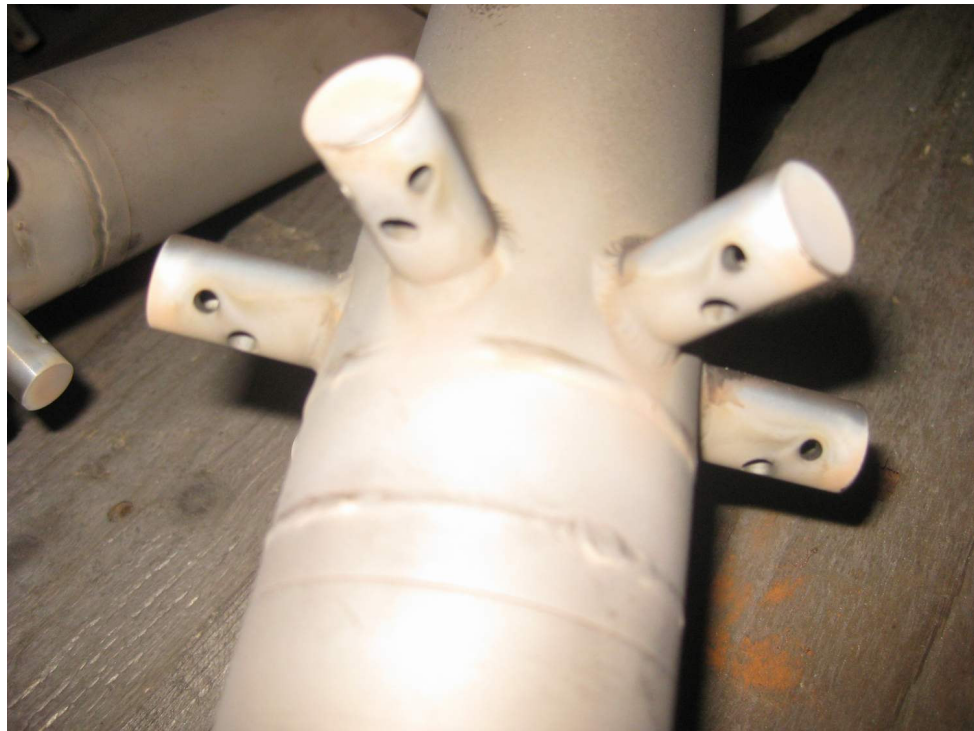
SECONDARY GAS FUEL NOZZLE WITH LIGHT CARBON DEPOSIT AND DISCOLORATION ON ITS SECONDARY TIP

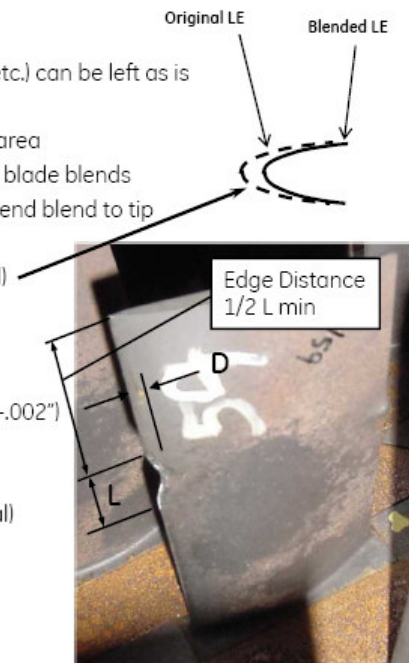
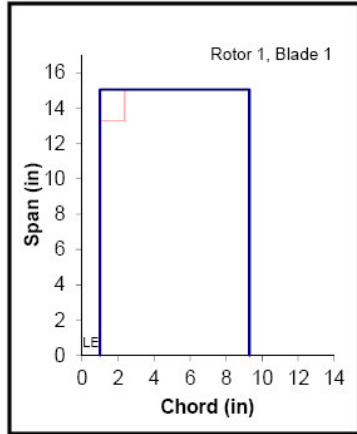
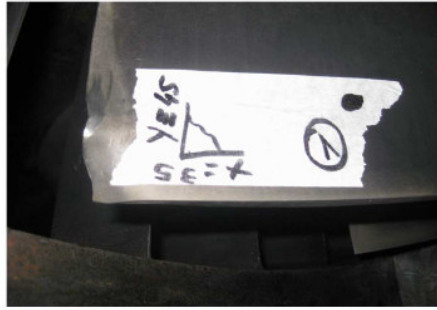
R1-B1.JPG

| Frame | 9E | Stage | 1 | Blade | 1 |
|---|---|---|---|---|---|
| 1 | LE | 0.00 | 1.38 | 1.77 | Bent Tip |

Damage requires analysis of blade.  
Disposition to follow.

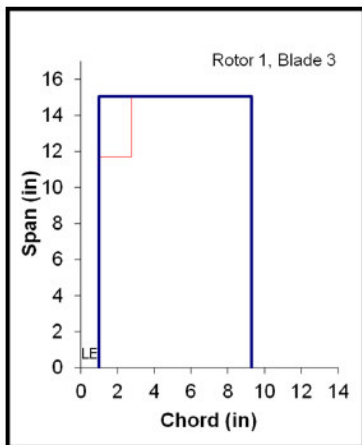
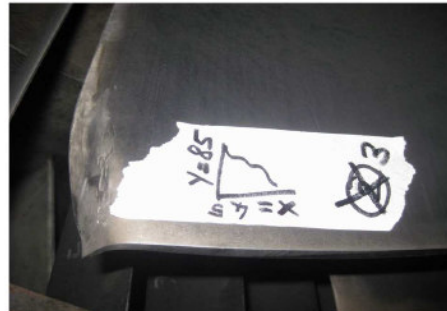
R1-B3.JPG

| Frame | 9E | Stage | 1 | Blade | 3 |
|---|---|---|---|---|---|
| 1 | LE | 0.00 | 1.77 | 3.35 | Bent Tip |

Damage requires analysis of blade.  
Disposition to follow.

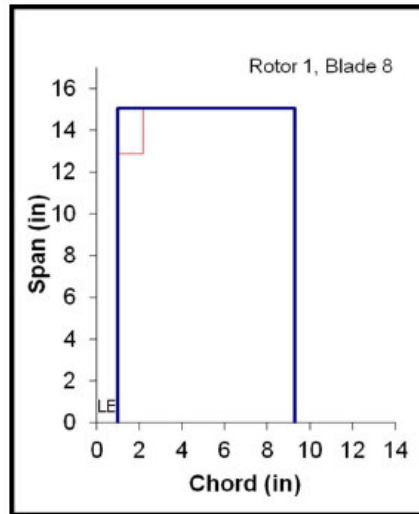
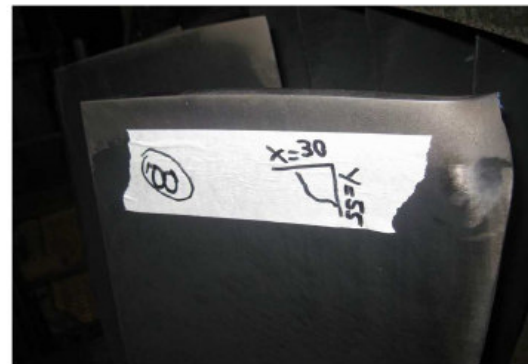
R1-B8.JPG

| Frame | 9E | Stage | 1 | Blade | 8 |
|---|---|---|---|---|---|
| 1 | LE | 0.00 | 1.18 | 2.17 | Bent Tip |

Damage requires analysis of blade.  
Disposition to follow.

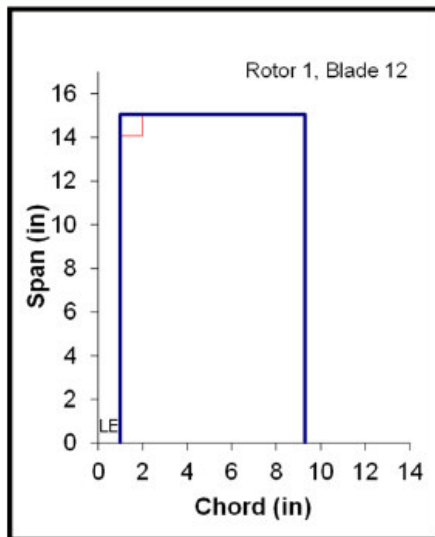
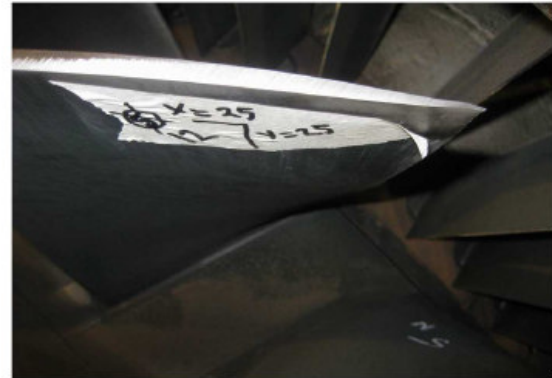
R1-B12.JPG

| Frame | 9E | Stage | 1 | Blade | 12 |
|---|---|---|---|---|---|
| 1 | LE | 0.00 | 0.98 | 0.98 | Bent Tip |

Type I blend repair to remove damage. Only remove as much material as necessary.  
Use D=0.99 inch, C=0.99 inch.  
FPI post blend.

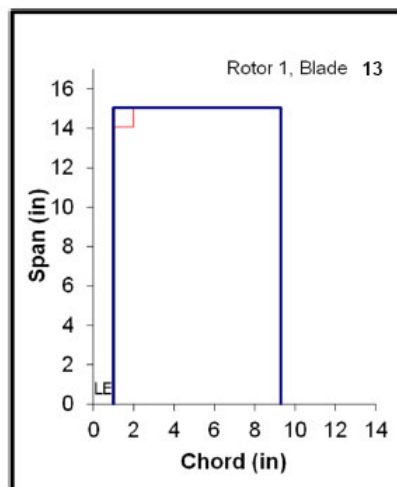
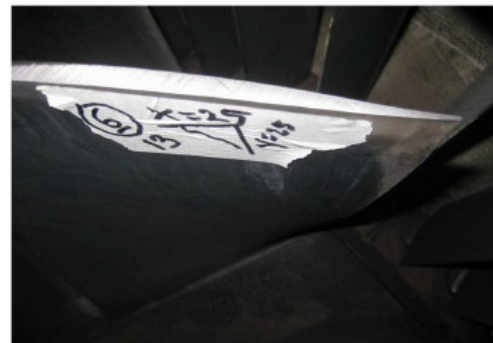
R1-B13.JPG

| Frame | 9E | Stage | 1 | Blade | 13 |
|---|---|---|---|---|---|
| 1 | LE | 0.00 | 0.98 | 0.98 | Bent Tip |

Type I blend repair to remove damage. Only remove as much material as necessary.  
Use D=0.99 inch, C=0.99 inch.  
FPI post blend.

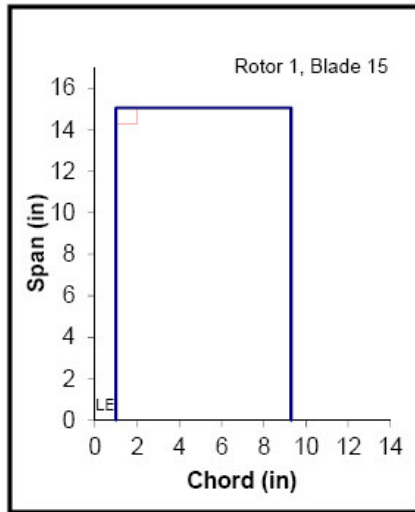
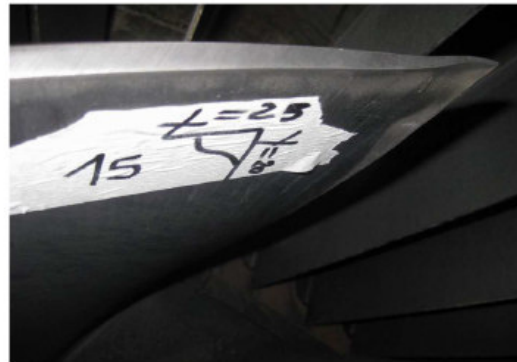
R1-B15.JPG

| Frame | 9E | Stage | 1 | Blade | 15 |
|---|---|---|---|---|---|
| 1 | LE | 0.00 | 0.98 | 0.79 | Bent Tip |

Type I blend repair to remove damage. Only remove as much material as necessary.  
 Use D=0.99 inch, C=0.8 inch.  
 FPI post blend.

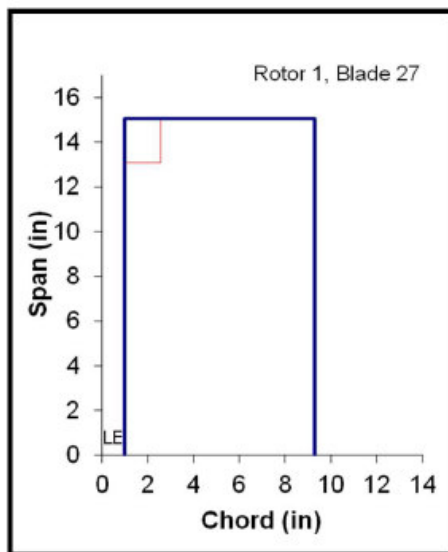
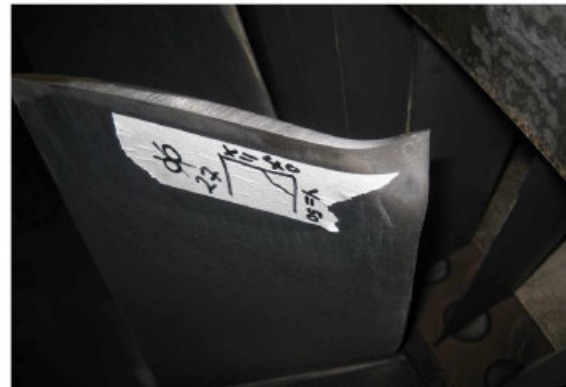
R1-B27.JPG

| Frame | 9E | Stage | 1 | Blade | 27 |
|---|---|---|---|---|---|
| 1 | LE | 0.00 | 1.57 | 1.97 | Bent Tip |

Damage requires analysis of blade.  
 Disposition to follow.

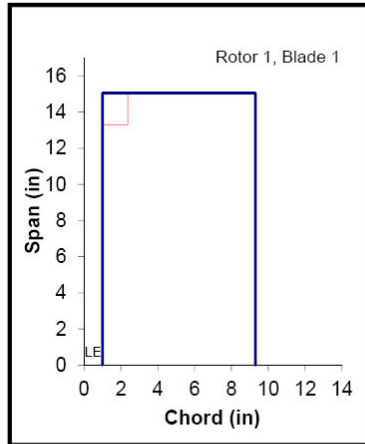
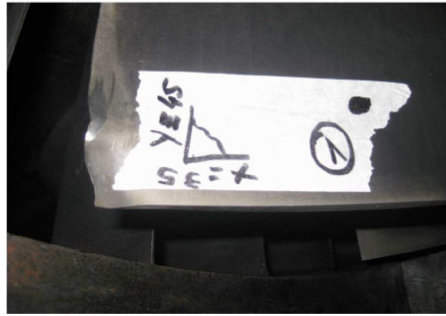
R1-B1.JPG

| Frame | SE | Stage | 1 | Blade | 1 |
|---|---|---|---|---|---|
| 1 | LE | 0.00 | 1.38 | 1.77 | Bent Tip |

Type II blend repair to remove damage. Make sure radius is at least 0.250 inch.  
Use F=1.39 inch, E=1.78 inch.

Make sure all radii are smooth.

FPI post blend.

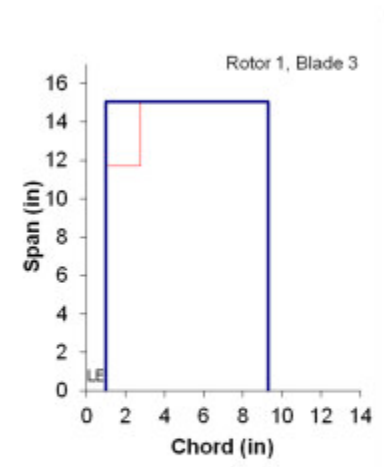
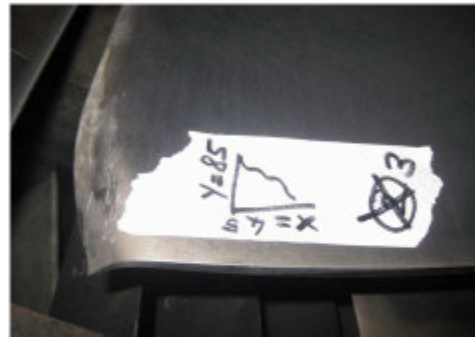
R1-B3.JPG

| Frame | SE | Stage | 1 | Blade | 3 |
|---|---|---|---|---|---|
| 1 | LE | 0.00 | 1.77 | 3.35 | Bent Tip |

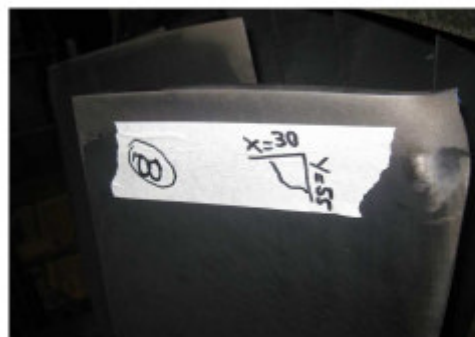
R1-B8.JPG

| Frame | SE | Stage | 1 | Blade | 8 |
| Damage | Edge | D | X | Y | Type |
| 1 | LE | 0.00 | 1.18 | 2.17 | Bent Tip |

Damage 1:

Type II blend repair to remove damage. Make sure radius is at least 0.250 inch.

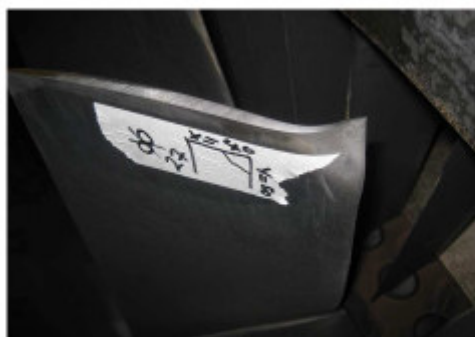
R1-B27.JPG

| Frame | SE | Stage | 1 | Blade | 27 |
| Damage | Edge | D | X | Y | Type |
| 1 | LE | 0.00 | 1.57 | 1.97 | Bent Tip |

Damage 1:

Type I blend repair to remove damage. Only remove as much material as necessary.

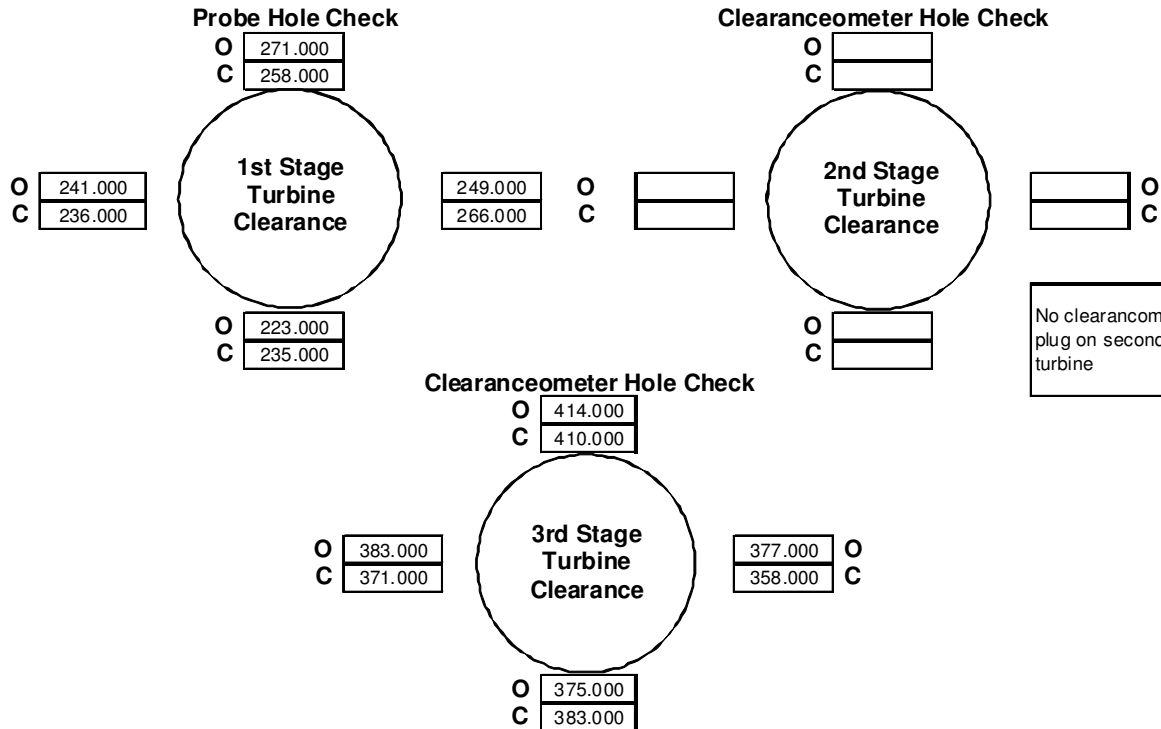
**Comments:**

ROTOR BUMP CHECK WAS DONE AND FOUND 0.6MM

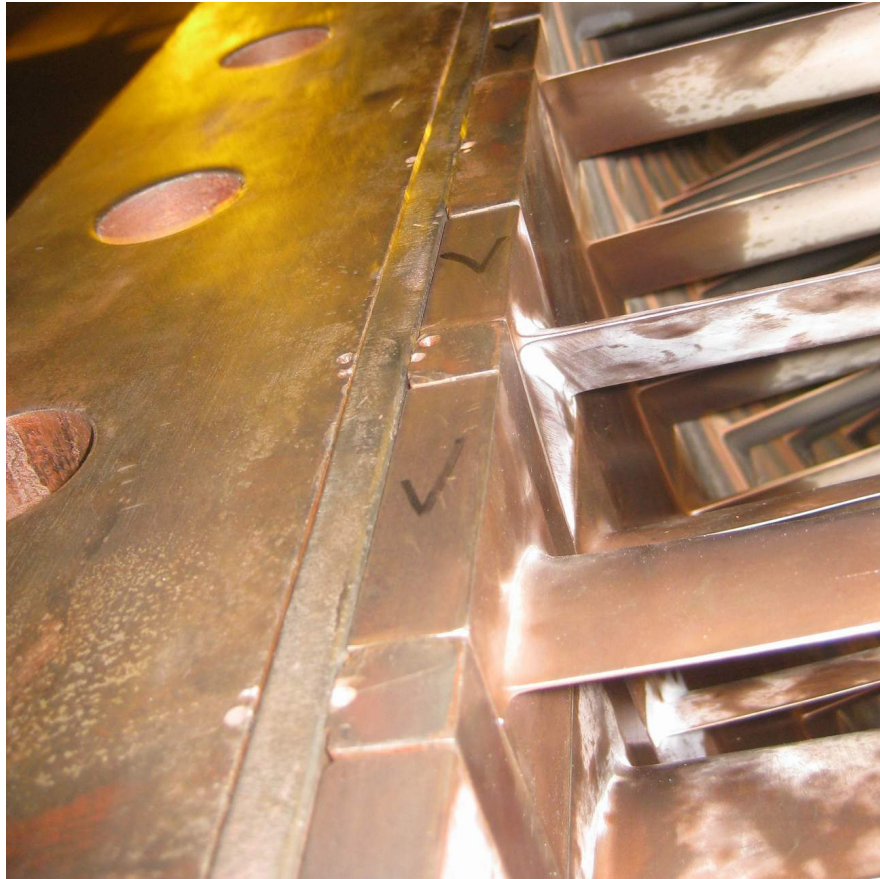
COMPRESSOR STATOR VANE MID JOINT DROP CHECK SET UP AS GE DESIGN VALUES

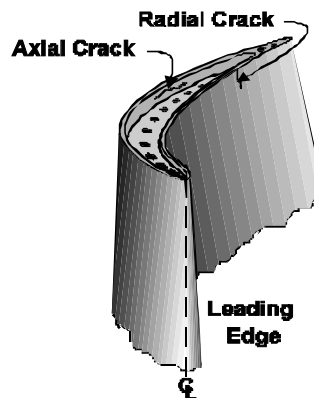
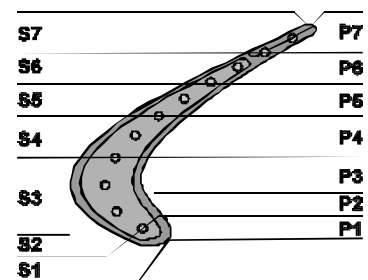
**Comments:**

First stage bucket was found in good condition without any FOD evidence or failure except the fact that it has significant discoloration. All set will be replaced with new as part of this outage scope since they will not last until the next HGPI. We noted squealer tip light rubbing on buckets with no serious consequences.

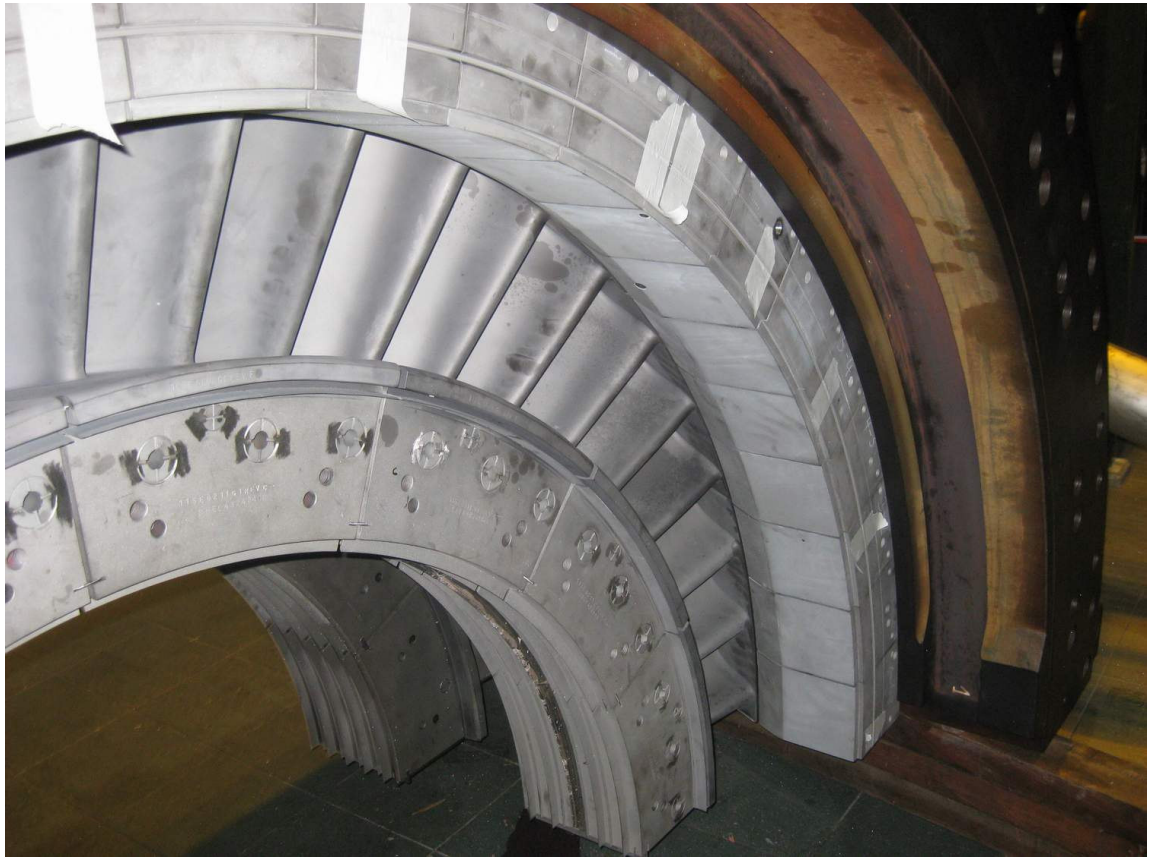
NEW HARDWARE INSTALLATION WITH PRESSURIZED W SEAL IN PLACE

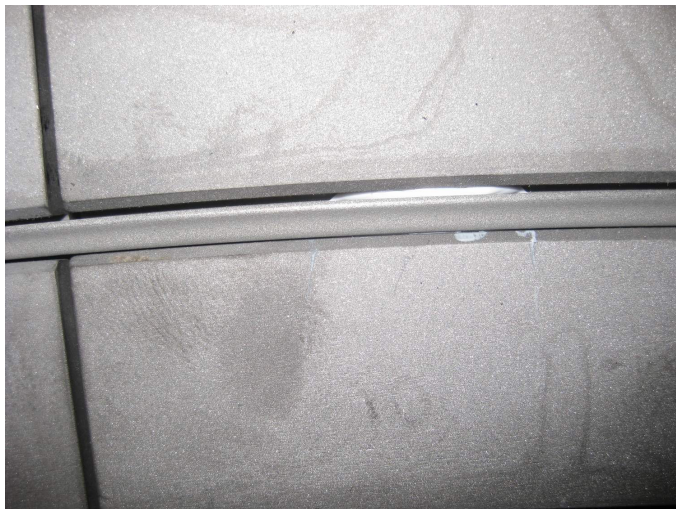
PRESSURIZED W SEAL IN PLACE

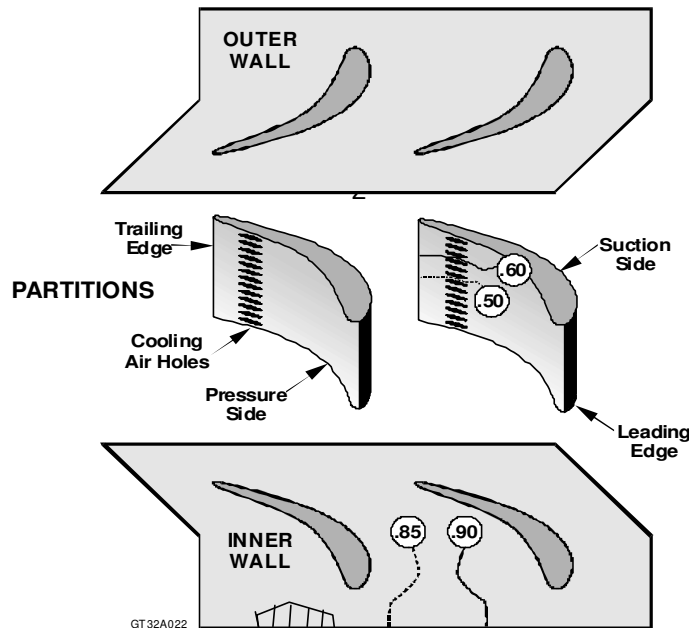
### Comments:

No cracks or any kind of failure third stage nozzle segments were found in a very good condition but still need to be change as part of FMI brush seal system with new aero bucket and nozzle third stage change out.

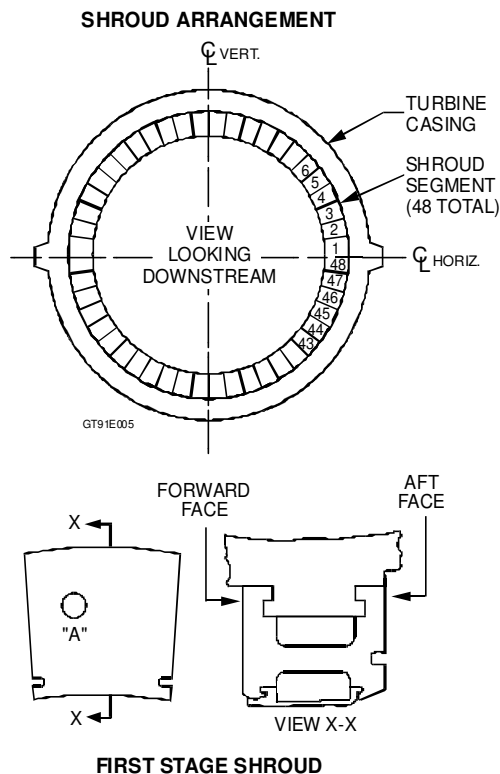
| Comments |
| ALL SHROUD SEGMENTS ARE REPLACED WITH THE NEW SET AS PART OF OUTAGE PREVENTIVE MAINTENANCE |

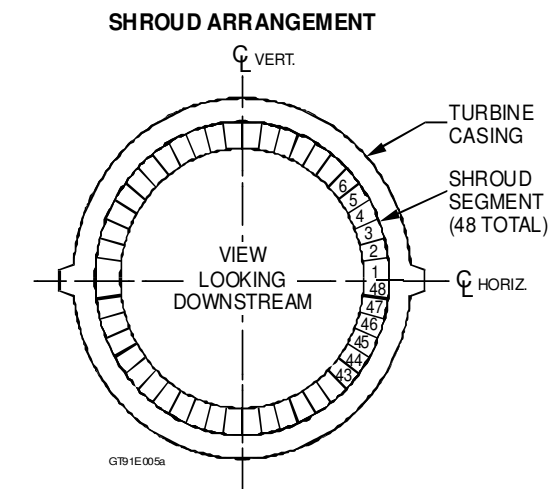
#### Comments

SECOND STAGE SHROUDS ARE ERRODED CORRODED BURNISHED MEDIUM , THEY HAVE ALL BEEN REPLACED AS PER PLANED OUTAGE MAINTENANCE SCOPE

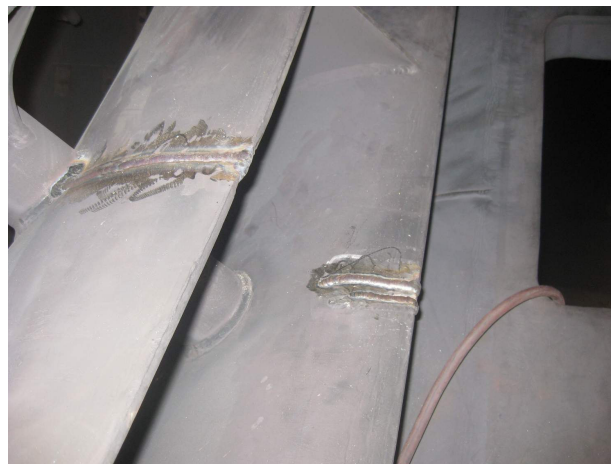
#### EXHAUST DIFFUSOR CRACK WELD REPAIR

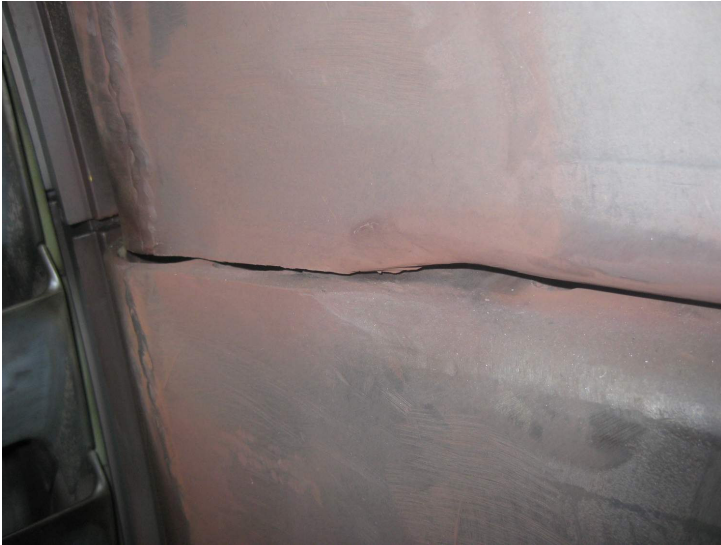
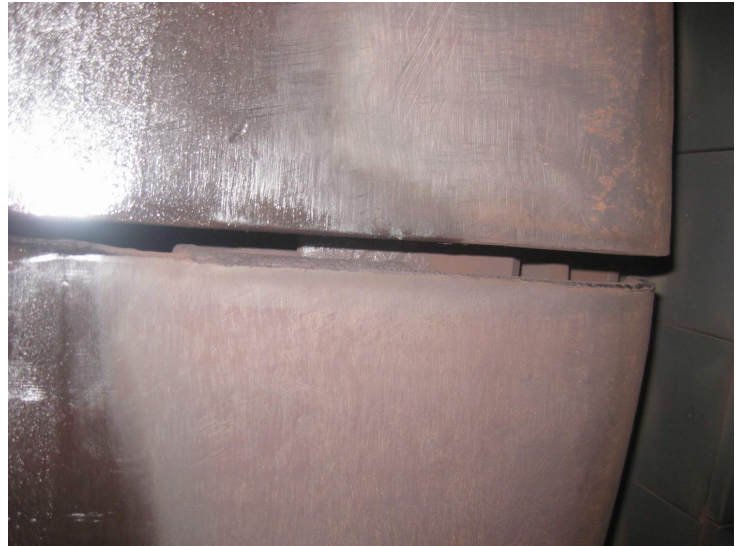
Exhaust diffuser was found cracked on various location and was requiring weld repair performed by customer subcontractor.

Check diffuser condition for potential crack and weld repair with proper electrodes or filler, diffuser is made of B7A62A commonly stainless steel 0304 L by the way filler should be 0308 L.

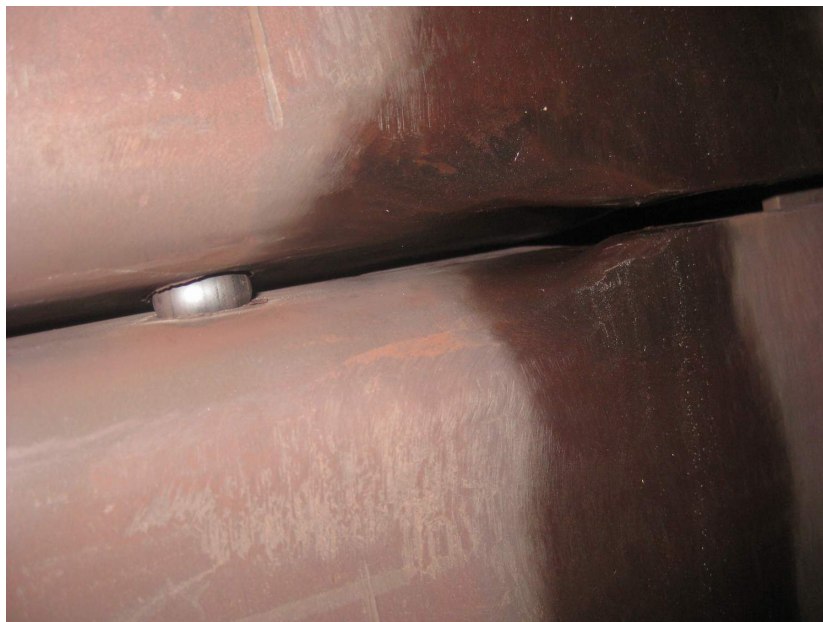
### EXHAUST INNER THERMAL SHIELD MISMATCH

Also during exhaust clean condition check prior to close hatch door we noticed big mismatch of inner and outer exhaust casing thermal shield which probably happened during the last major inspection, seems like they failed in installing upper half exhaust hood which is out of its centering pins.

Check flex seal forward and aft condition and change them if necessary during the next planed HGPI also if possible correct this big mismatch of inner thermal shield at the first opportunity.

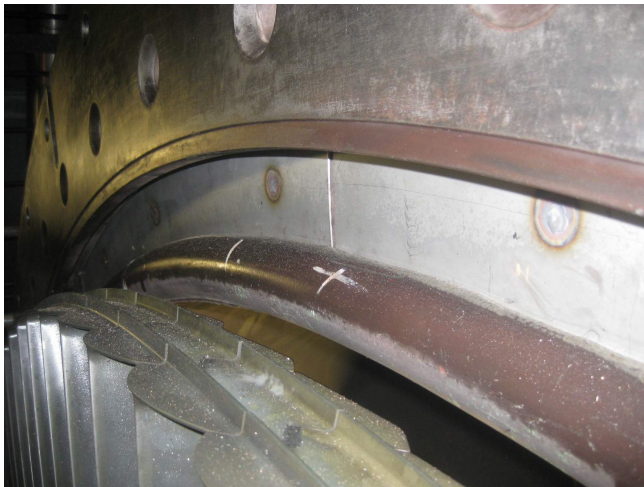
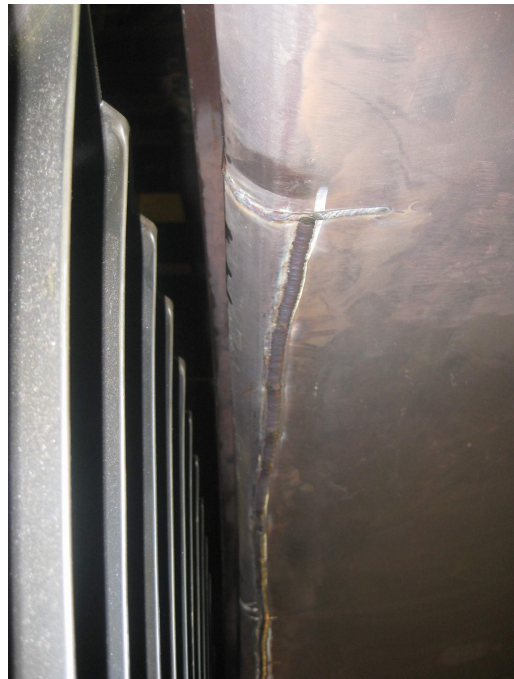
EXHAUST FLEX INTERNAL FLEX SEAL REPAIR BY EON

Exhaust casing forward metal expansion segment flex seals integrated in the exhaust hood were repaired by customer due their bad condition. Seals were heavy worn and disordered in several point. Therefore customer decided to cut the pipe bracket in the exhaust hood forward flange then remove the damaged flex seal afterward weld back and secure the cut piece. The following pictures shows this repair which is not guaranteed by GE since the standard procedure has not been respected.

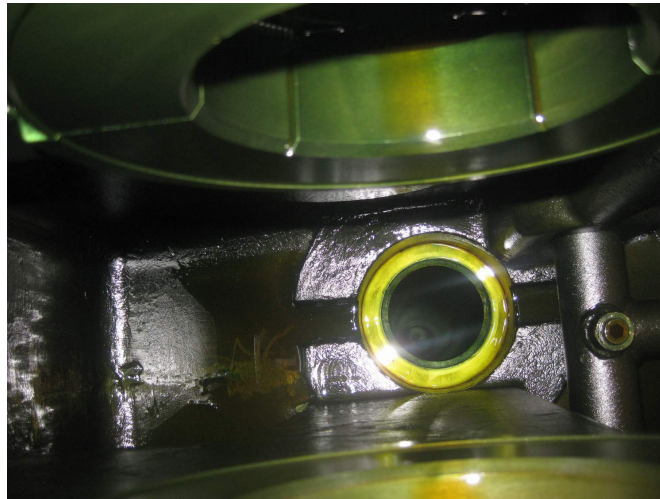
Accessory gear box inspection cover was removed in order to check whether we have Babbitt particles at the bottom of gear box .See the following pictures which don t show any evidence of Babbitt particles neither hard material loss.

NO EVIDENCE OF BABITT DEBRIS

Remove gear box upper half inspection cover and check any trace or debris of Babbitt loss.
