## PROPERTY RISK EVALUATION REPORT

### TILBURG UNIVERSITY

| Premises: | Tilburg University (Stichting Katholieke Universiteit Brabant) |
| Date Visited: | 25 November 2020 |

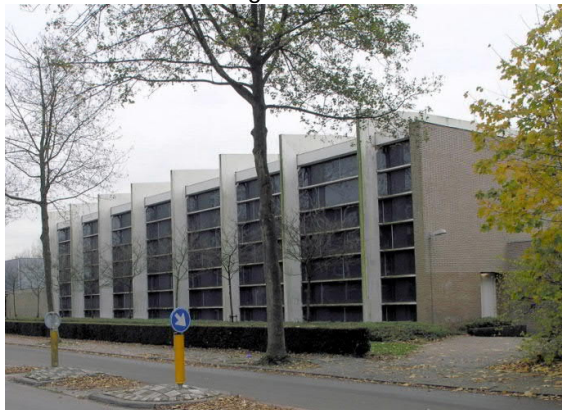
Building O (Olympia)

Only the restaurants in buildings O (Olympia), F (Faculty Club) and R (Restaurant) are not protected with hood protection system. We recommend installing this system in these locations too.
