## 1. Executive Summary

The March 2019 survey of all 14 regional referral hospitals in Uganda conducted by representatives from MOH Uganda confirmed a clear need for intervention into the 6 core departments identified in the 2017 AMPC feasibility study report.

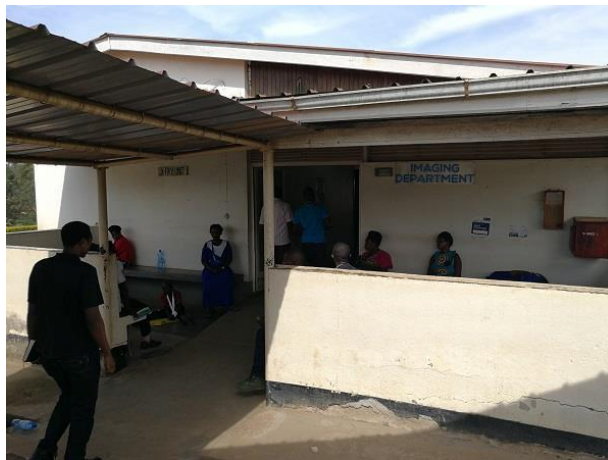
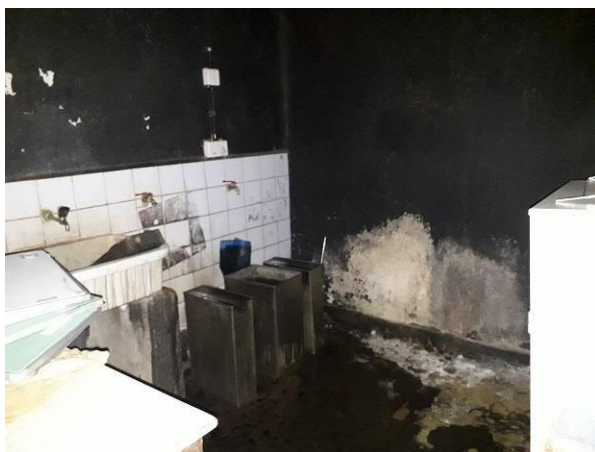
## Radiology:

The Radiology Department is located in a dilapidated, stand-alone structure and is in fairly close proximity to the theatre complex. The Radiology Building has an X-ray machine, which is still functional, but has no automatic film processing units or dryers available. Films are processed manually and hung to dry outside. Ultrasound services are provided from within this department. The building was found to have very limited space and would require expansion to accommodate new and additional equipment. There is adequate space adjacent to the building to accommodate the expansion of the building, however it is recommended that the entire structure be demolished and rebuilt.

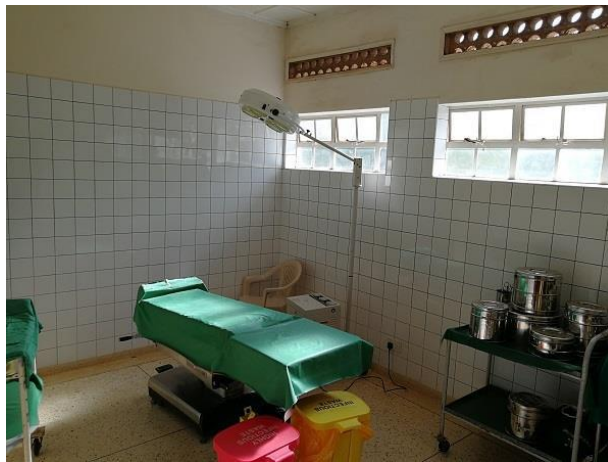
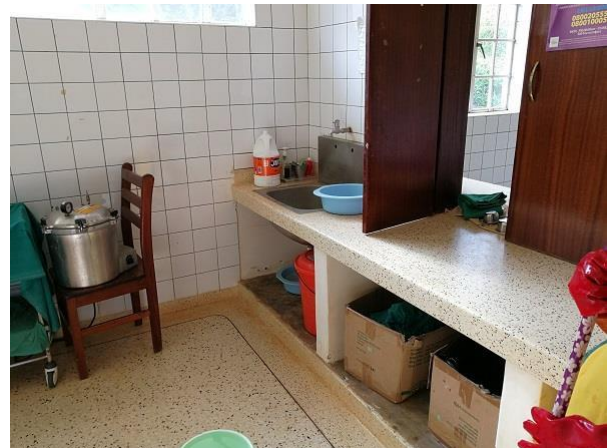
## Accident & Emergency:

The existing A&E unit comprises of 4 beds and a theatre. Due to the lack of staff, and the fact that this unit is only open between 9am and 5pm daily, the occupancies in this ward are very low. There are no afterhours A&E services provided by this department. The A&E is housed in the out-patient building, far from Radiology and the Theatre Complex. The necessary equipment within the A&E was found to be inadequate and/or not available.

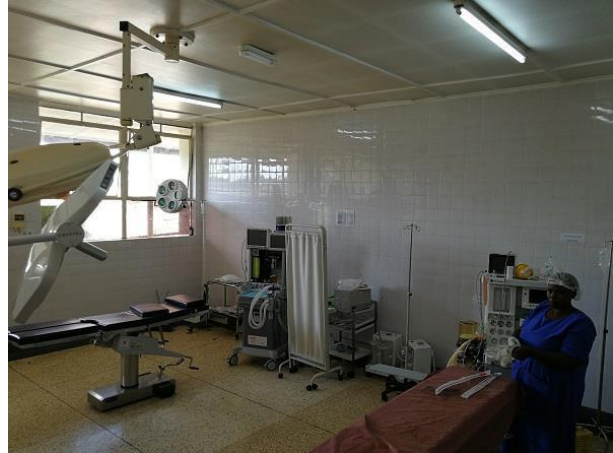
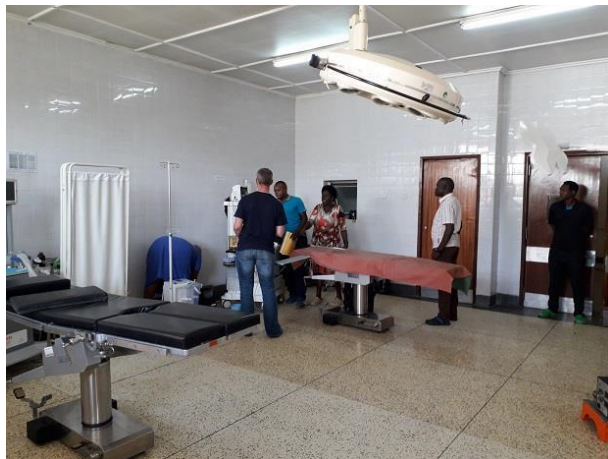
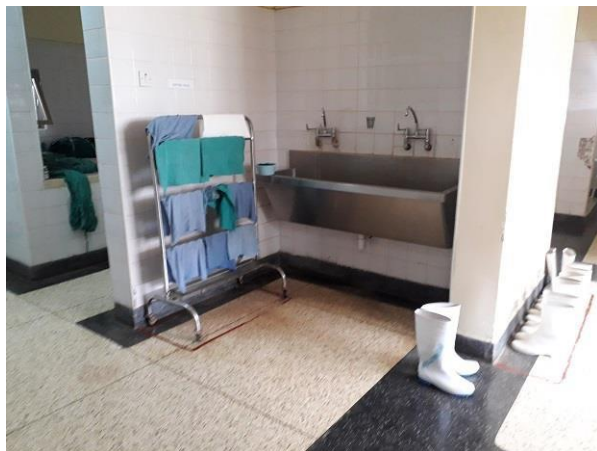
## Main Operating Theatres:

Two theatres are located in a stand-alone building in close proximity to A&E and Radiology. The structure of the building was found to be in a good condition, however the roof structure is dilapidated and the electrical services are not compliant nor safe.

Internally, the Theatre Complex was found to be well kept and functional for the procedures being undertaken, however the equipment being utilised has reached its end-of-life and/or is not functional. Recovery within the Theatre complex is non-functional as there is no equipment available for this function.

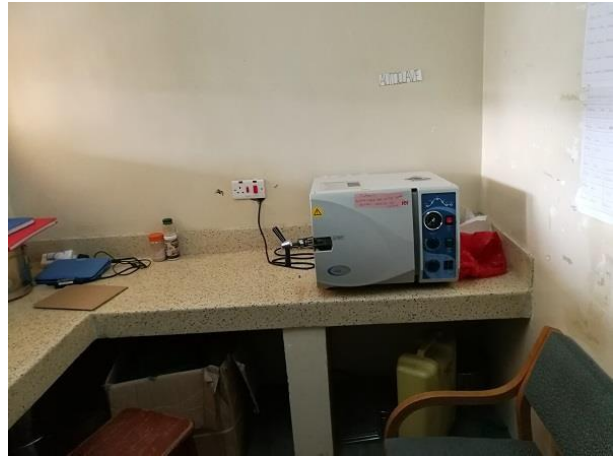
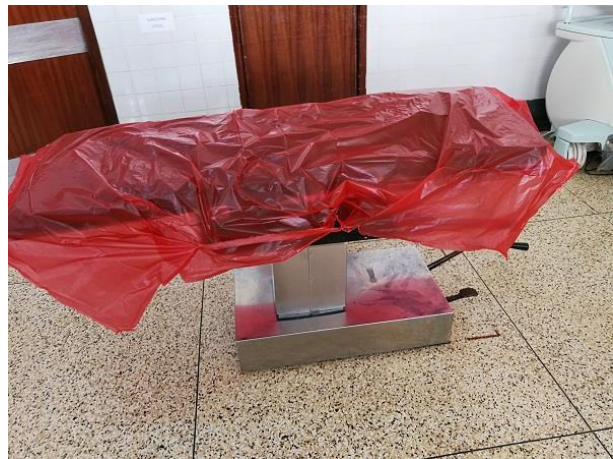
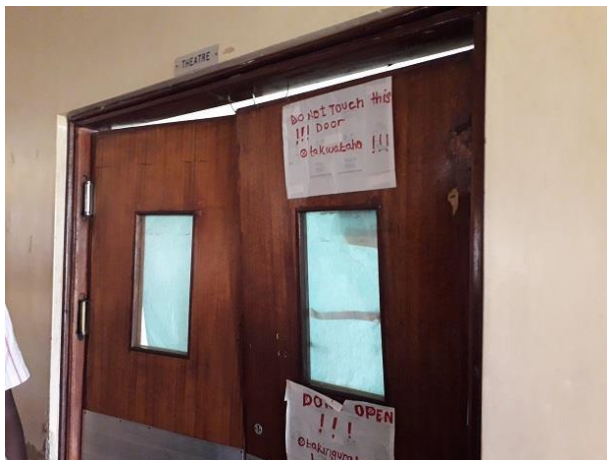
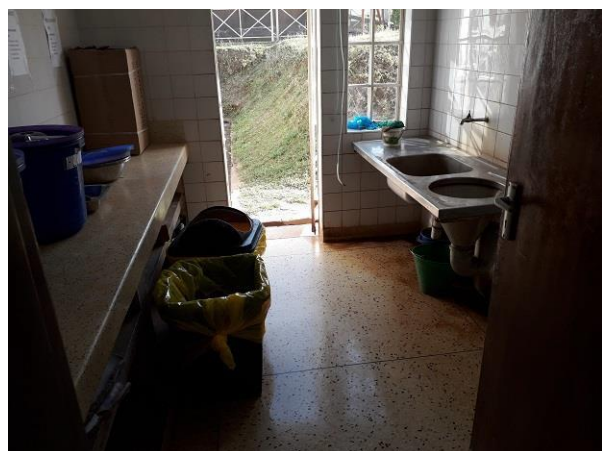
The Maternity Ward is located adjacent to the Radiology Department. Obstetric Theatres are available in the Maternity Ward, however due to the theatres being in use at the time of the inspection, access was not permitted to assess the condition of the theatres and equipment.

The building containing the Maternity Ward was found to be structurally sound, however the roof is dilapidated. Internally the condition of the ward was poor and in need of refurbishment.

Occupancies within the Maternity Ward are very high, with up to 10 Caesarian deliveries being performed per day, indicating an inadequate level of service at District Hospitals with a desperate need for this service by the surrounding population.

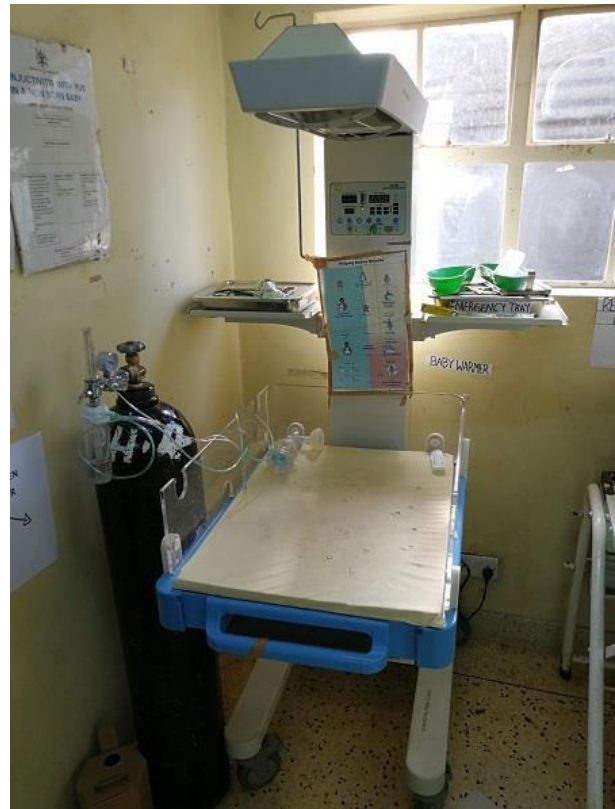
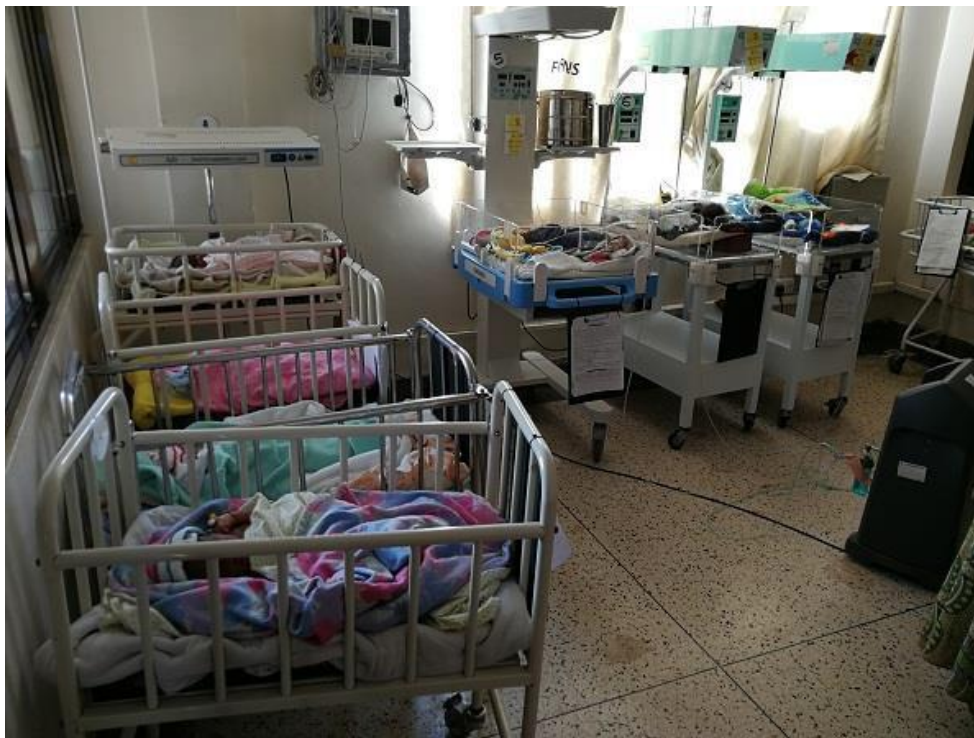
## NICU:

As was observed in the Maternity Ward, the NICU also has a very high occupancy rate with the space being over utilized with end-of-life equipment. Up to 28 babies are born in this facility per day, and there were 21 babies in the nursery at the time of inspection. A localized piped oxygen supply to this room is desperately required as it was observed that up to 5 babies were connected to each oxygen concentrator thus not allowing staff to regulate/monitor the amount of oxygen delivered to each baby.

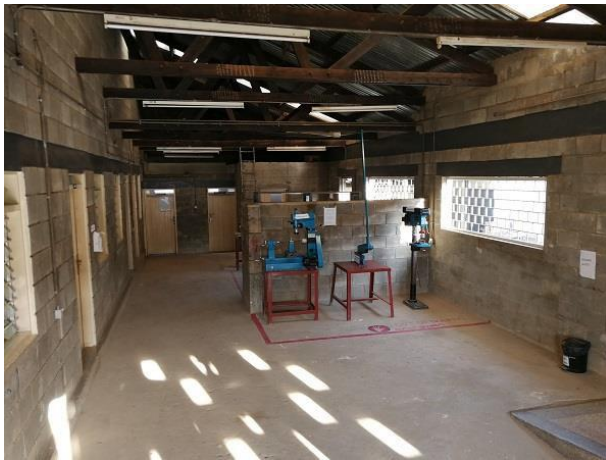
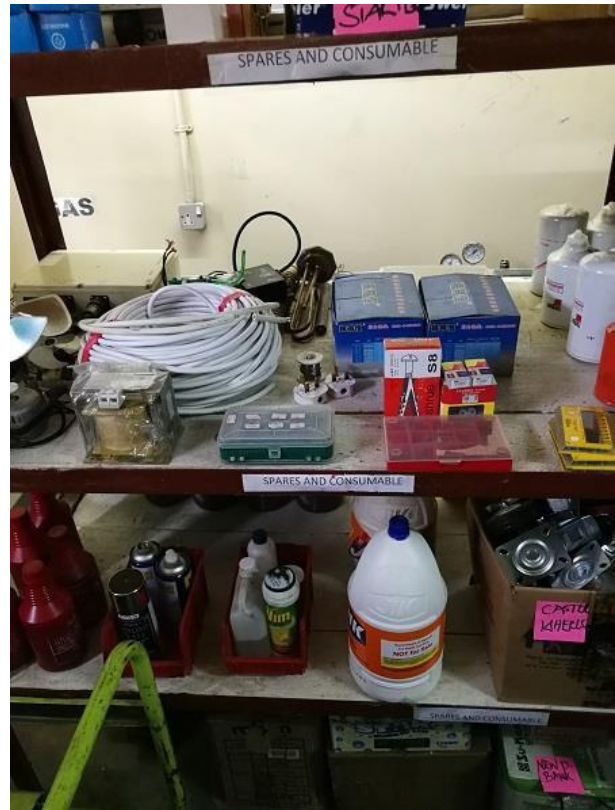
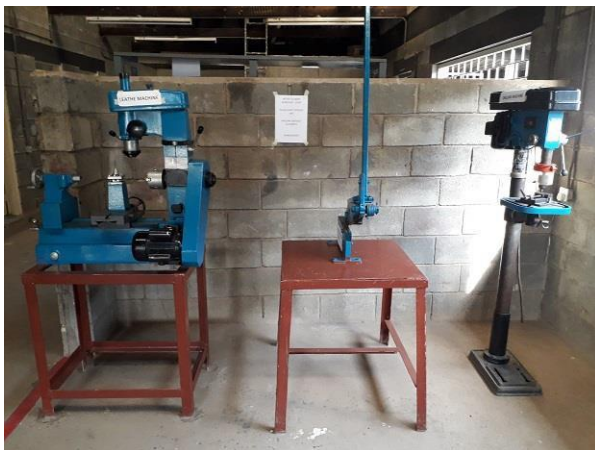
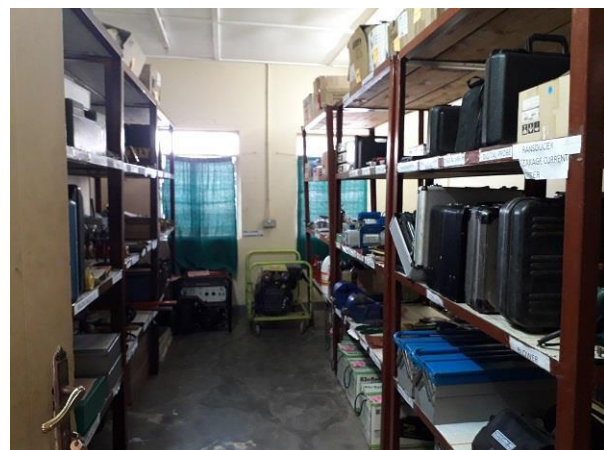
## Maintenance Workshops:

A dedicated workshop is located to the rear of the hospital. The workshop was found to be spacious, very well organized and equipped to facilitate the repairs of the hospital and medical equipment.

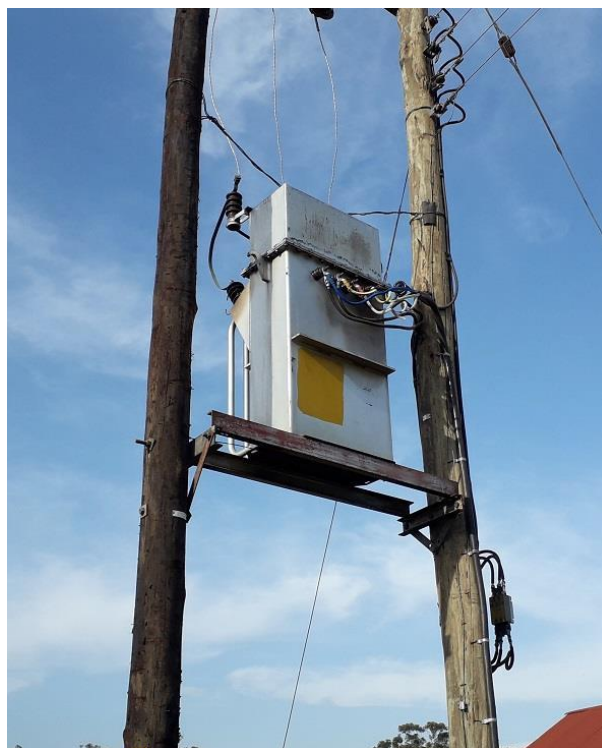
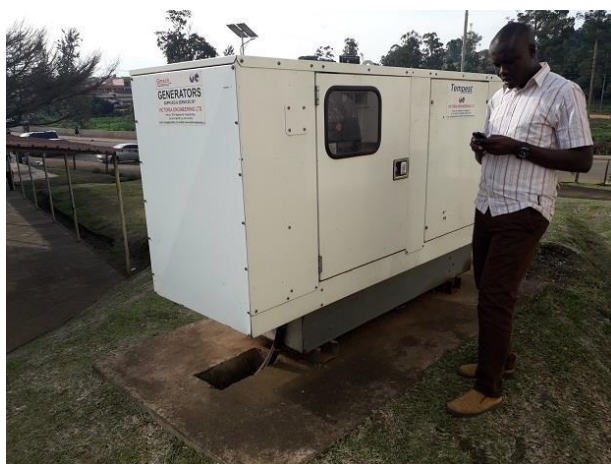
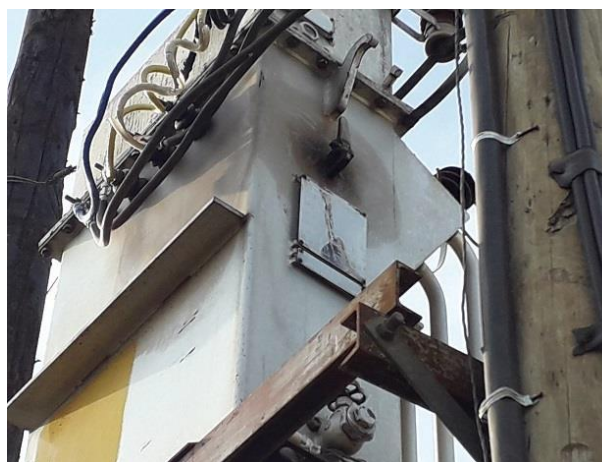
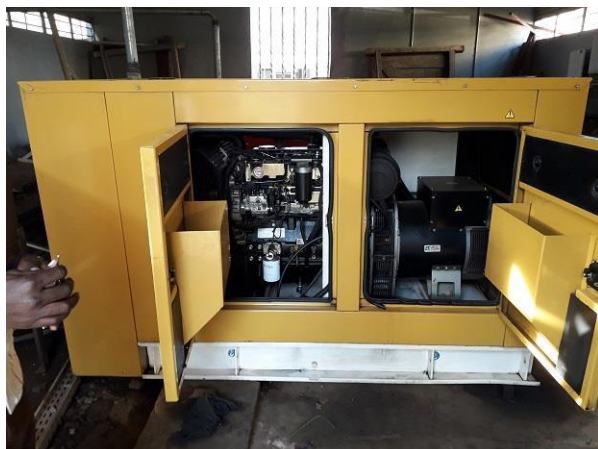
## Infrastructure:

Electrical supply to the hospital is a very high risk, at present the entire hospital is powered by a single overhead 100kVA transformer, which is inadequate for a facility of this size.

Numerous generators are located around the hospital and were found to be in varying conditions. It could not be assessed as to which generators powered which sections of the hospital nor which generators were operational at the time of the inspection.

Additional bulk electrical supply will be required to the hospital to accommodate any upgrades and new equipment.

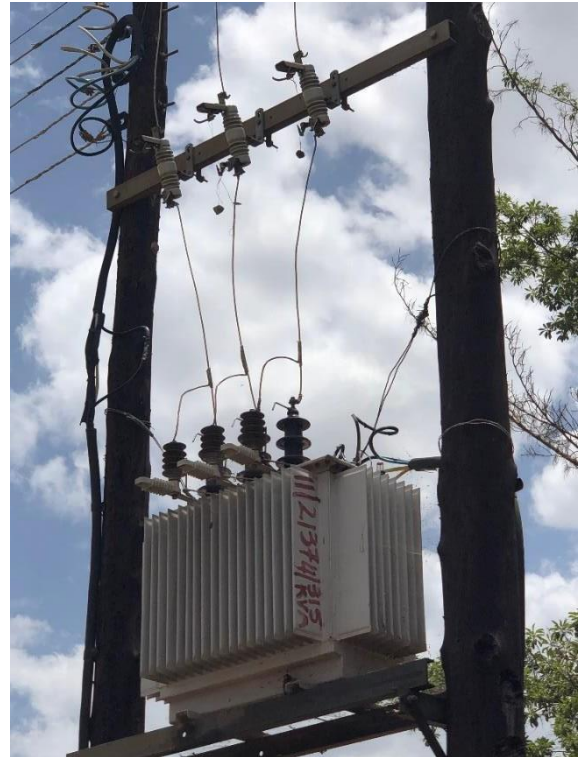
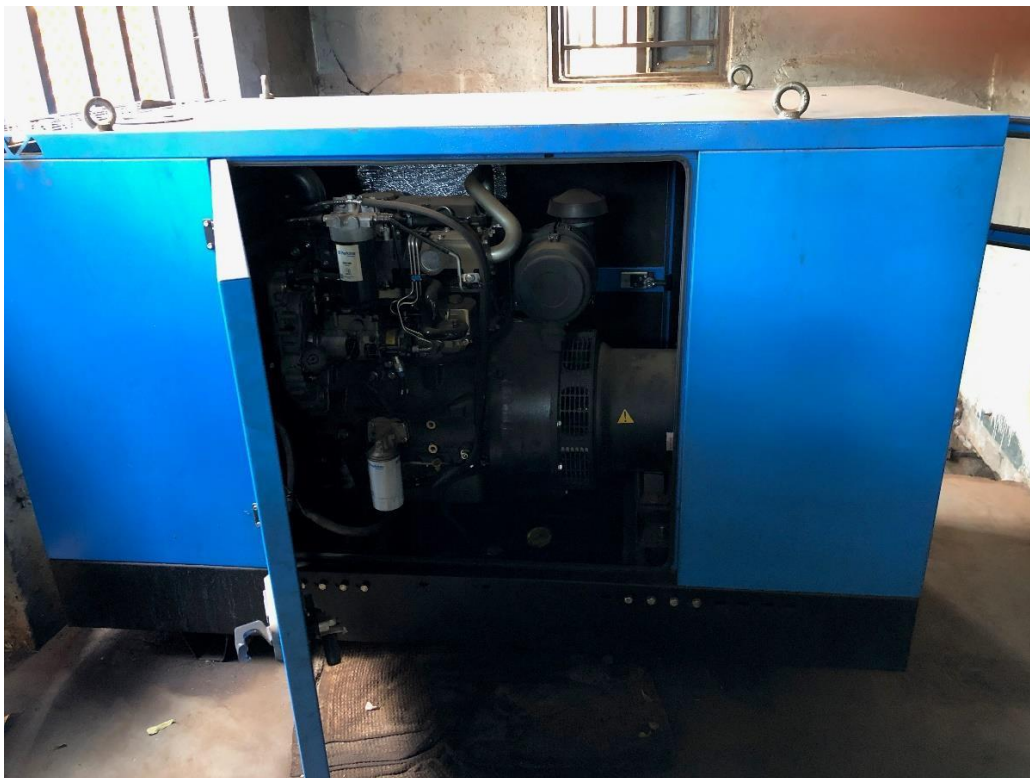
## Infrastructure:

The hospital is currently powered by an overhead 315kVA transformer, which is an adequate supply of electricity for a hospital of this size, however additional build electrical supply will be required in order to accommodate additional upgrades and equipment. Generators were inaccessible at the time of the inspection, thus recording their condition and sizing was not possible.

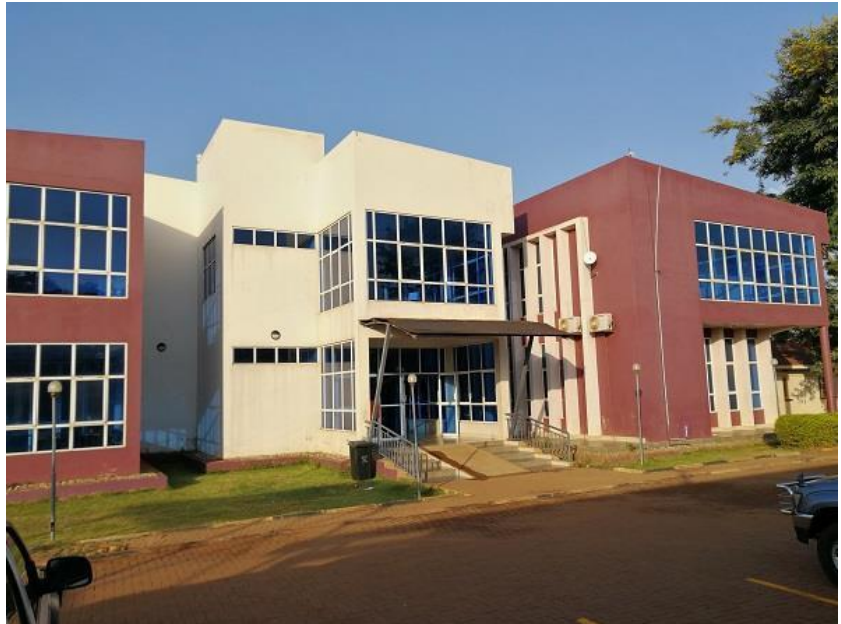
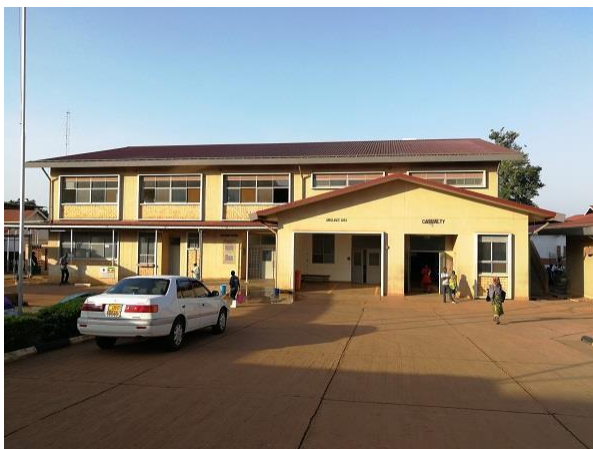
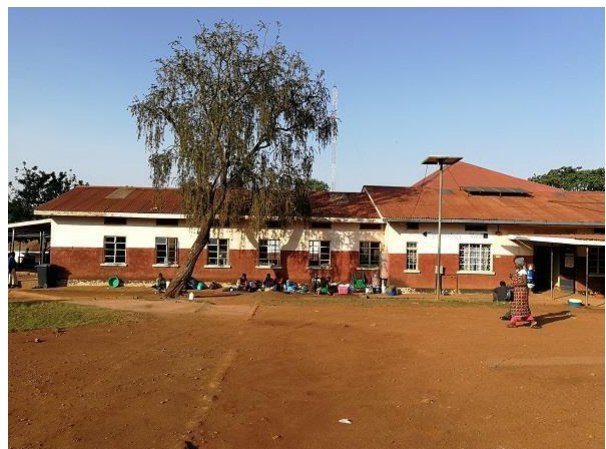
contribution the need for mother and child care/facilities is immediately evident as it was observed that the original (much older) Maternity, Obstetrics and Neonatal Intensive Care buildings were still in use. These facilities are severely dilapidated and are not fit for providing decent healthcare for the surrounding population.

Electrical Bulk Service supply to the hospital was identified as an immediate risk to the daily operations of the facility and the patients. Additional Bulk Electrical Service was installed at the hospital during the JICA projects, however this was done exclusively for the new JICA buildings and are insufficient for the day-to-day operations of the remaining buildings.

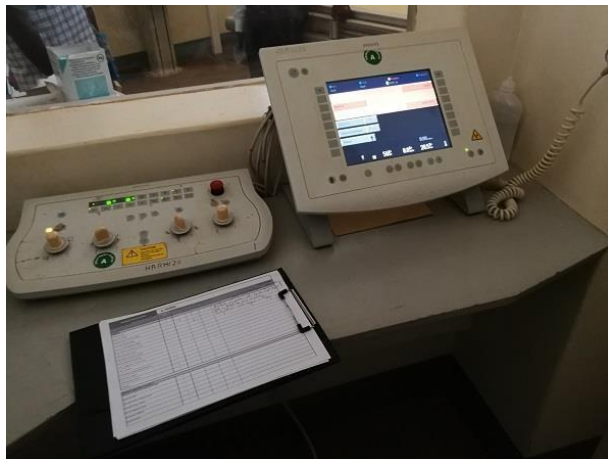
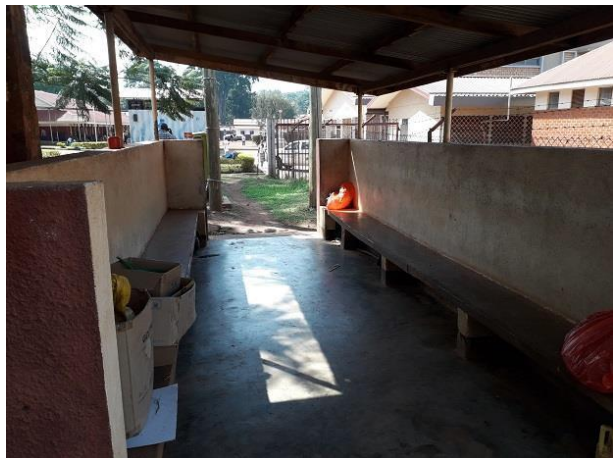
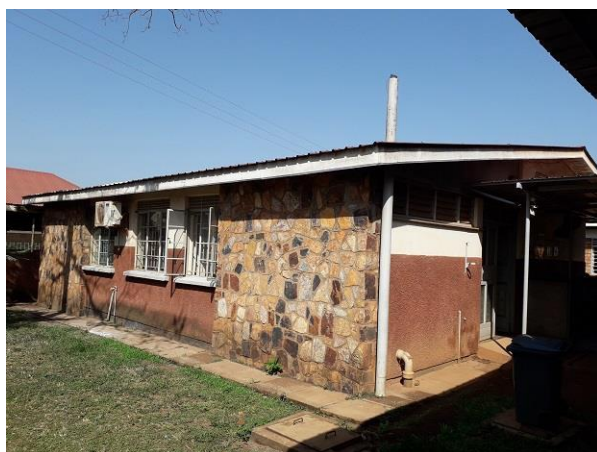
The Radiology Department is in a dilapidated, stand-alone structure behind the newly constructed Administration Building. It is in close proximity to the new JICA building housing the theatre complex, A&E and ICU. The Radiology Building has an X-ray machine, which is still functional, but has no automatic film processing units or dryers available. Films are processed manually and hung to dry outside. Ultrasound services are provided from within this department. The building was found to have very limited space and would require expansion to accommodate new and additional equipment. Ideally the existing Radiology building should be demolished and a new structure built, as there is adequate space adjacent to the building to do so.

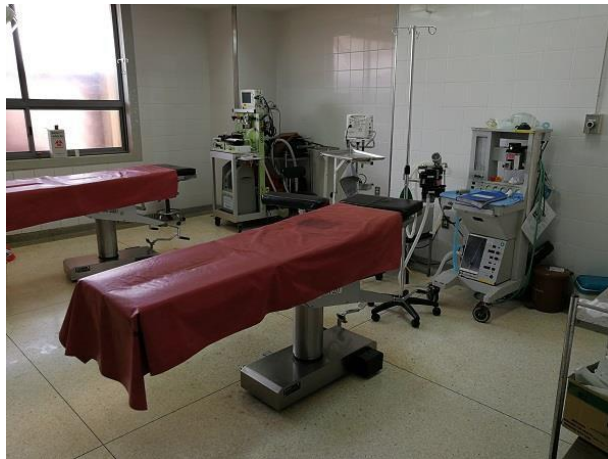
Three theatres are located on the ground floor of the newly built JICA building. The theatres were found to be in a good condition, however the equipment is reaching end-of-life and requires replacement. A CSSD is located directly adjacent to the theatre complex, however the autoclaves are not utilised due to insufficient electrical supply to the hospital.

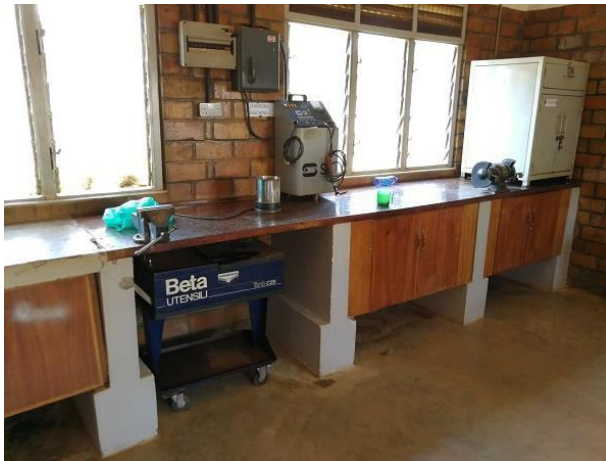
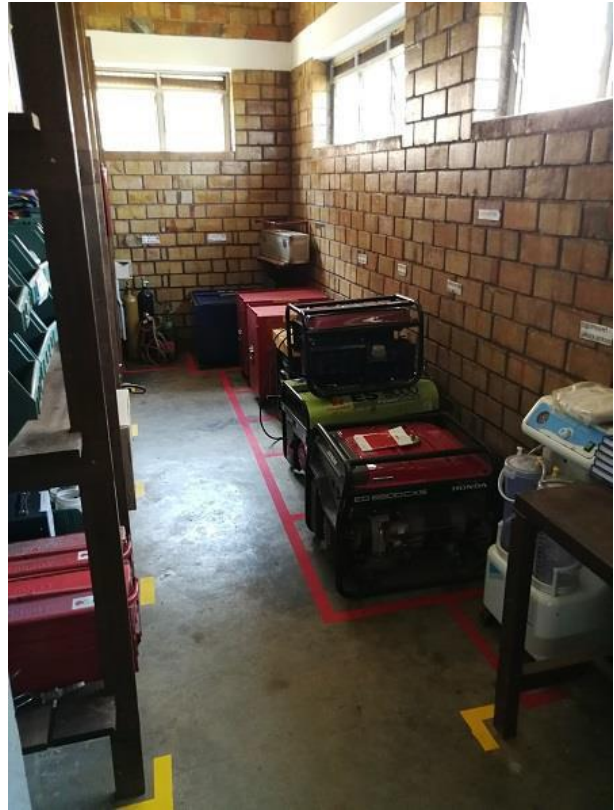
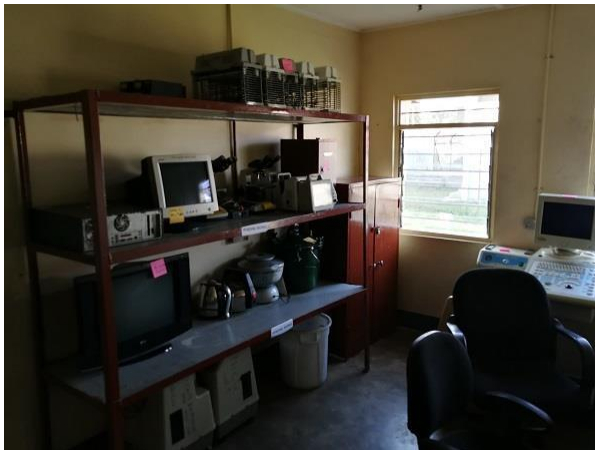
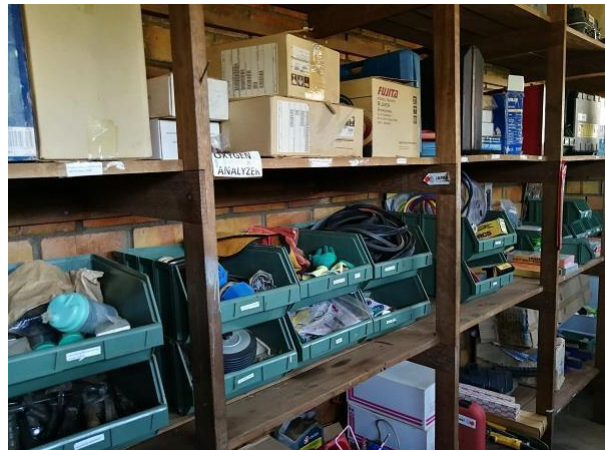
A dedicated workshop is located to the rear of the hospital. The workshop was found to be spacious and very well organized and equipped to facilitate the repairs of the hospital and medical equipment.

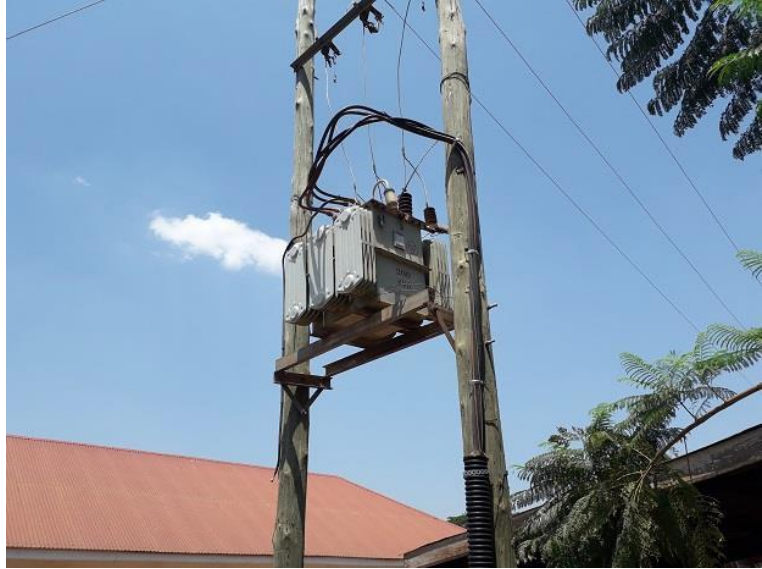
Insufficient electrical supply is an extremely high risk to Hoima Hospital and its patients that it serves. At present the entire “old” portion of the hospital is powered by a single overhead 100kVA transformer, which is inadequate for a facility of this size. An additional 200kVA transformer was installed by the JICA foundation, which provides dedicated power to the new JICA buildings, however this was also found to be inadequate as it was reported that the autoclaves in the CSSD tripped the mains power supply when they were used.

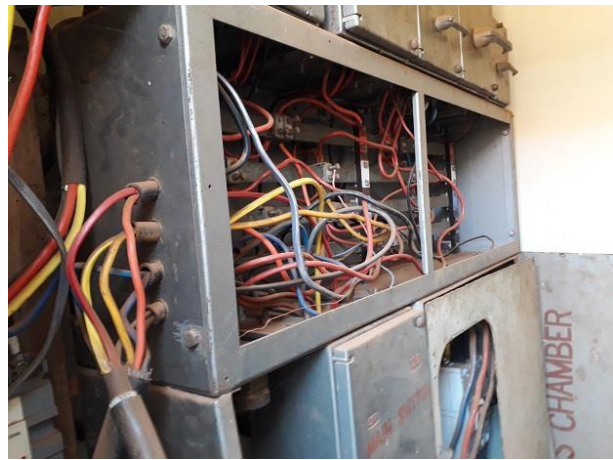
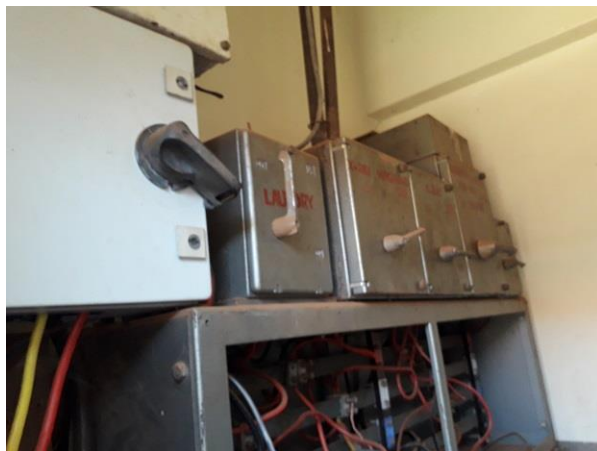
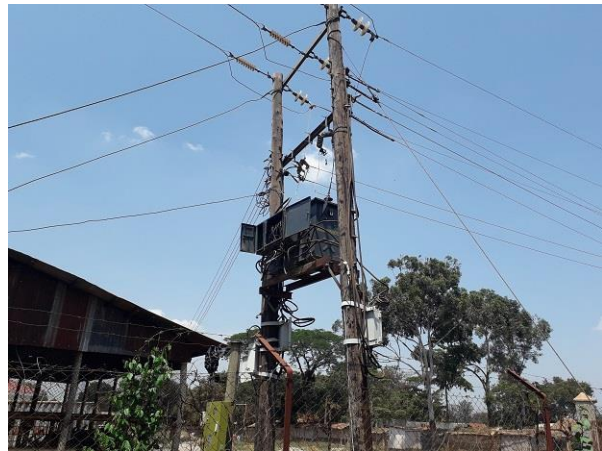
Numerous generators are located around the hospital that were found to be in varying conditions. It was not possible to record the size of all the generators installed nor which parts of the hospital they supplied backup power too. A new infectious disease center is currently being built at the rear of the hospital, which will add further strain to electrical demand of this facility. Addition bulk electrical supply will be required at Hoima in order to accommodate any additional and new equipment.

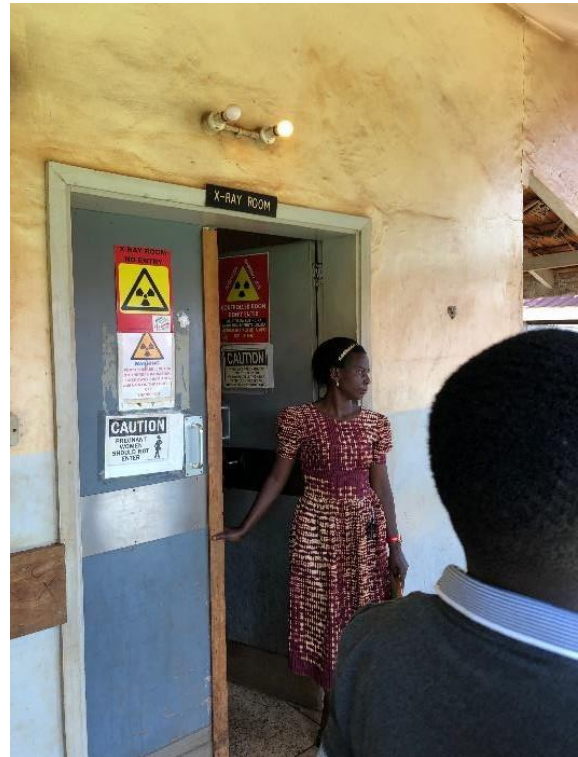
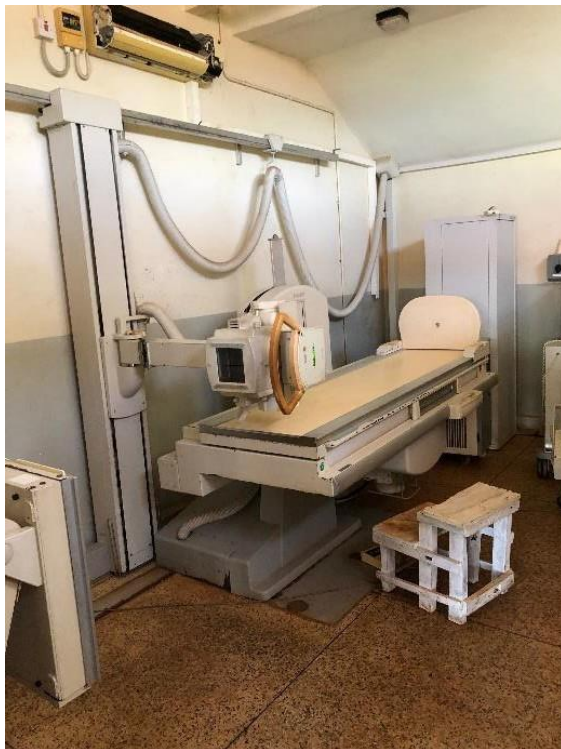
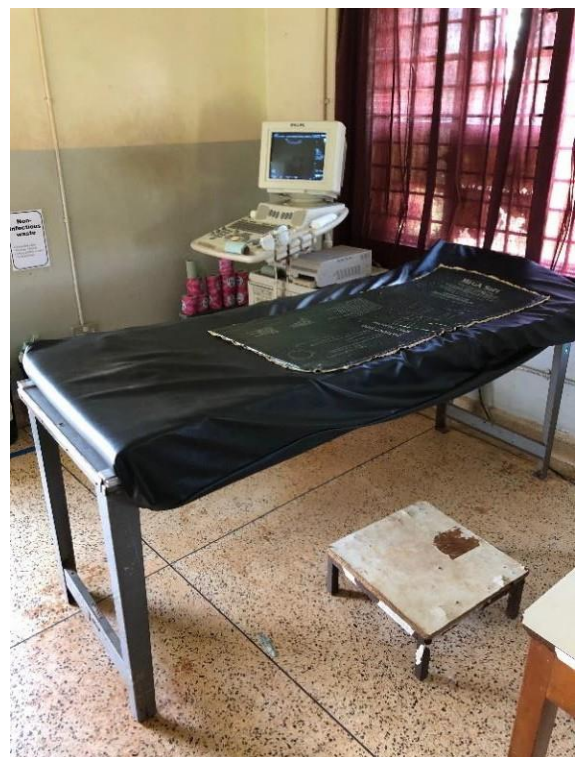
The existing Radiology Department is housed in an old dilapidated building, which is in desperate need of an upgrade, or ideally, a total rebuild. The building houses an Ultrasound room and an X-ray room. A Fluoroscopy room is available however it was found to have no equipment. To allow for expansion for mammography and CT scan services it is recommended that the department be relocated to a new building in closer proximity to the Operating Theatres, ICU and Accident & Emergencies Department. A dedicated 30kVA generator is connected to this department, however it has not functioned since 2006.

The X-Ray machine/Bucky table is still functional and is an analogue unit. The unit is obsolete and software updates are no longer supported. Approximately 25 scans are conducted per day and film processing is done manually and hung to dry outside. Up to 30 ultrasound scans are conducted each day on a very old black and white ultrasound machine.

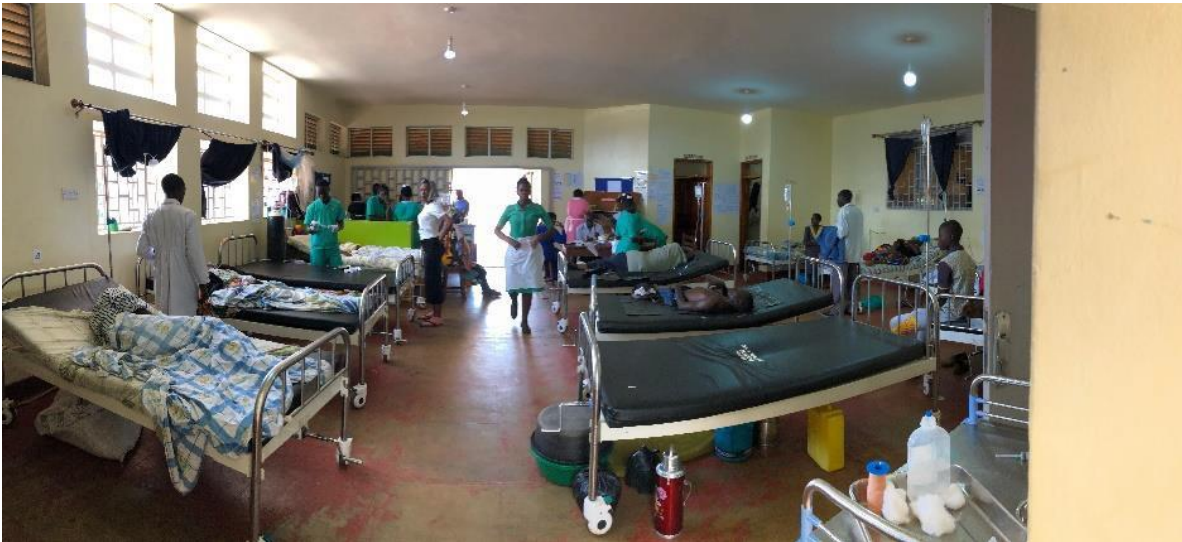
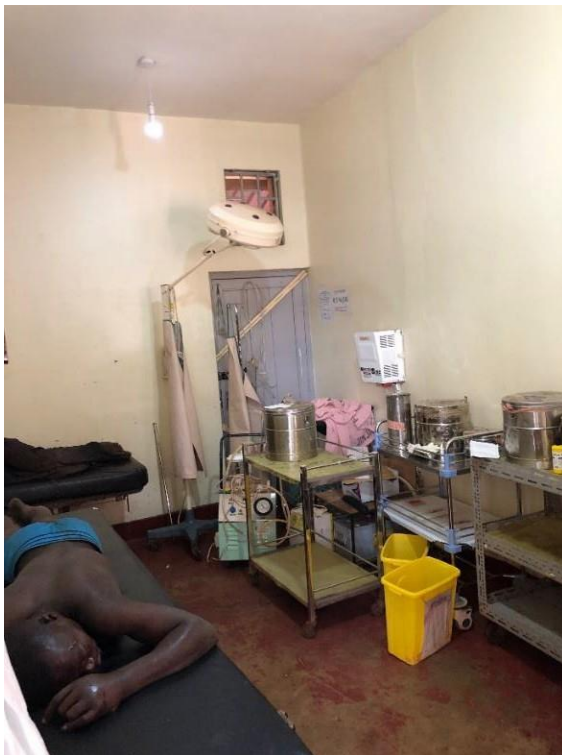
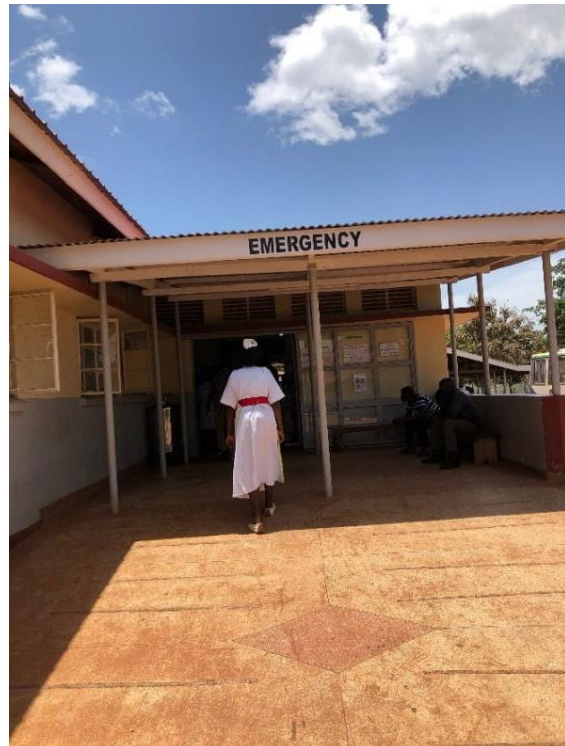
The A&E is located at the entrance to the hospital and also houses an OPD Department. Moving patients from the A&E to other hospital departments is done via the main entrance road for the hospital as there are no covered pathways. Space is limited within the A&E and it is too small to accommodate the amount of patients requiring care. This results in patients being put into beds located in back-of-house areas in this department. Equipment within this unit is very old with the majority of it being non-functional. Essential equipment for this department, i.e. defibrillators and ventilators, are not available.

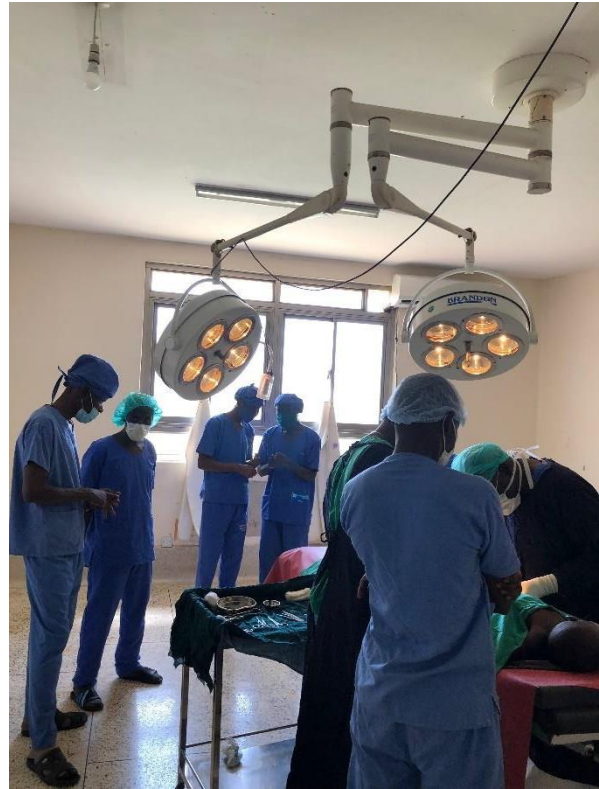
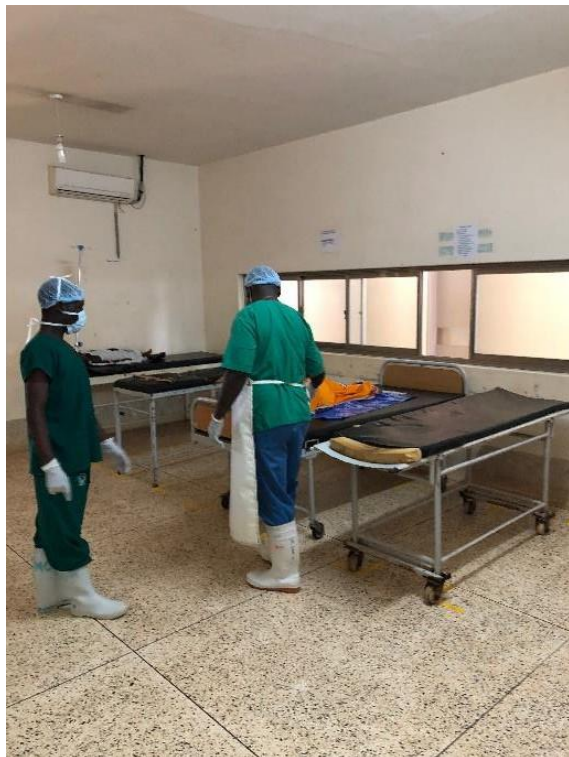
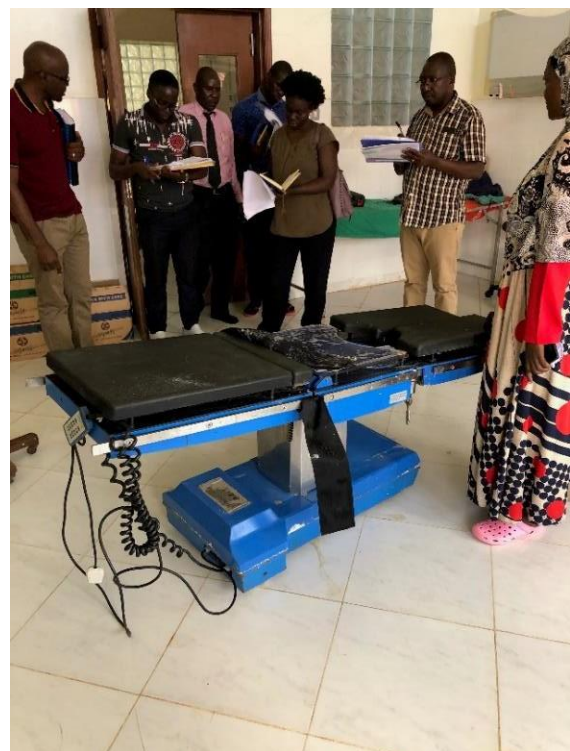
The Main Theatre Complex received new equipment from GE Healthcare in 2009, which is still in working condition but is reaching end-of-life. All theatres are in need of refurbishment. Feedback from staff indicate that the lack of surgical instrument sets are a major concern for surgeons. The recovery area does not have any equipment, other than beds and need is in need of a refurbishment.

The Orthopaedic Theatre Complex infrastructure is in a fair condition, however there is a lack of equipment and surgical instrument sets within this unit. All equipment (that is available in this unit) was found to be old and broken and in need of replacement. The condition and age of the existing equipment impedes the procedures that surgeons are able to undertake.

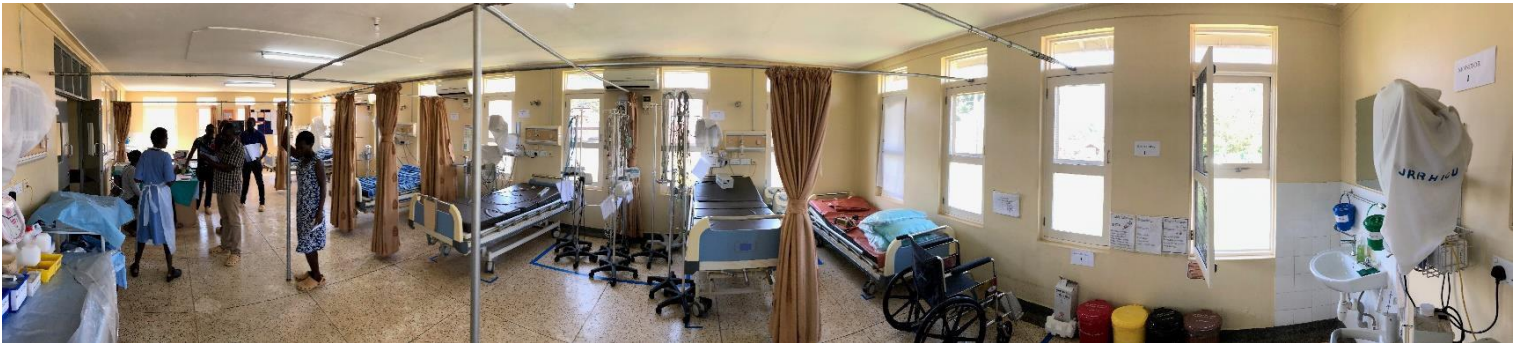
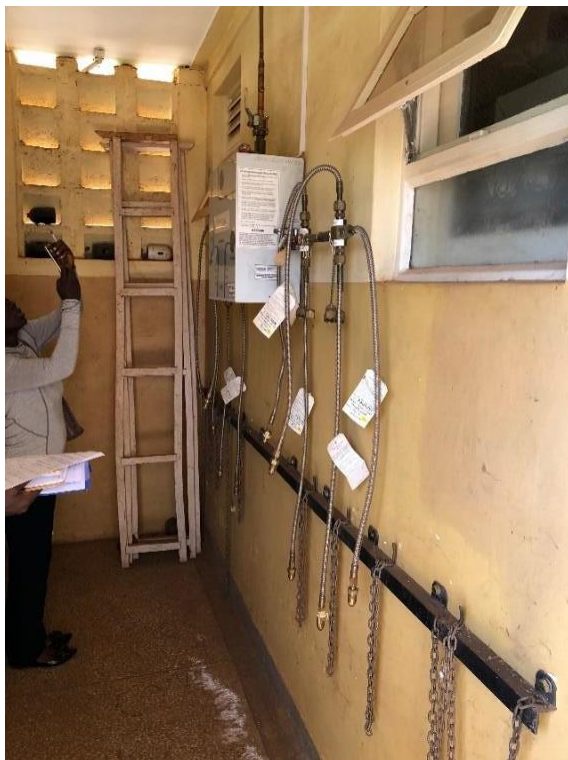
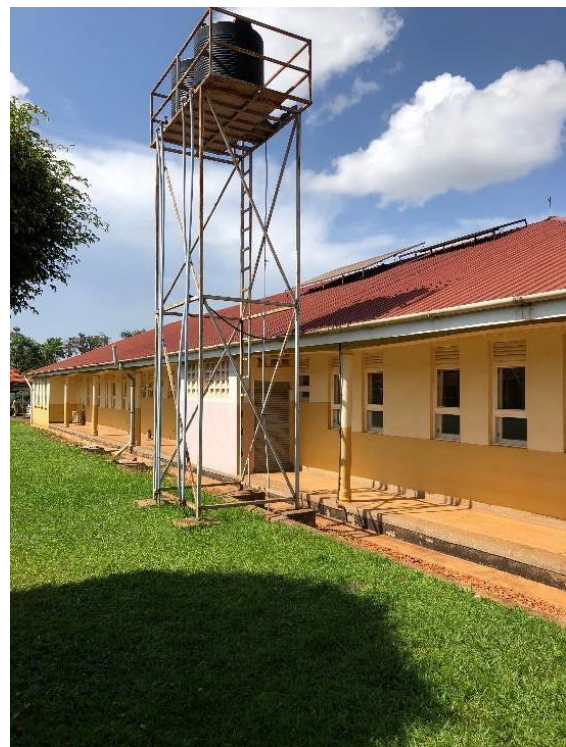
The unit is fully equipped with GE Equipment, however the unit has not been occupied for the last 4 years as the hospital does not have any ICU trained doctors and staff. All equipment in this unit requires servicing, calibration and accessories.

The Oxygen manifold bank requires servicing as it was reported that there is a leak in the system.

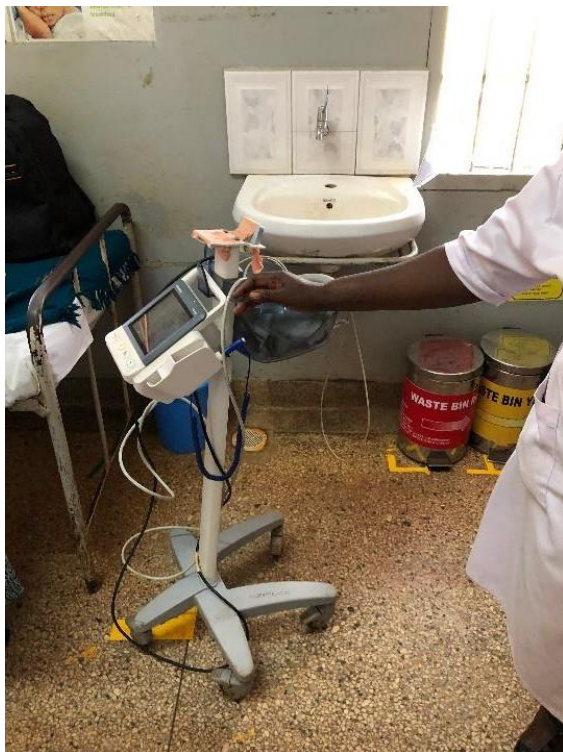
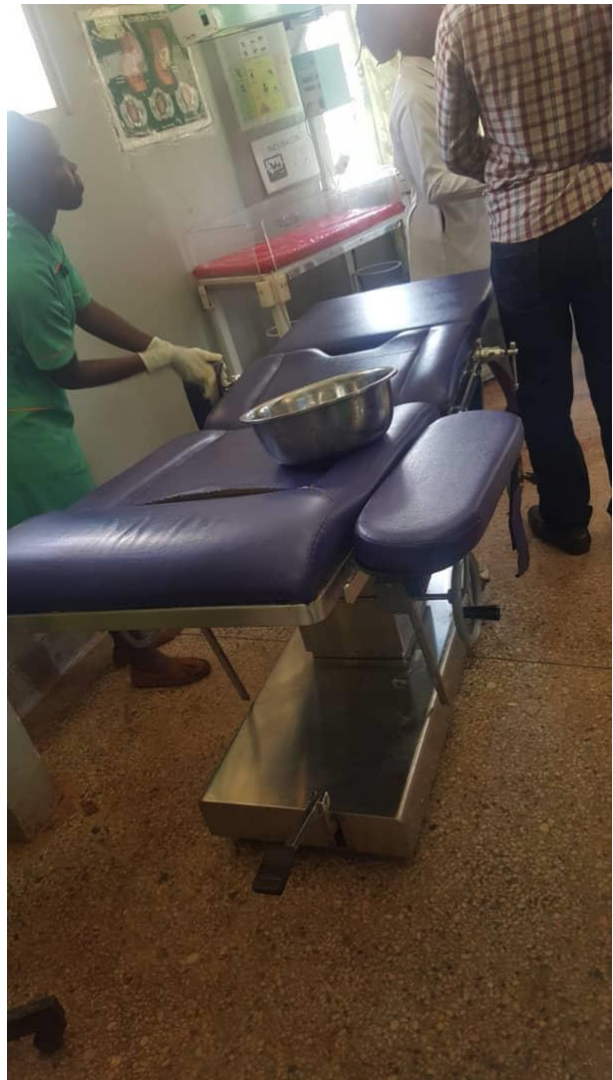
The Maternity Unit consist of 4 wards and is fully occupied and very busy. The team were unable to inspect this unit due to patients being in labour. Feedback from staff indicated that that there is a shortage of equipment within this unit to deliver an adequate service to the patients.

Infrastructure to the Maternity Unit requires upgrading to ensure compliance.
