## 1. Executive Summary

The March 2019 survey of all 14 regional referral hospitals in Uganda conducted by representatives from MOH Uganda confirmed a clear need for intervention into the 6 core departments identified in the 2017 AMPC feasibility study report.

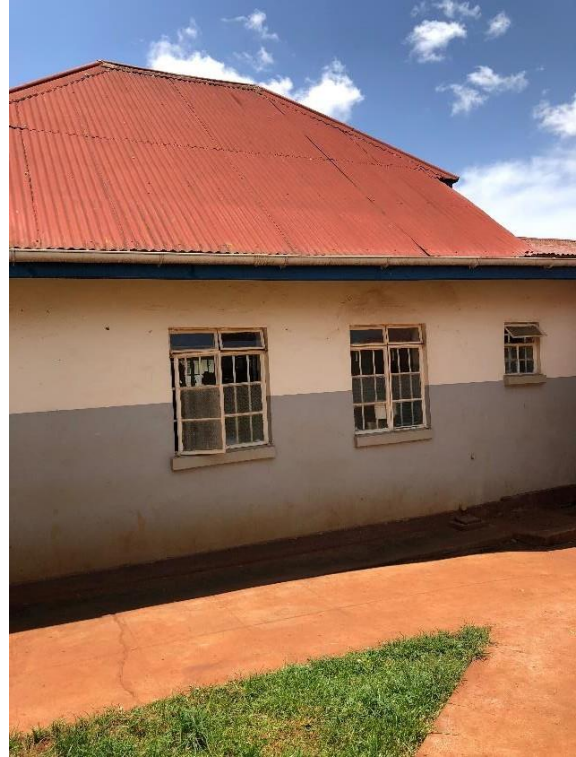
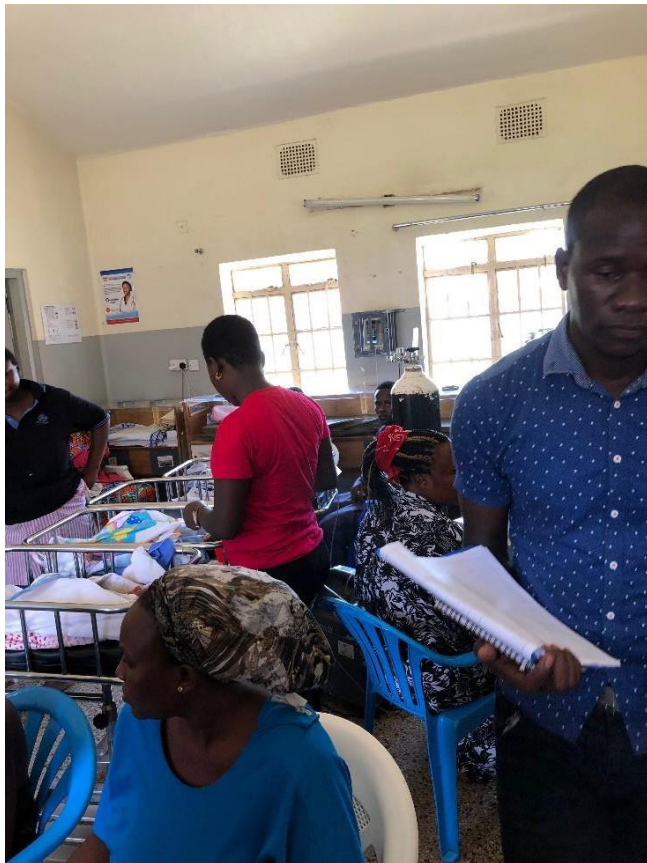
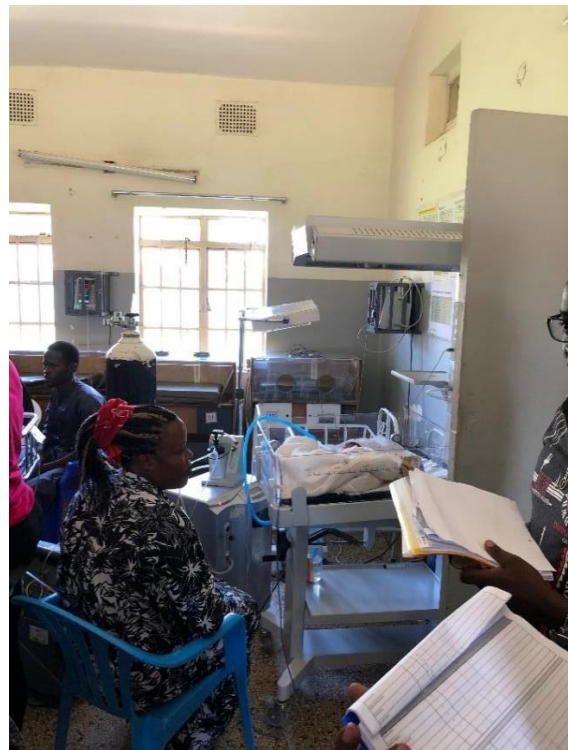
The NICU, NHCU and nursery are housed in a single department due to a lack of infrastructure. This unit is housed in a converted theatre and does not have adequate space for the number of babies being cared for.

The unit is overcrowded and space to move between babies is restricted, that resulting in inefficiencies in providing nursing care.

In addition to the above there is a shortage of equipment for the number of babies being cared for, and the equipment that is available has reached end-of-life and is in need of replacement.

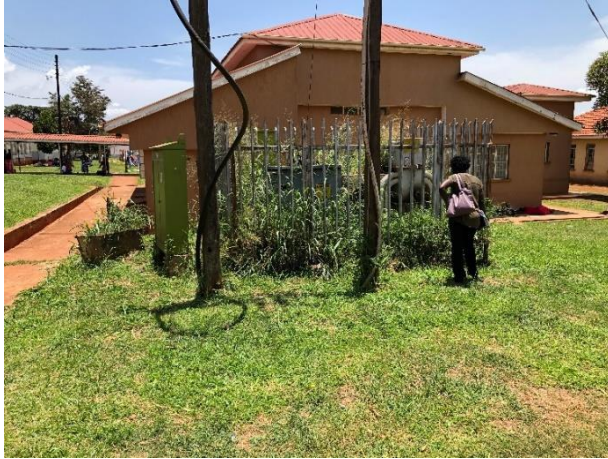
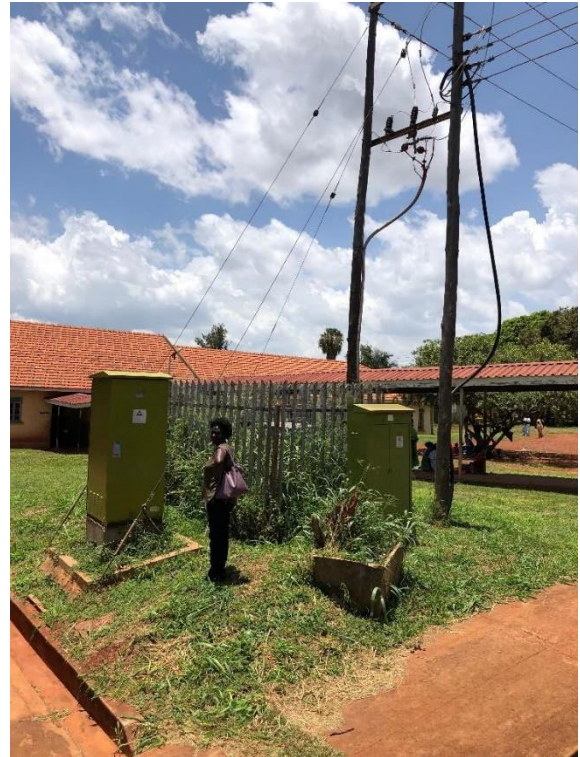
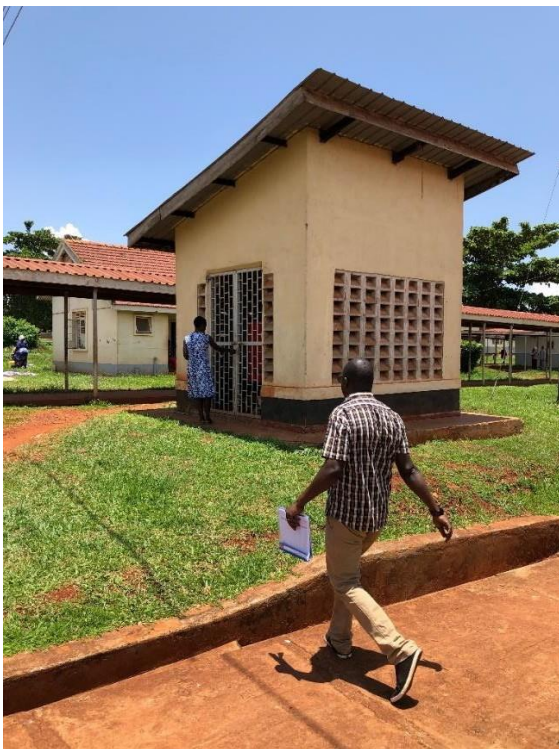
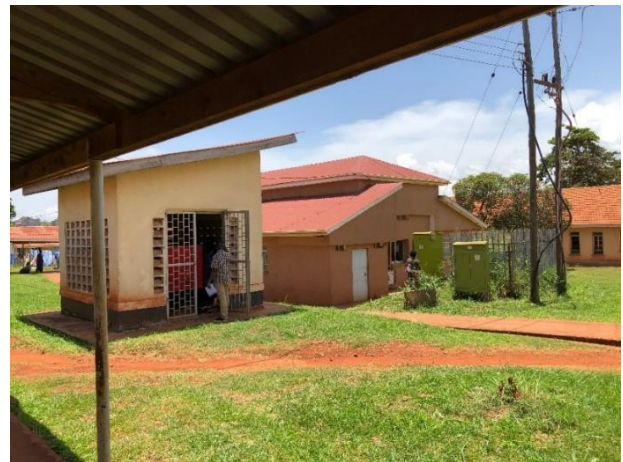
Jinja Hospital is currently powered by a 300kVA electrical transformer, which is adequate for a hospital for this size, however additional capacity will be required in order to accommodate any additional radiology equipment.

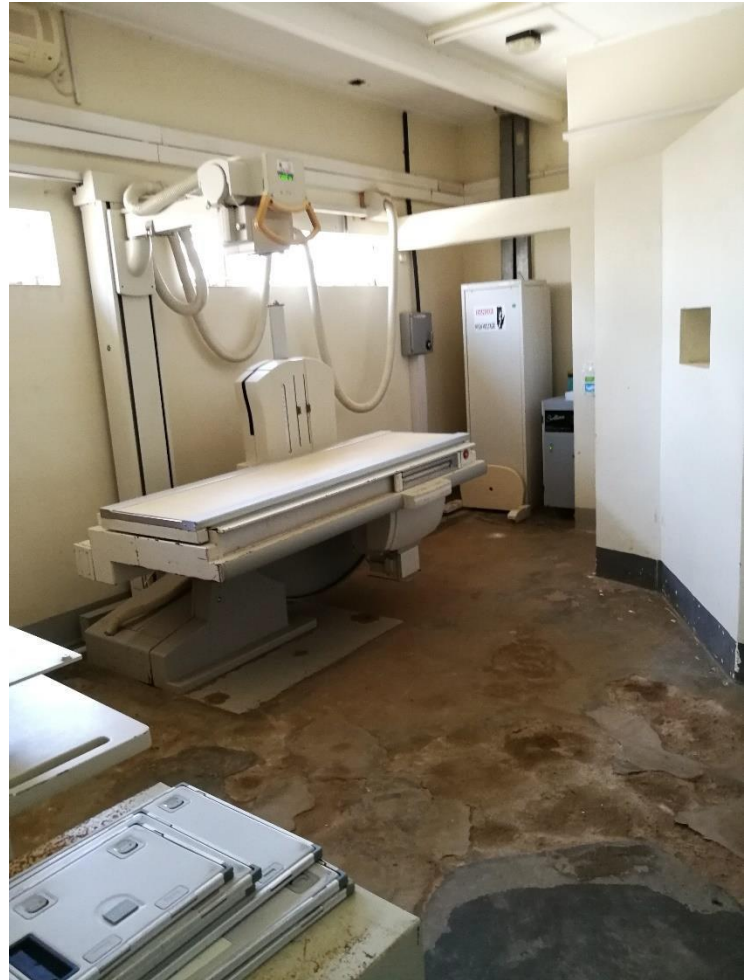
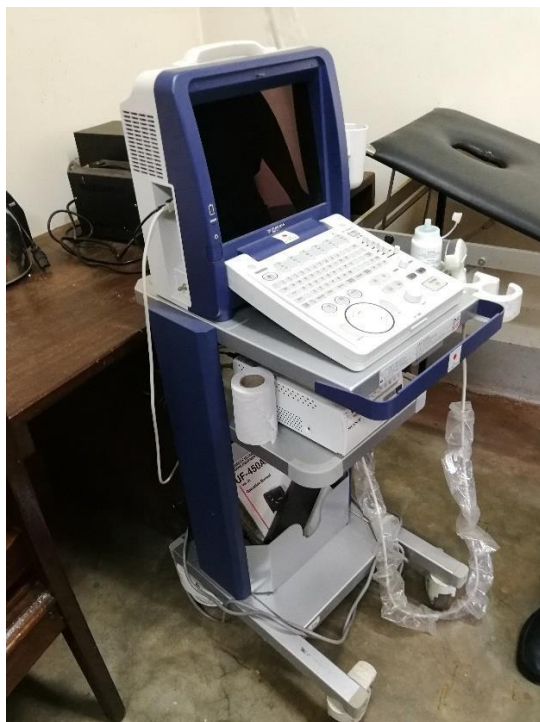
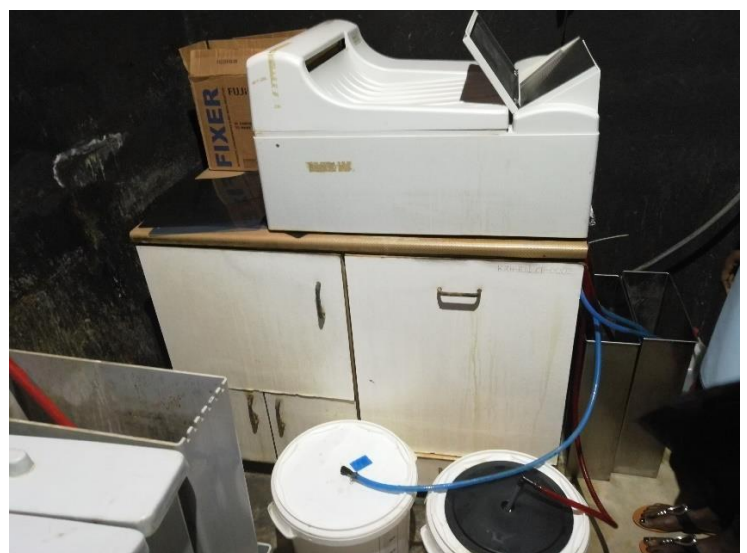
The existing X-Ray department building is in extremely poor condition with several roof leaks, and the floor is breaking up.

The department is still fully analogue, however there is a partially functioning Carestream X-Ray processing unit but manual wet processing is still the norm.

The building will require rebuilding and enlarging to accommodate the addition of a CT scanner and dedicated flouro and bucky room.

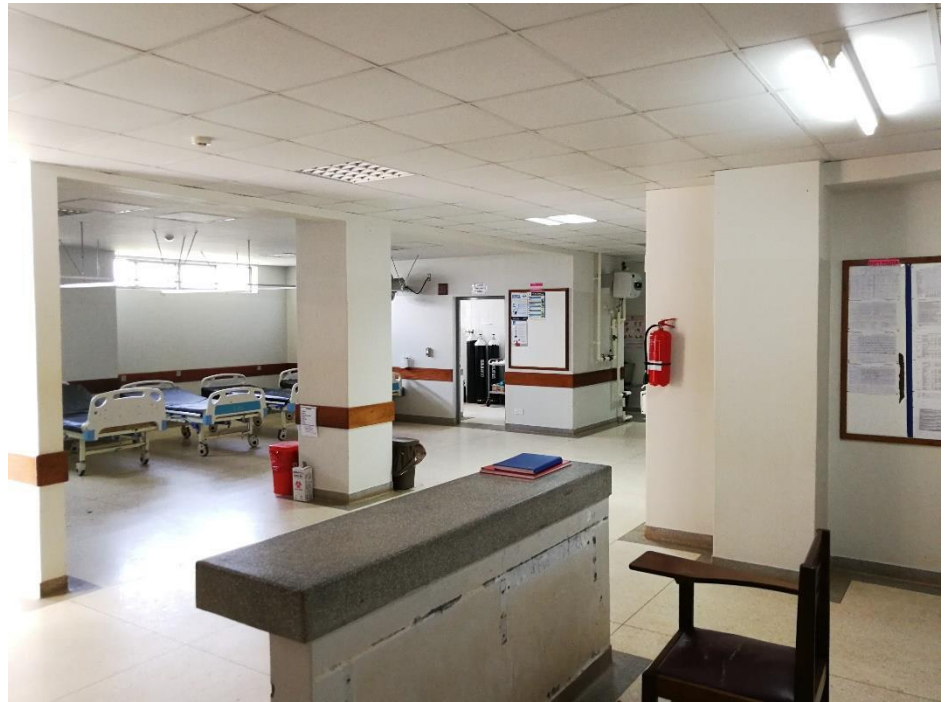
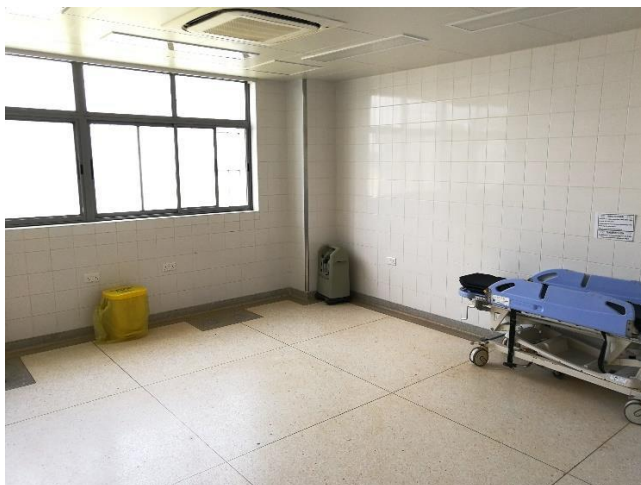
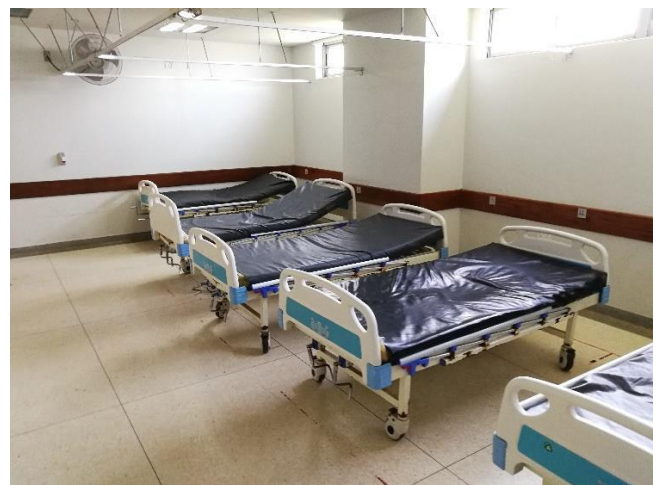
Despite being, the only casualty department for quite a large geographic area and being almost brand new, and in extremely good condition the department was totally empty when we surveyed at 11am on a Monday.

Besides the beds and some basic equipment, the department does lack the majority of equipment that would normally be found in a casualty department. The minor operating room is essentially empty with no equipment at all.

There were virtually no staff for this department on duty, however this may be due to the fact that they lack key equipment to enable them to offer a casualty service and may have been redeployed elsewhere,

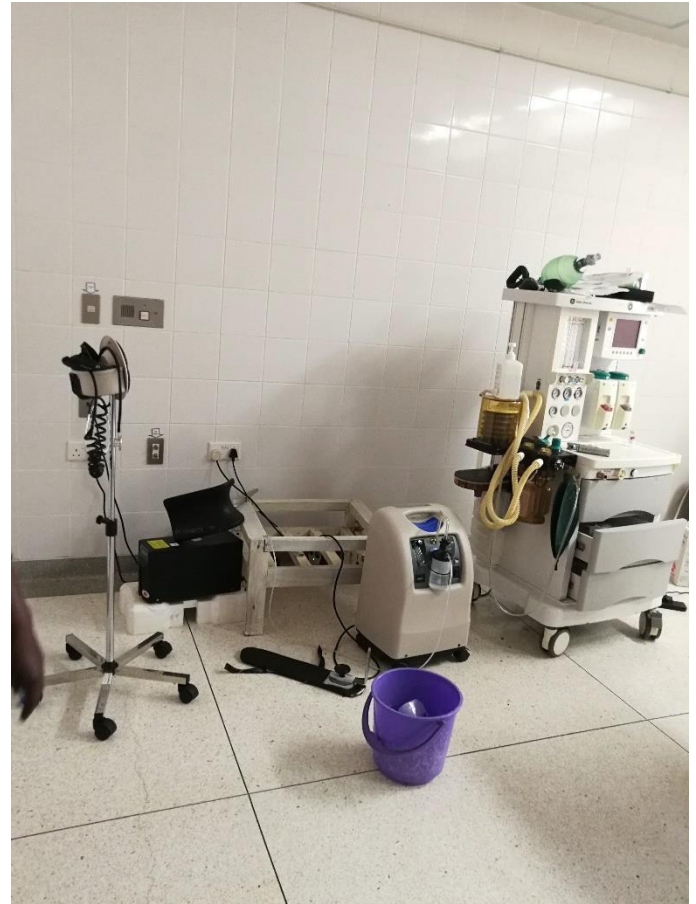
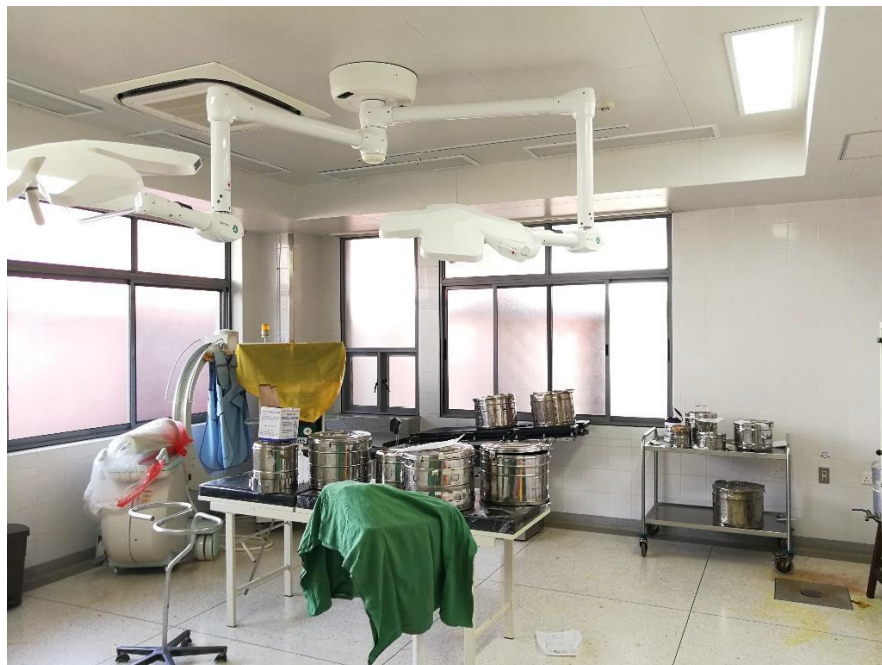
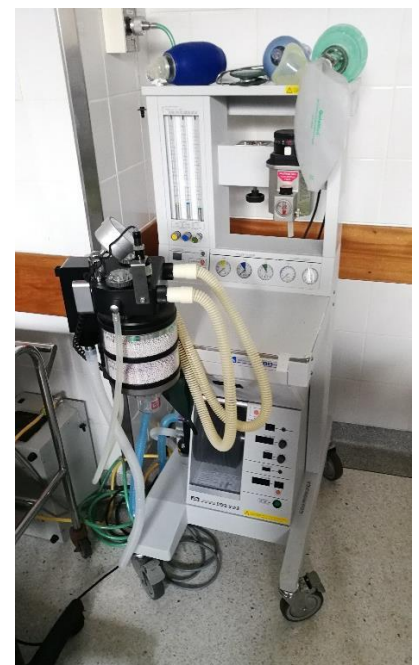
## Main Operating Theatres:

The main operating department only carries out procedures 4 days a week, Mon-Thurs and is in very good condition. It has been well equipped; however, some equipment is not complete such as the anesthetic machines, which have been supplied without monitors.

While the facilities are of a high standard and there is some good equipment available, this department is failing to reach its full potential due to a lack of training, skills mix and gaps in key equipment.

For example despite Tuesdays and Thursdays being designated for orthopedic surgery, the brand new mobile C-Arm is unused making it very challenging for surgeons to verify the successful completion of procedures.

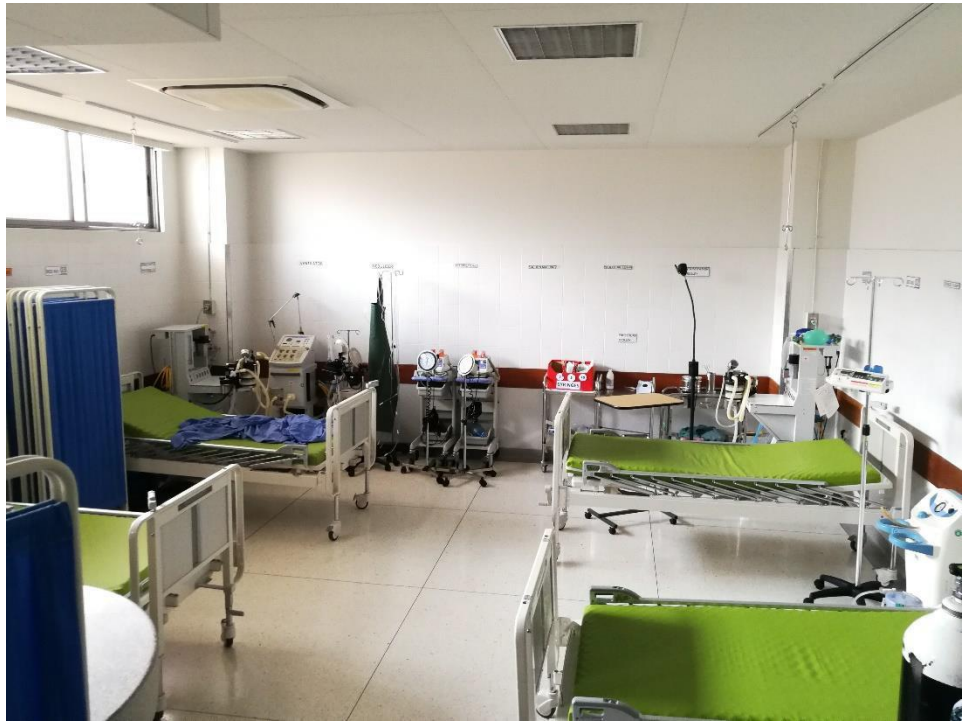
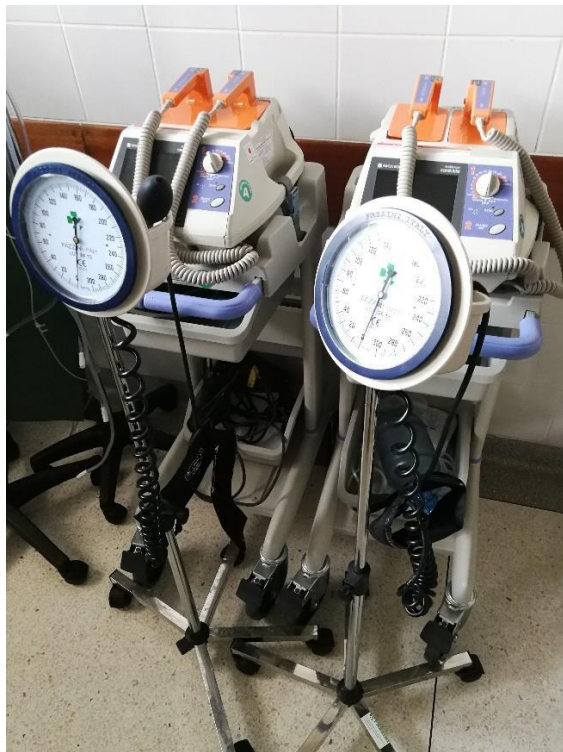
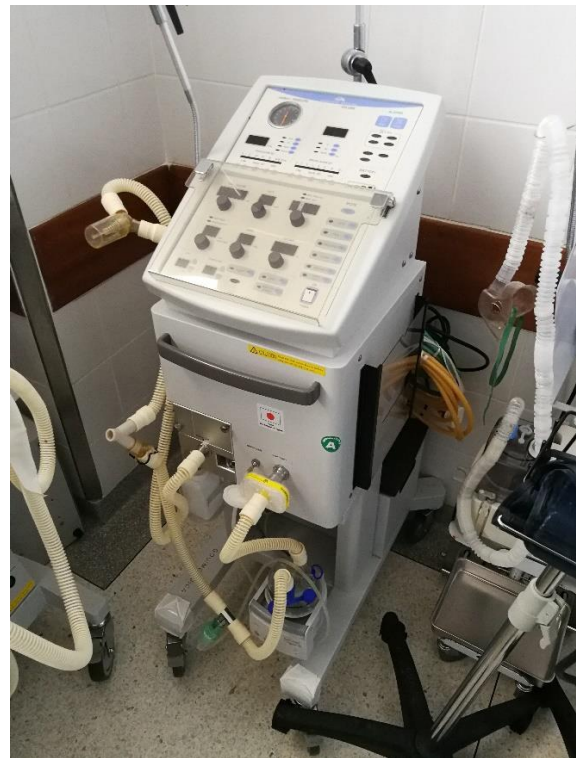
## ICU:

A brand new 4 bed HCU is housed in the new theatre complex and was also empty at the time of the survey. The department head informed us that they have a lack of trained ICU nurses resulting in the unit rarely being used.

While much of the equipment is nearly new, the beds for example are not suitable for full ICU functionality and there are insufficient medical gas outlets.

The bed spacing also does not allow for space around the head of the bed for emergency resuscitation and a reconfigured layout would be advised if this unit is to be upgraded to a full ICU.

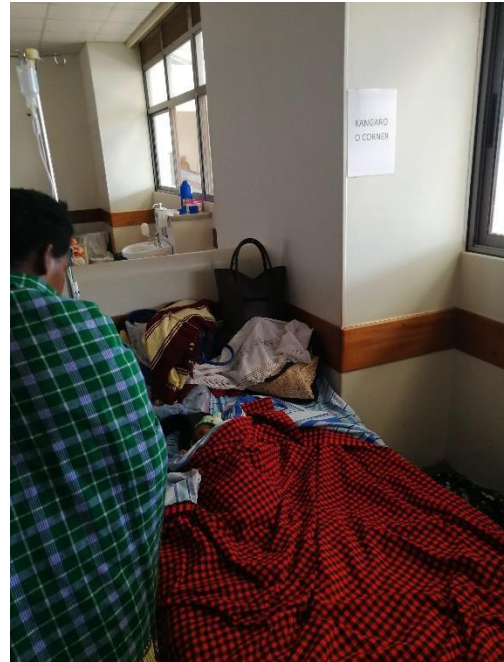
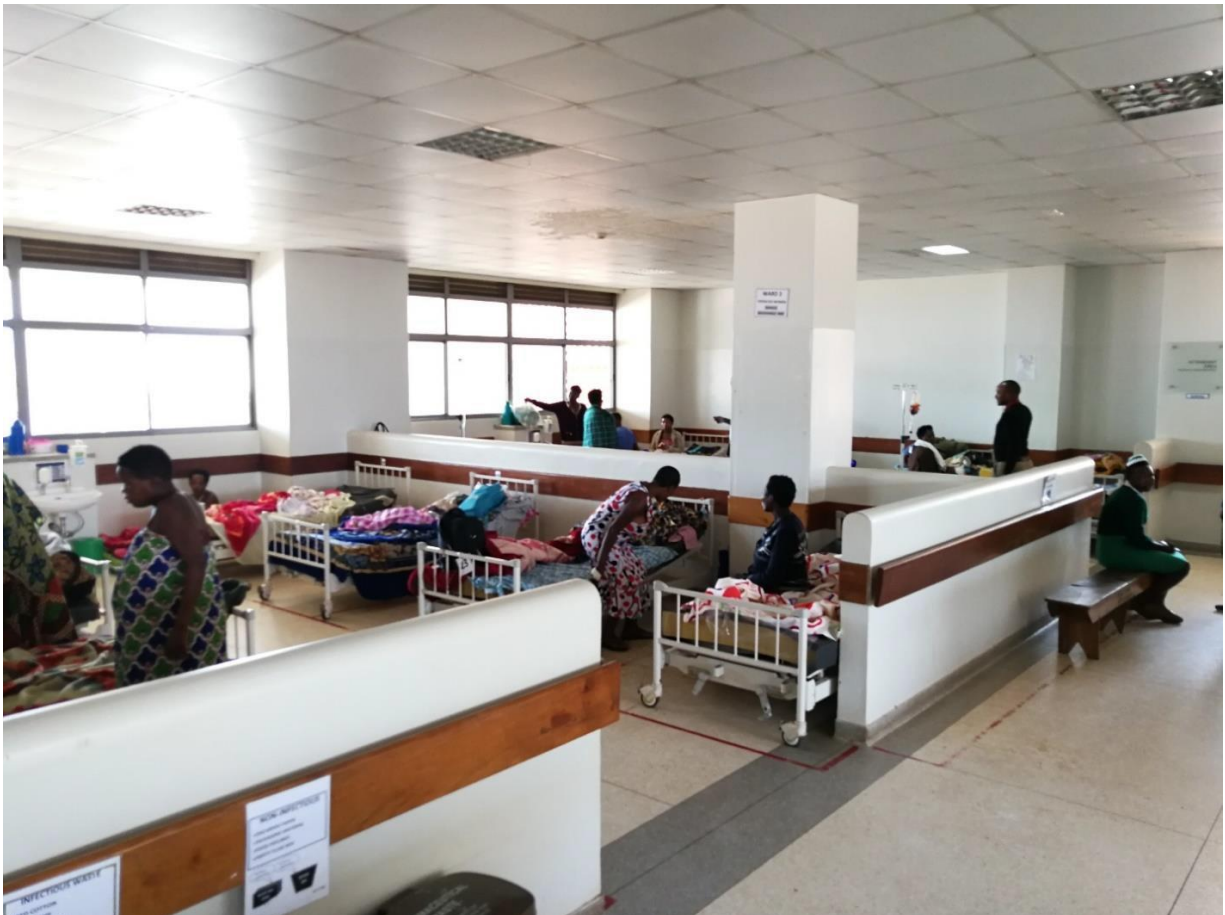
## Maternity:

This was one of the quietest maternity departments out of all the hospitals surveyed and was in a good condition also housed in the new JICA building and situated directly above the operating department.

Despite Kabale being in the colder South Western region of Uganda there was no heatig available in the ward and even the infants are exposed to the low temperatures at night time and early mornig. Ward heating and ventialtion would be advised in this deparment.

The low number of births per month in this unit seems disproportionate to the polulation of the region and it seems expectant mothers are seeking care elsewhere.

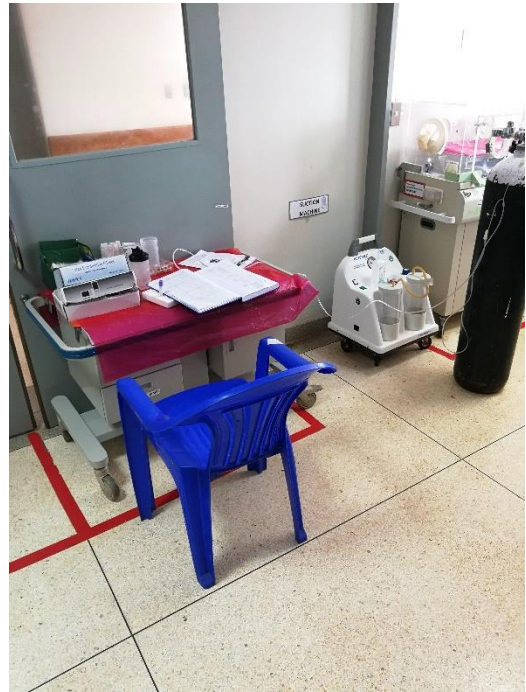
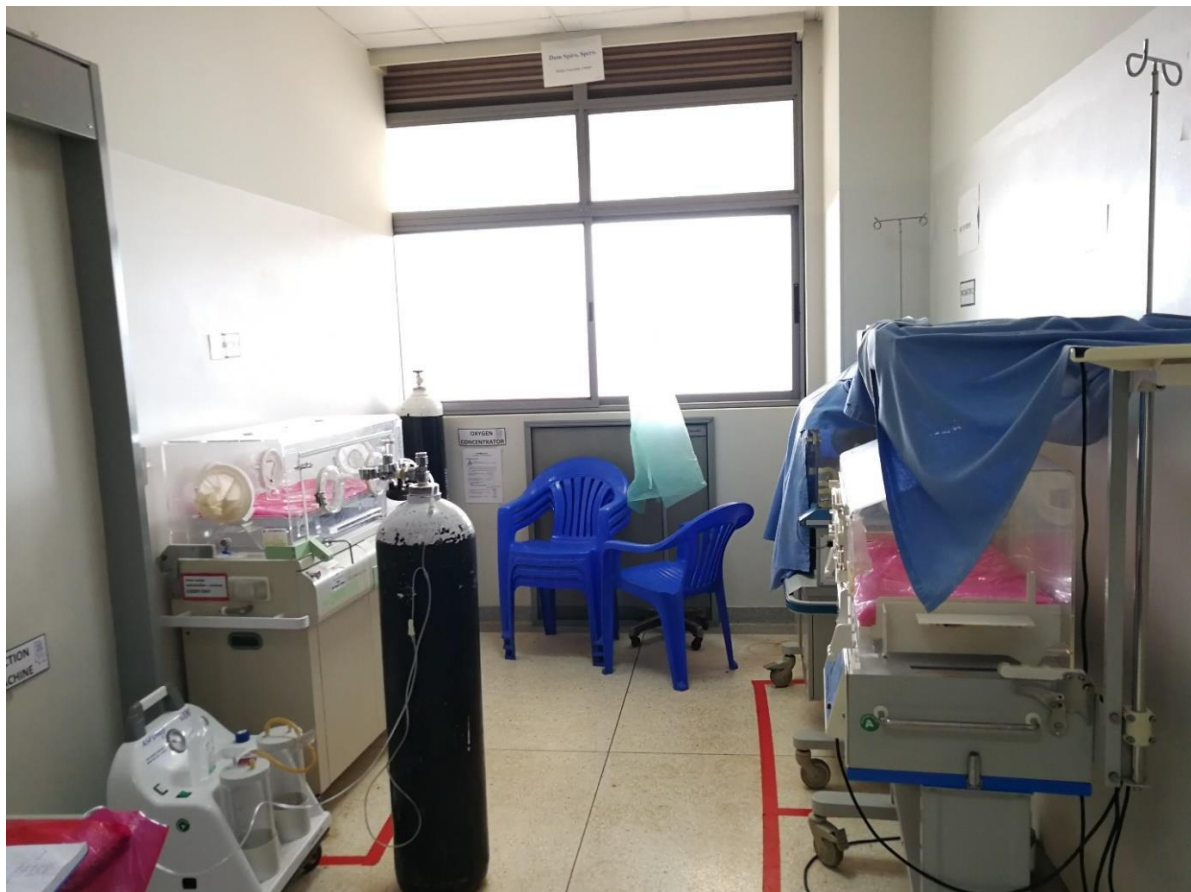
## NICU:

The current neonatal ICU appears to be inside a converted storeroom with no heating or ventilation and the room was found to be extremely cold at the time of the visit.

The unit was not in use with no babies at all at the time of the visit and appeared not to be used regularly at all.

From the birth register, statistically a dedicated neonatal ICU is definitely required, but as with many other departments at Kabale, there seems to be another underlying reason impacting the patient volumes and activity in all departments.

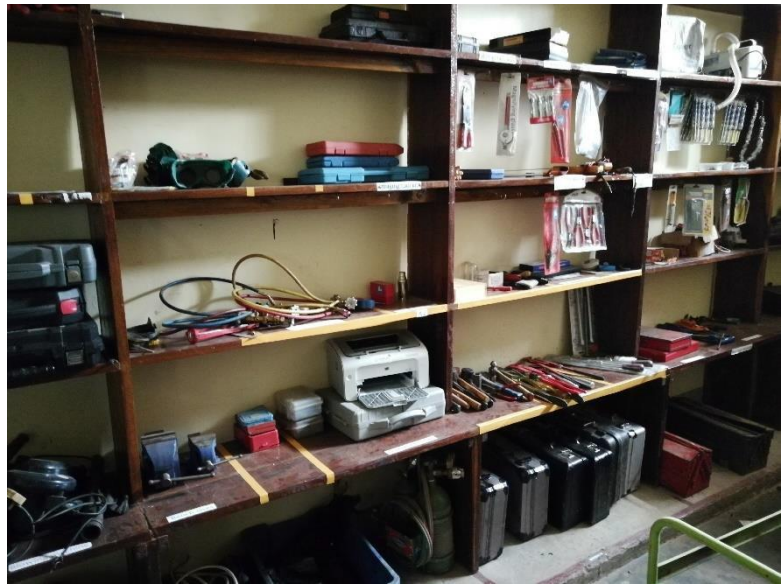
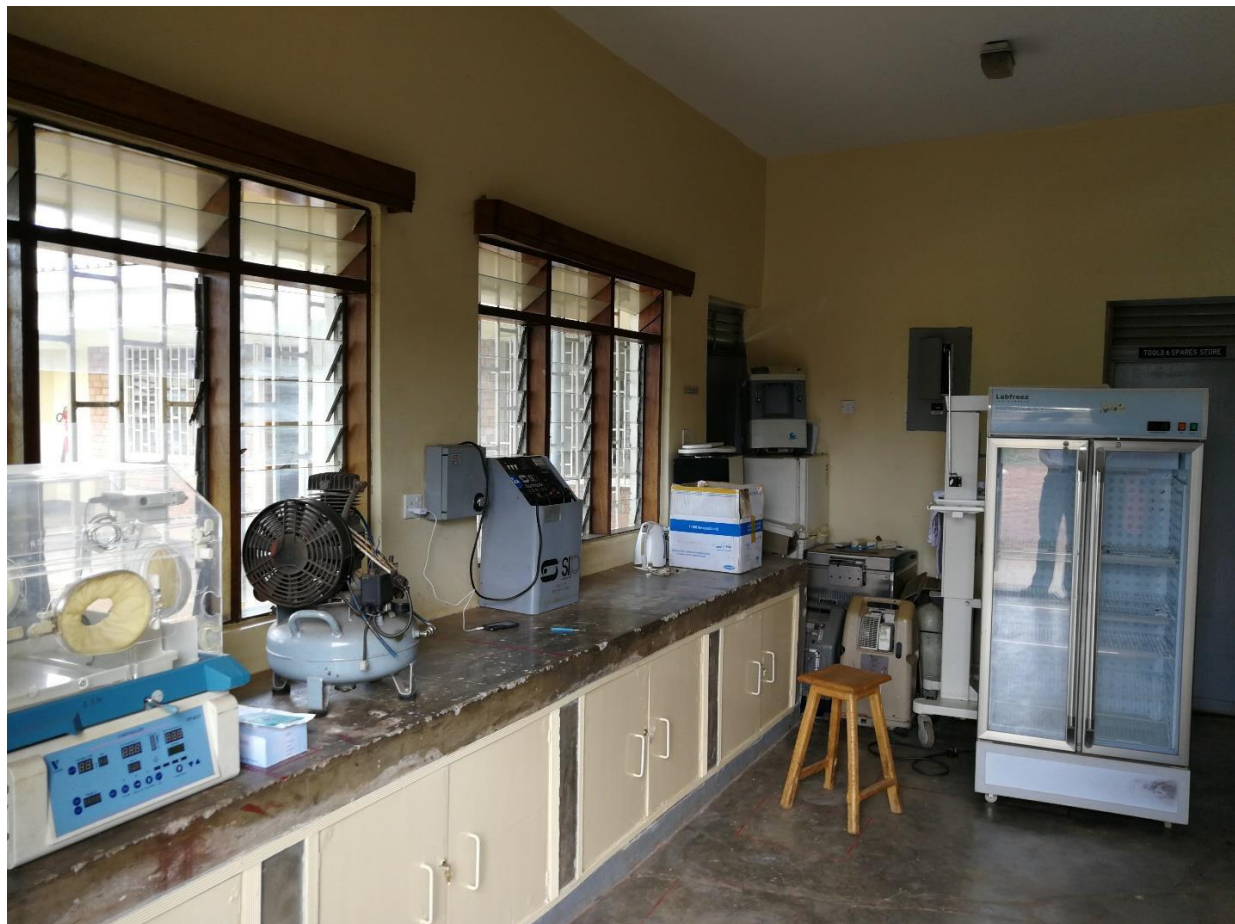
## Maintenance Workshops:

The maintenance workshops is situated just outside the main hospital and acts as a regional workshop for the surrounding areas.

The workshop is spacious, well laid out, with good workbench space and a good range of hand tools and test equipment.

The local engineering team are well equipped to carry out 1<sup>st</sup> line repairs, however they struggle with obtaining spares when faults are identified resulting in a backlog of broken equipment awaiting spare parts.

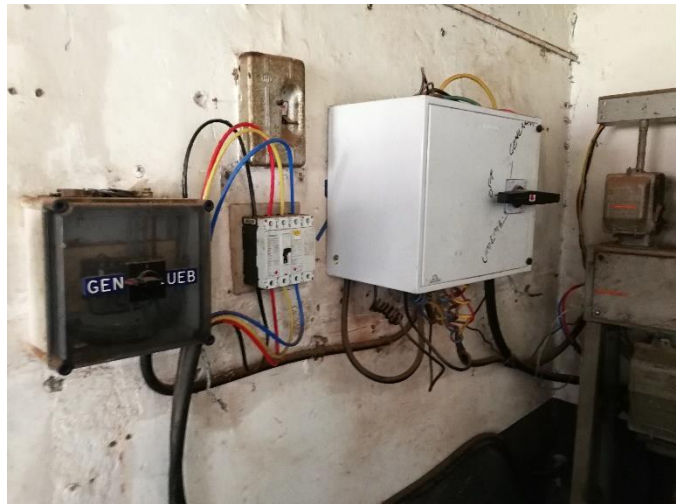
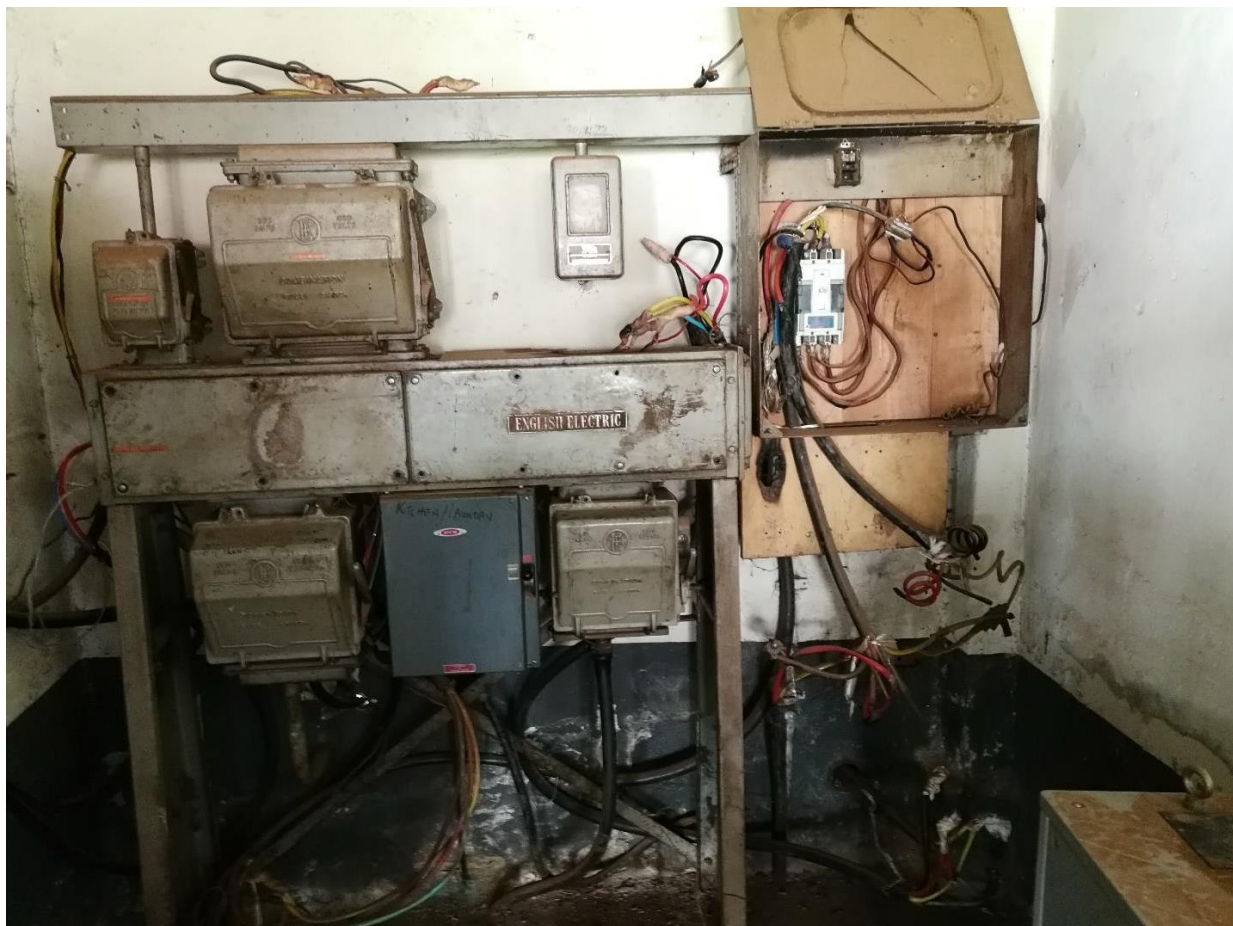
## Infrastructure:

The main hospital site is fed by 2 by 200KVA transformers so there should be sufficient incoming power to the site from the local municipality, however Kabala as a town suffers from frequent power trips and as such UPS and generator backup is critical to maintain effective running of life support systems.

The new JICA building has a dedicated power supply and switchgear which is in excellent condition, the rest of the hospital however is fed from old switchgear which is a poor condition and a full upgrade of the main switchgear and backup power generator system will be required to facilitate the running of the proposed new equipment.

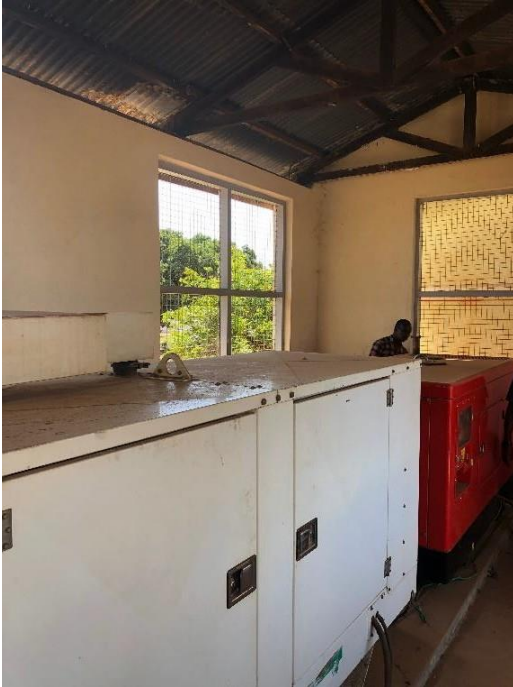
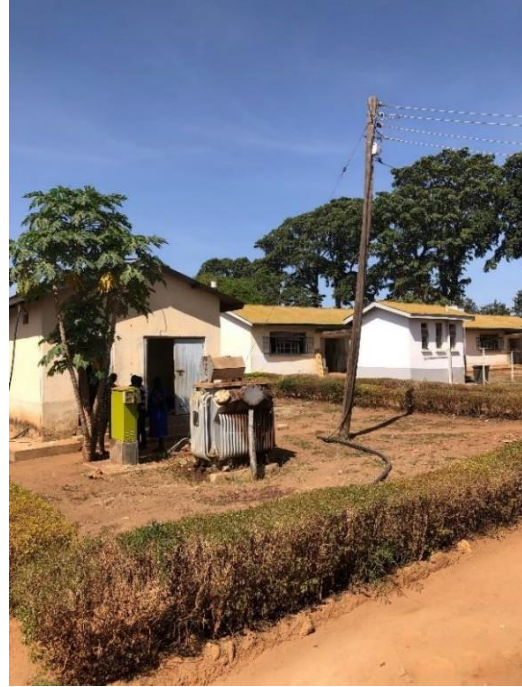
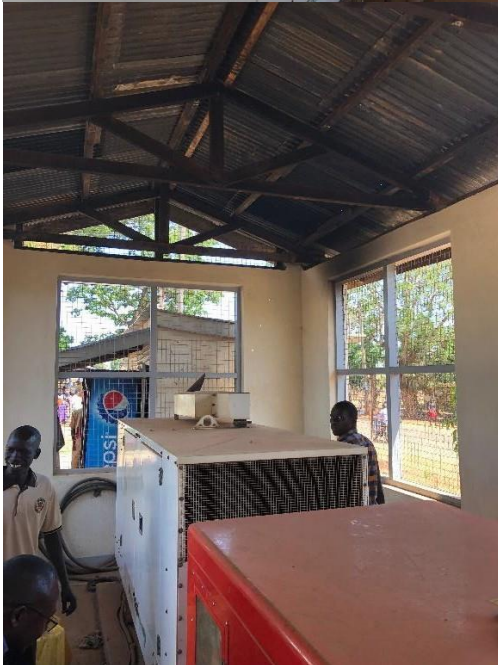
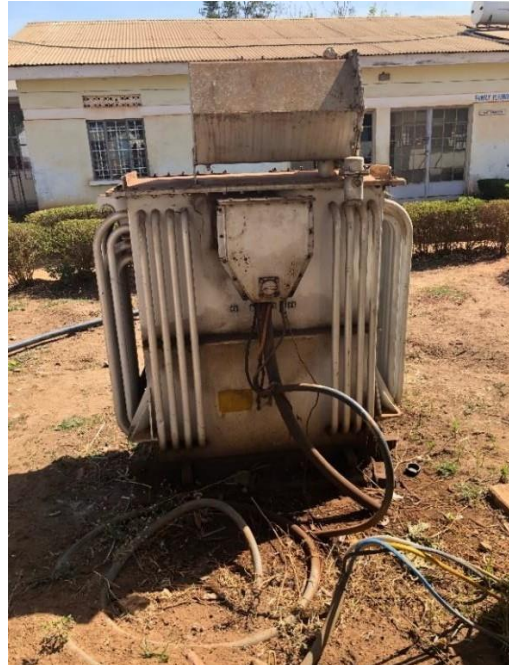
## Infrastructure:

Electrical power supply to Lira Hospital is via a 200kVA overhead electrical transformer, which is insufficient for a facility of this size. Two generators (a 100kVA and 30kVA) are installed for backup power, however only the larger generator is utilized as the smaller generator is believed to use too much diesel. Additional electrical supply will need to be provided to this hospital in order accommodate any additional equipment.

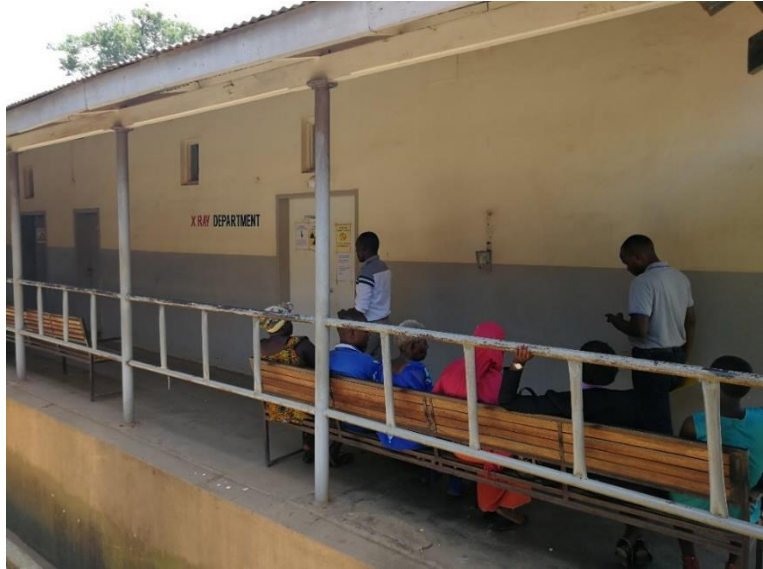
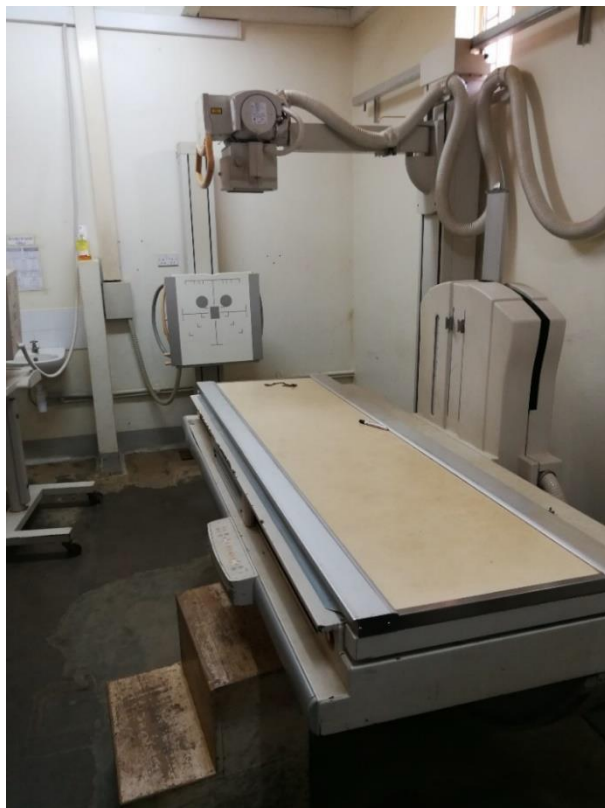
## Radiology:

The general X-Ray department is housed in a very old building, which is in desperate need of an upgrade, or ideally, a total rebuild.

Up to 75 ultrasound scans are conducted each day on the 2 available ultrasound machines, however they lack probes and have problems with artifacts on the one machine.

The general X-Ray machine is still functional and is from a previous donor-funded ORET project however is now nearing end-of-life and is becoming less reliable due to frequent voltage fluctuations and instable power supply. Approximately 45 scans per day are conducted on this machine.

Space is very limited in the current location to allow for expansion for mammography and CT scan services and it would be recommended to relocate the department to a new building more appropriately placed close to the Operating Theatres and A&E Department.

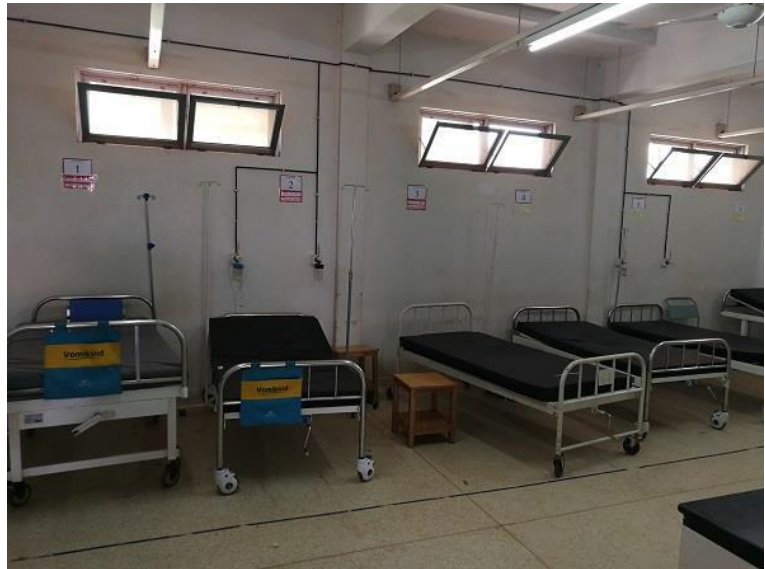
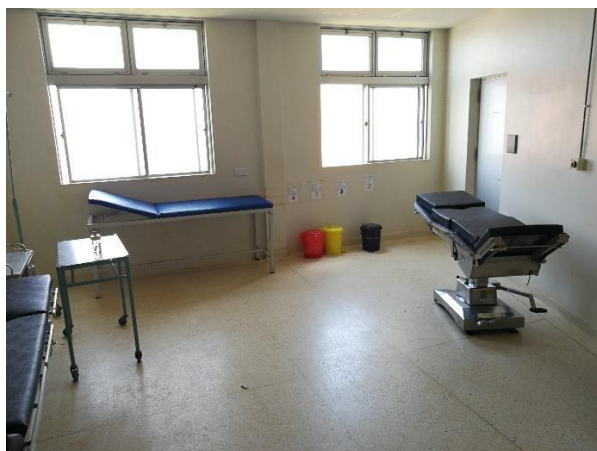
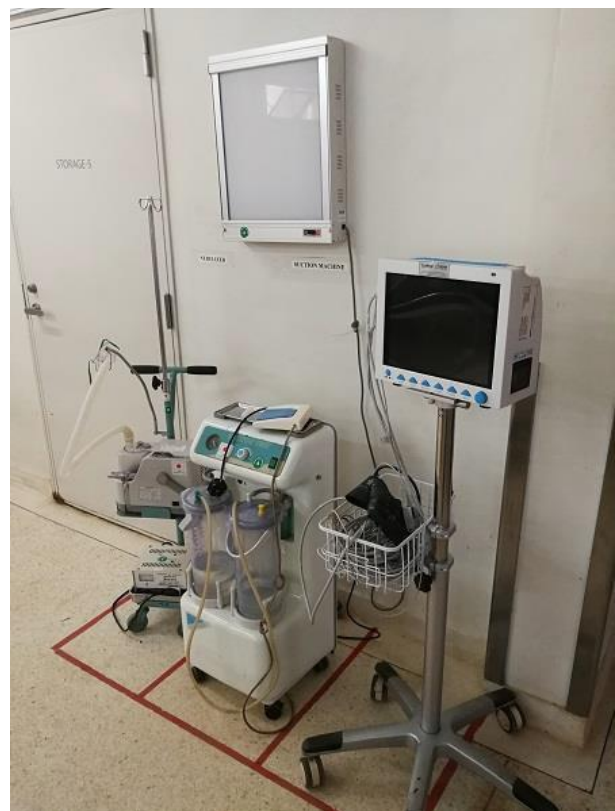
## Accident & Emergency:

The casualty department is housed in the new JICA funded building adjacent to the new operating theaters and is one of few that has piped oxygen available.

The department was extremely quiet and had very few patients at the time of the visit. As with several other RRH's visited, a lack of skills and sufficient staff hinders the functioning of these facilities.

This once again highlights the need for a significant training and skills development program as part of this project to ensure any equipment and upgrades provided are fully utilized and are sustainable for many years to come.

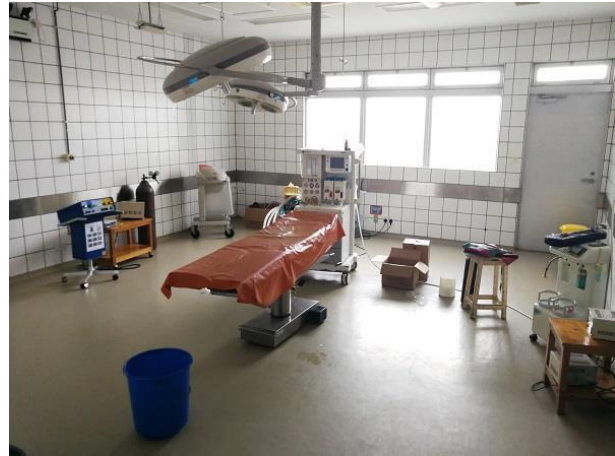
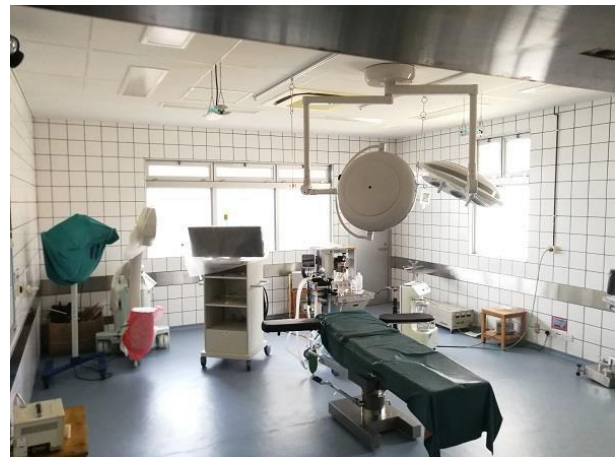
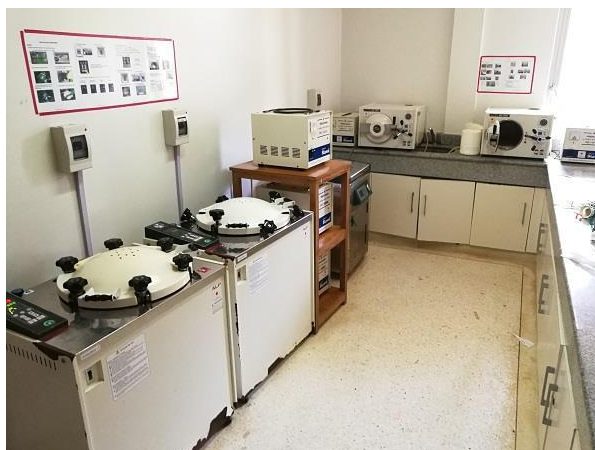
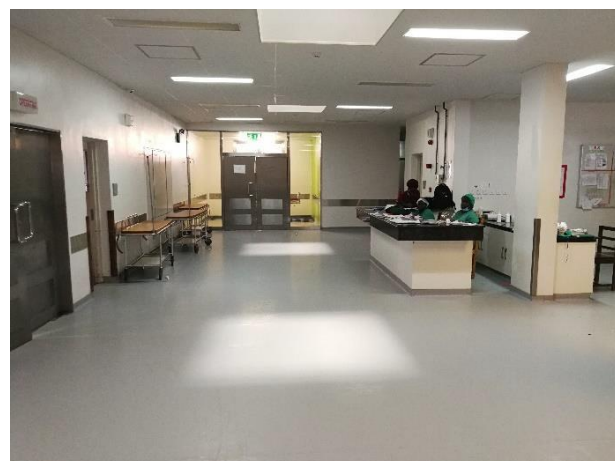
## Main Operating Theatres:

Considering how new the operating complex is, it was in a surprisingly poor condition and appears to have had very limited or no maintenance and general upkeep since it was opened.

As with all hospitals visited the cleaning regimes rely heavily on a bleach and water mixture which is poured across the floors regularly and pushed around and mopped up. The combination of a average high humidity climate of Uganda and frequent wetting with bleach and water has resulted in significant damage to joinery, finishes and especially medical equipment.

As can be seen in the below photo, all of the new equipment is already showing signs of significant rusting around the base where it comes into contact with water every time the department is cleaned.

Compared to other regional referral hospitals, the Masaka operating theatre complex was relatively quiet with few cases being carried out. The staff highlighted a shortage of orthopedic sets and equipment as a challenge and as with all hospitals, the halogen type operating lights do not last with the frequent power spikes and are often non functional.
