## 1. Executive Summary

The March 2019 survey of all 14 regional referral hospitals in Uganda conducted by representatives from MOH Uganda confirmed a clear need for intervention into the 6 core departments identified in the 2017 AMPC feasibility study report.

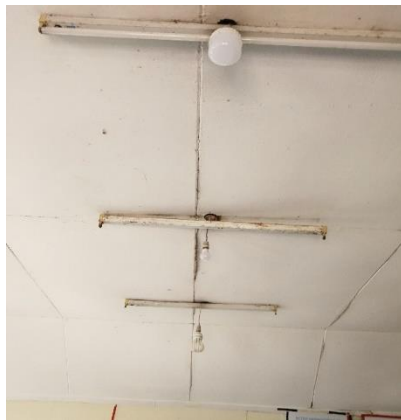
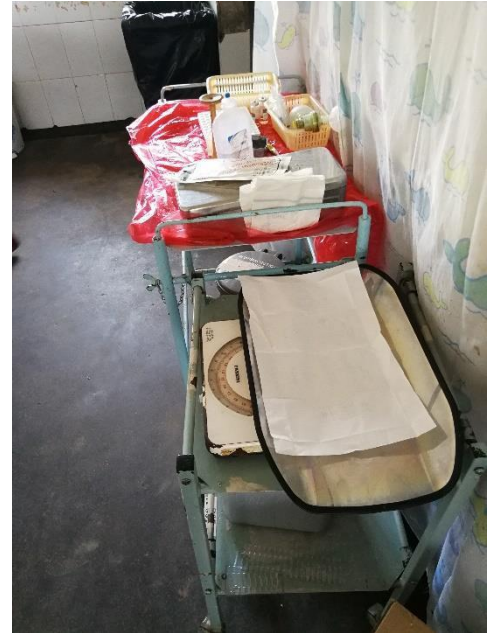
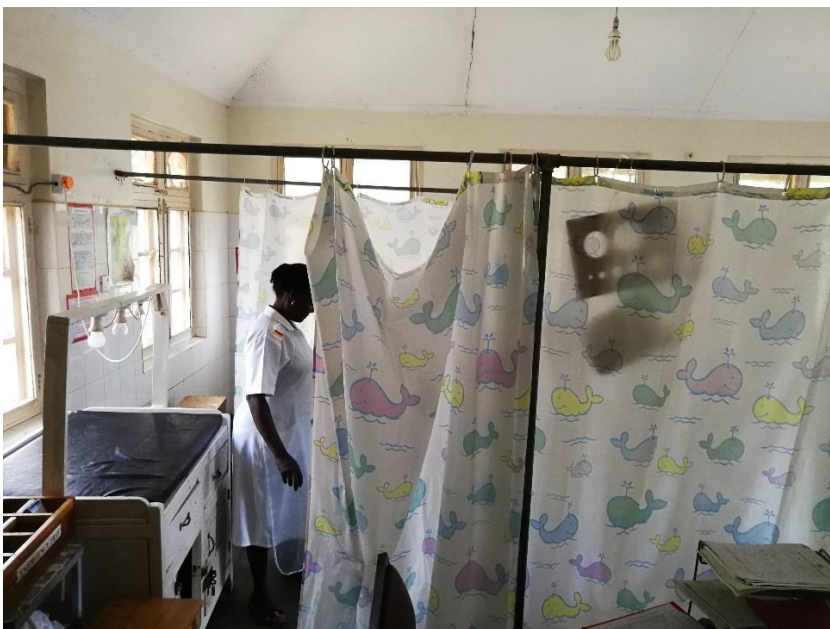
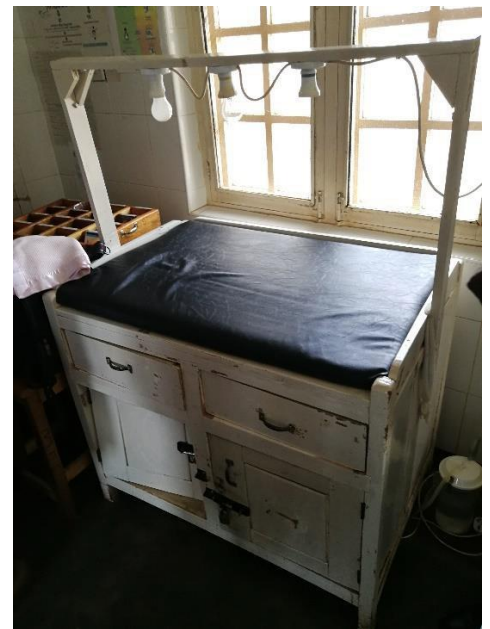
The maternity department is housed in a very old building which is in a poor condition, lighting is a big problem especially in the delivery room where many babies are delivered at night.

The department only has 2 delivery beds which are extremely close to each other and almost no equipment to deal with complications during birth. There is 1 makeshift infant warmer as shown below right which hardly serves the required function.

The unit delivers on average 20 babies per day on the 2 delivery beds which results in the labor ward keeping mothers until very late in labor and then trying to move them to the delivery beds at the last possible minute or they end up delivering in the ward if a bed is not available.

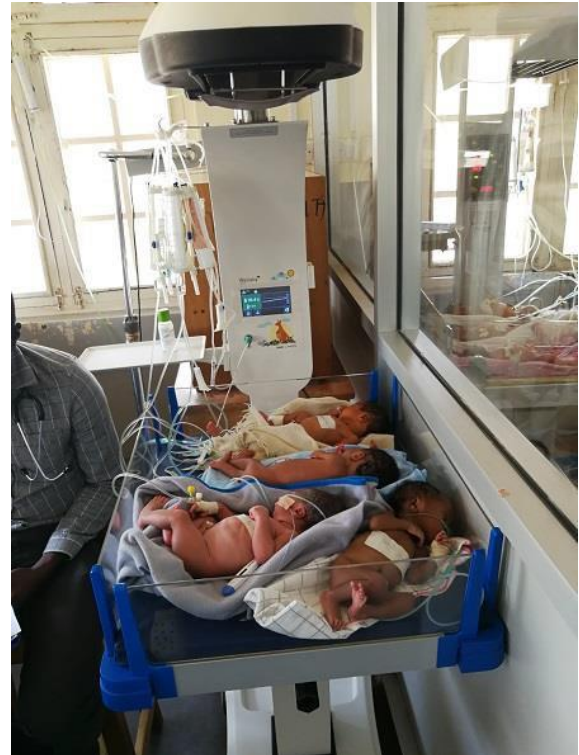
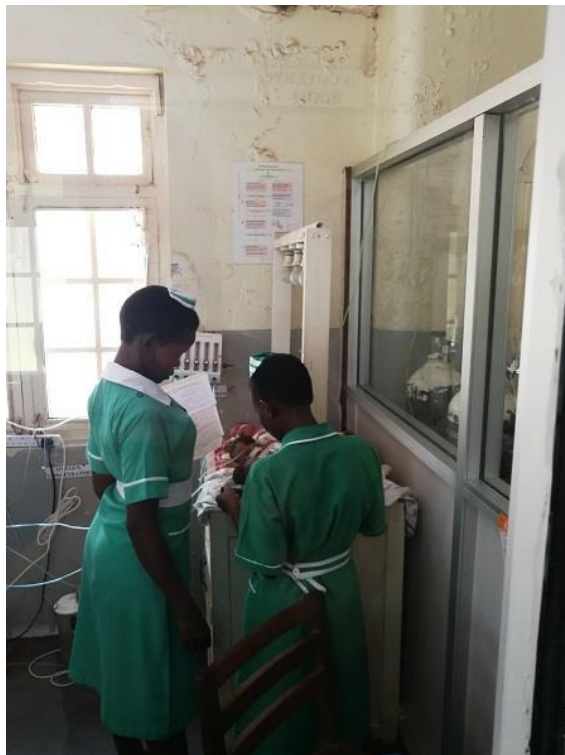
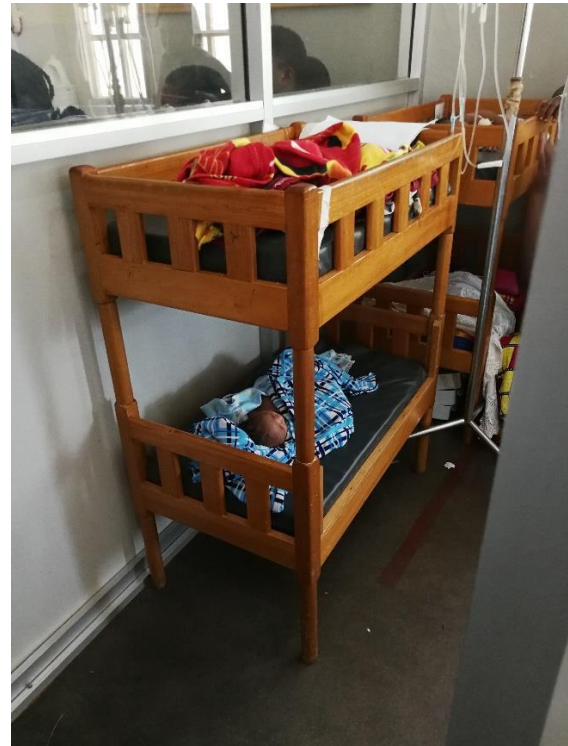
## NICU:

The neonatal ICU was extremely busy with 32 babies present at the time of the site assessment. As can be seen there are up to 4 babies per cot with any available surface being used to place babies.

The significant overcrowding results in a huge challenge for the few staff available to provide each baby with the required level of care. Equally the close proximity of the babies and lack of ventilation significantly increases the risk of an outbreak of communicable diseases in the unit.

The mortality rates sadly are high in the unit despite the best efforts of the team to cater for such a high number of babies.

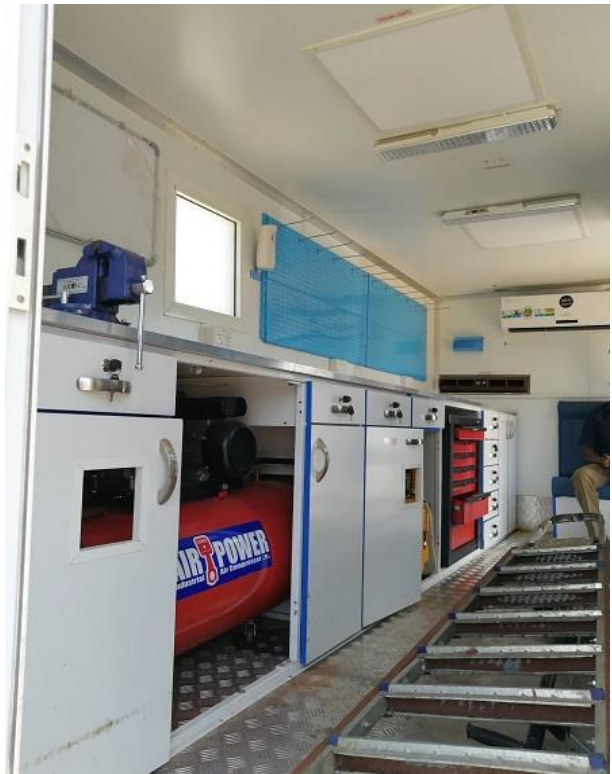
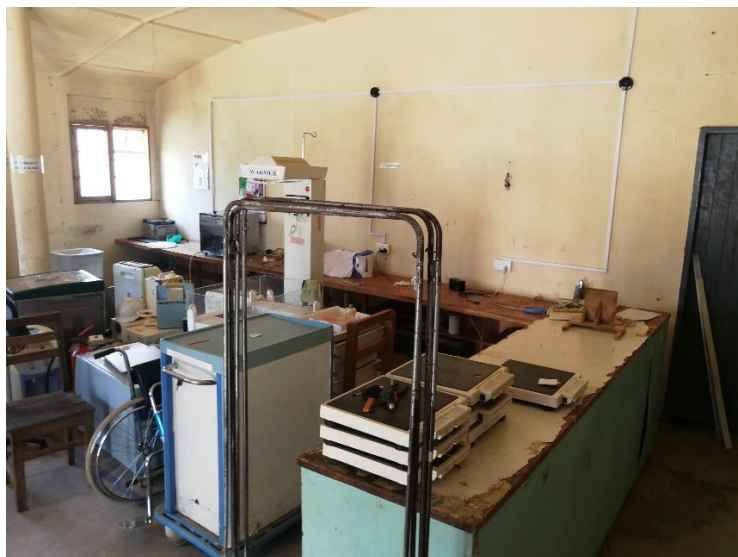
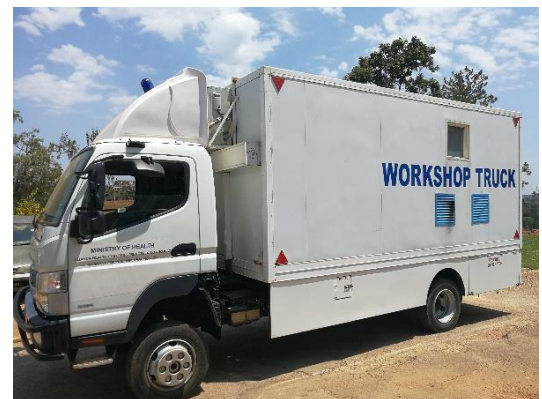
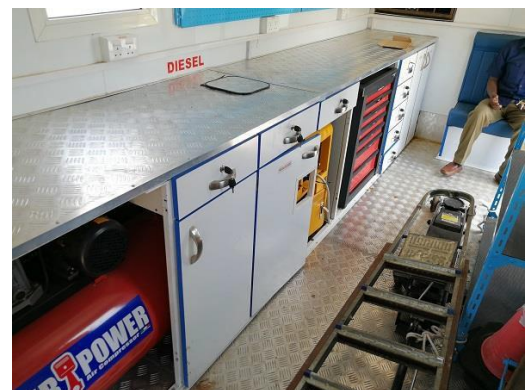
## Maintenance Workshops:

The maintenance workshop is located in a very old building with asbestos roofing which is in a poor condition and should be carefully renovated or rebuilt.

Compared to other hospitals this department was in a poor condition and did not appear to be well kept with little structure or order to how the workshop was laid out and kept.

The local engineering team had limited tools or spares available in the workshop and it did not appear as if many repairs were being undertaken in this building.

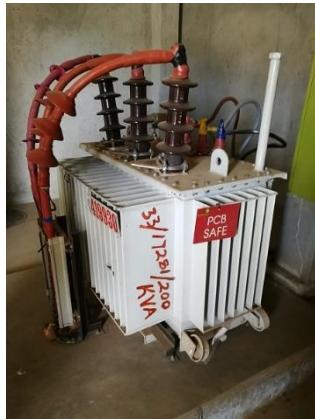
As can be seen by the below examples, the contrast between the old infrastructure and new JICA building power supply is significant.

That being said, the old switchgear is still in a good condition and appears well looked after.

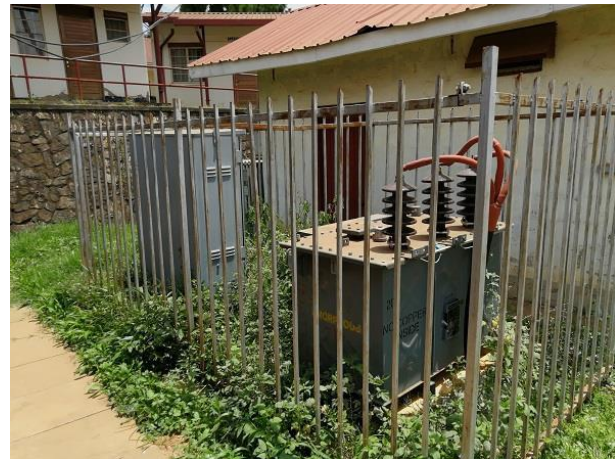
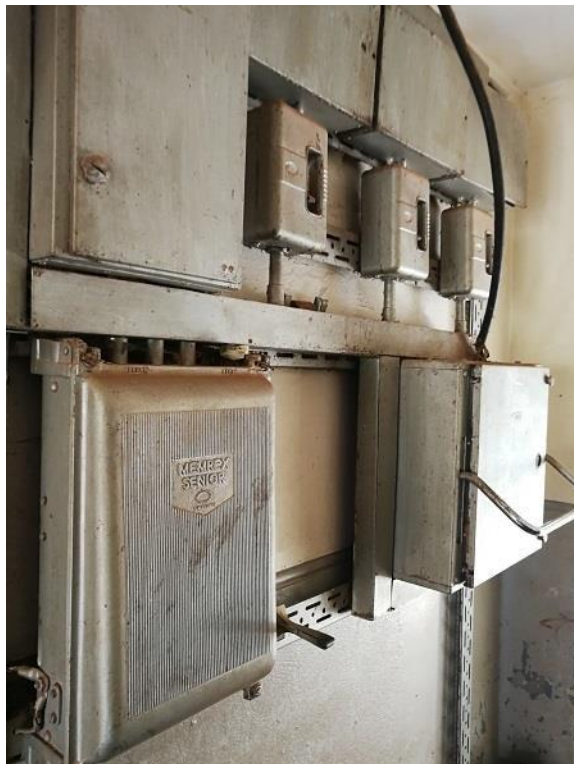
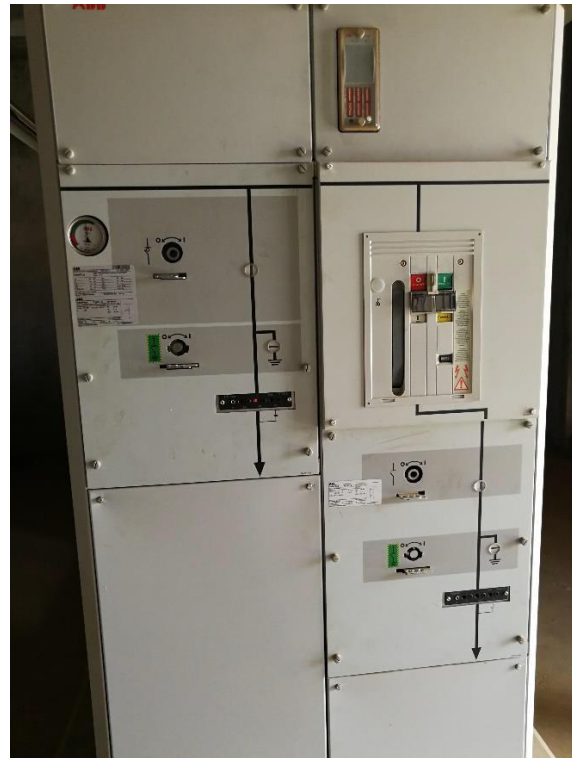
The hospital does however have a shortage of available power on site to enable the upgrading and expansion of the x-ray department and addition of the new CT scanner.

A new transformer and main switchgear will be required to facilitate the planned upgrades.

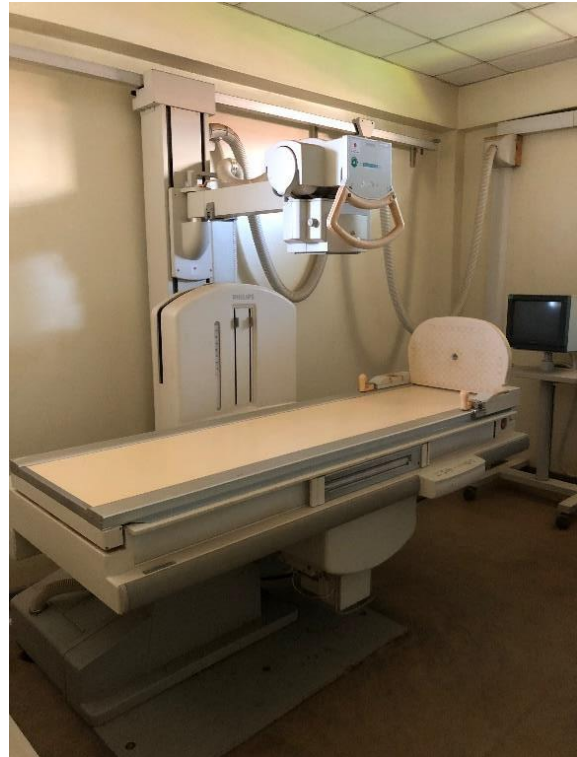
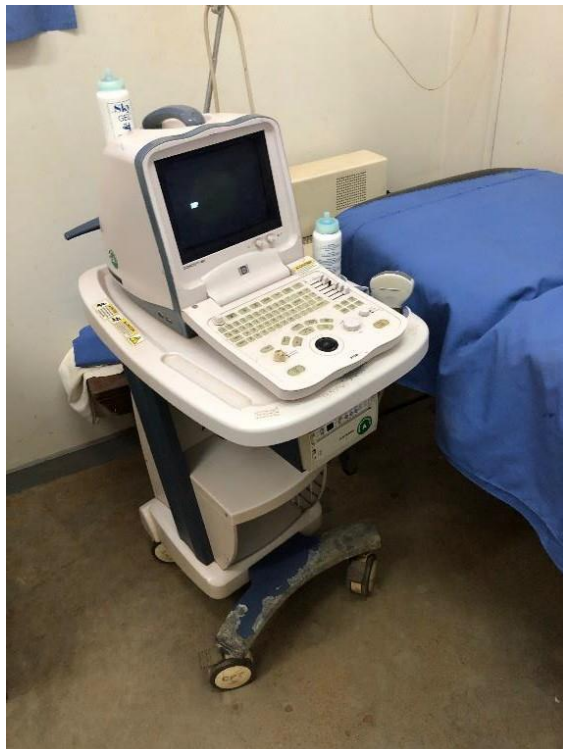
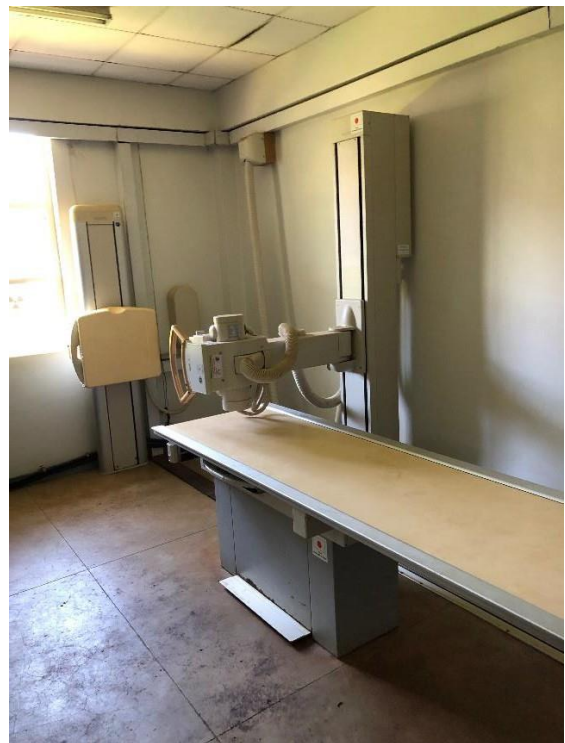
## Radiology:

All the major equipment in this unit is functional but is nearing end-of-life. The only functional ultrasound unit is used to conduct approximately 60 - 80 scans per day. The general X-Ray machine/ Bucky table is an analogue unit and approximately 50 scans are conducted on this machine per day. This unit is obsolete and software updates are no longer supported.

In order to accommodate the expansion for mammography, CT and MRI services it is recommended that this department be relocated to the new Surgical Complex building.

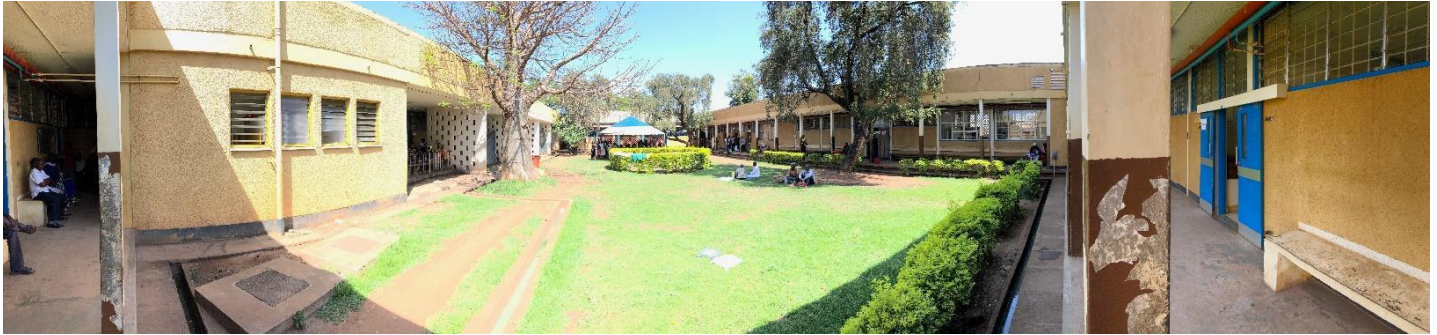
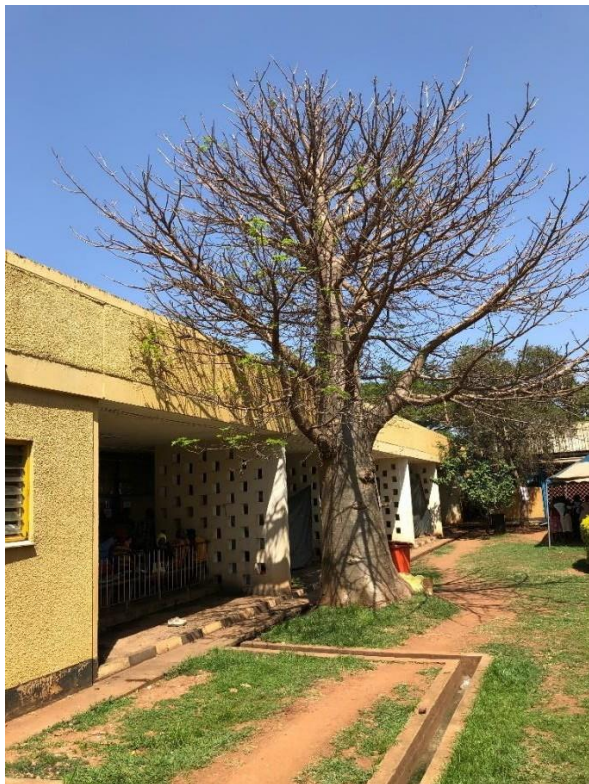
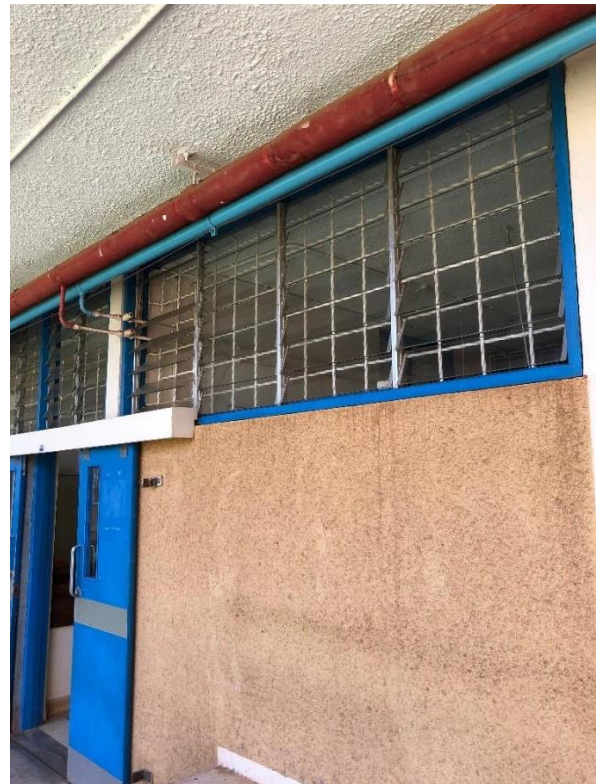
## Accident & Emergency:

The Accident and Emergency department is located in the same building as the OPD department, but is scheduled be relocated to the new Surgical Complex. Space within the Unit is limited and is overcrowded.

It was found that there is a critical shortage of equipment to deliver care to the patients. The equipment that is available is very old, with the majority of it being nonfunctional and in need of replacement.

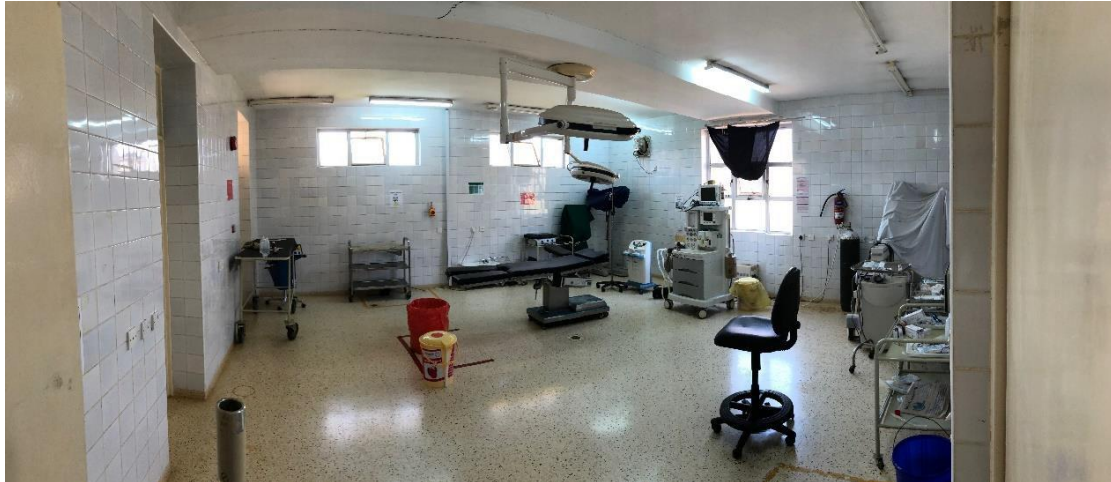
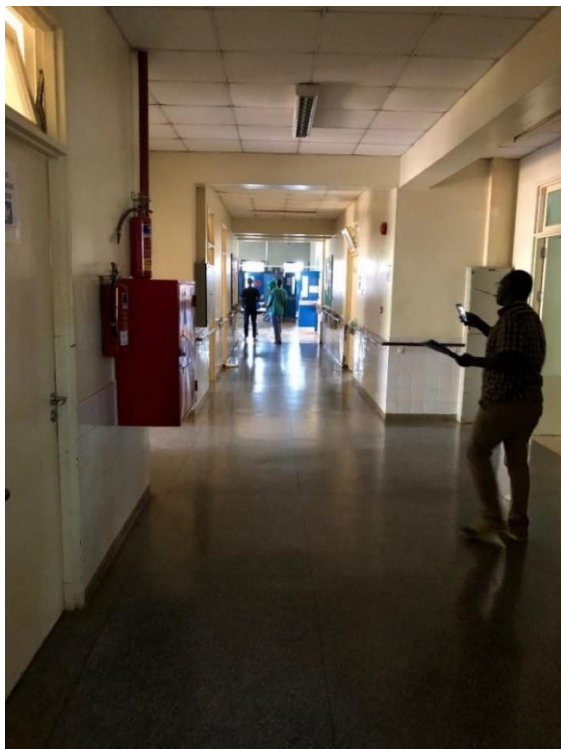
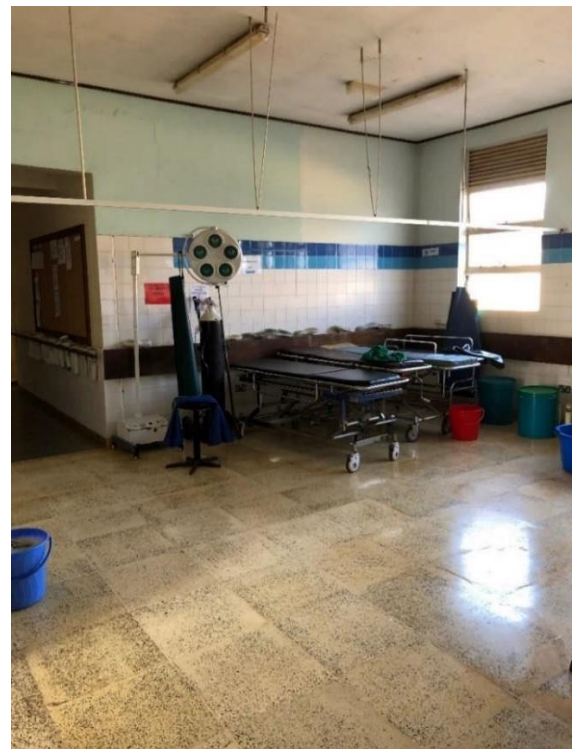
## Main Operating Theatres:

The Main Theatre complex was increased from 1 to 3 theatres through a JICA project. The majority of the equipment is in a fair working condition, but has reached end-of-life and is in need of replacement.

The recovery area does not have any equipment and is in need of a major refurbishment. The Theatre Complex is planned to relocate to the new Surgical Complex once completed.

At the time of the inspection the team were advised that the lack of surgical instrument sets were a major concern for the surgeons.

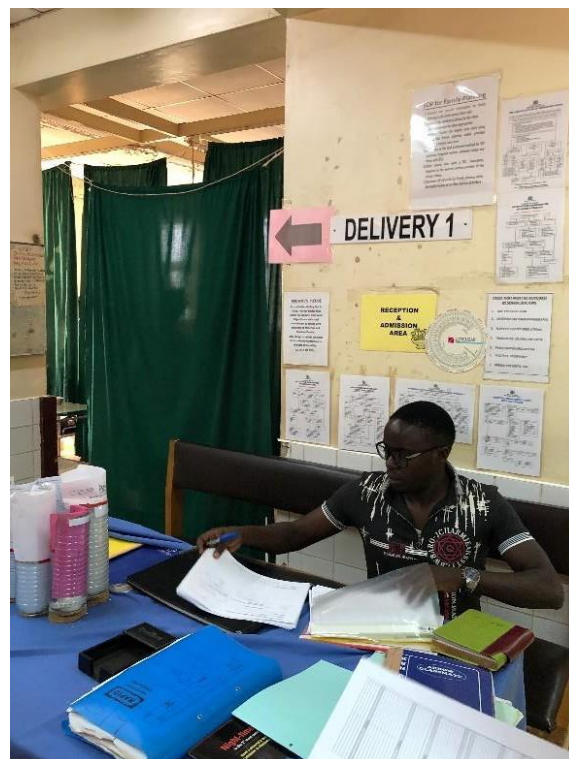
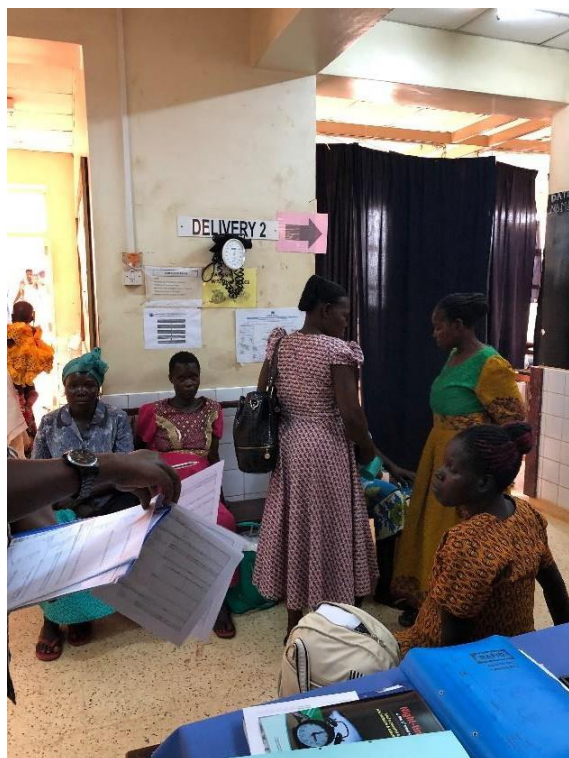
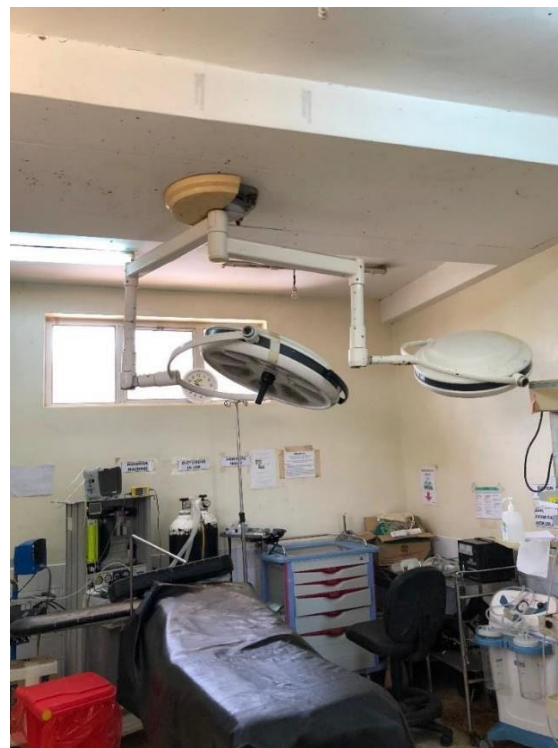
## Maternity:

The Maternity Departments consists of two rooms with 3 delivery beds per room. The unit was found to be very busy and overcrowded, and is reported to be doing between 650 -750 deliveries per month. Entry into the units was not permitted due to patients being in labour at the time of inspection. All available equipment was found to be old and in need of replacement. Equipment within this unit is insufficient to provide care to the number of patients beings seen to and the infrastructure is in need of an upgrade.

The Obstetrics Theatre is located in the Delivery Unit and was upgrade by JICA. This theatre is currently doing between 200 –250 procedures and deliveries per month. The equipment was found to have reached end-of-life and is in need of replacement. Infrastructure to this theatre is also in need of an upgrade.

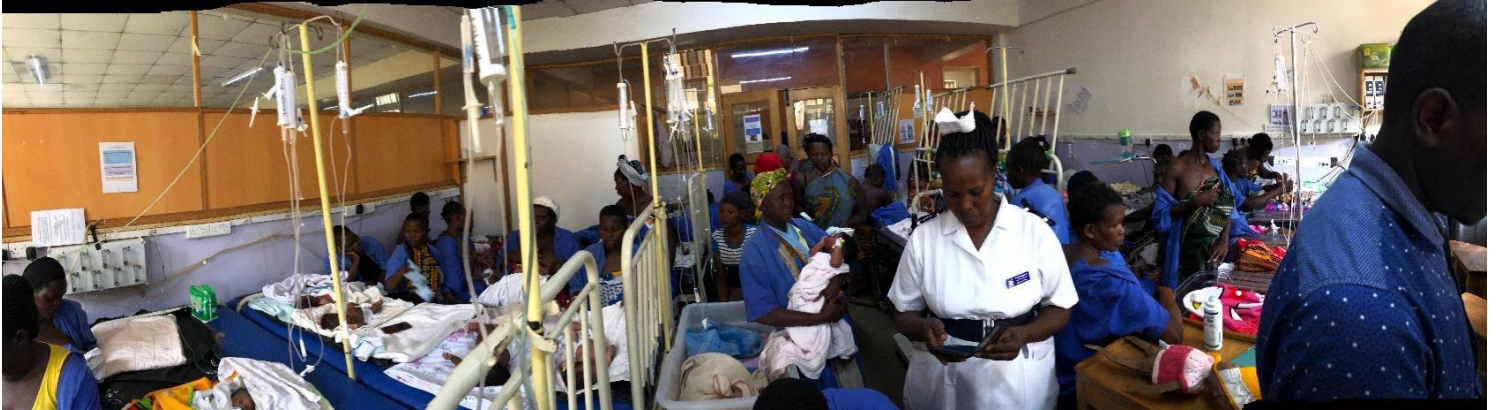
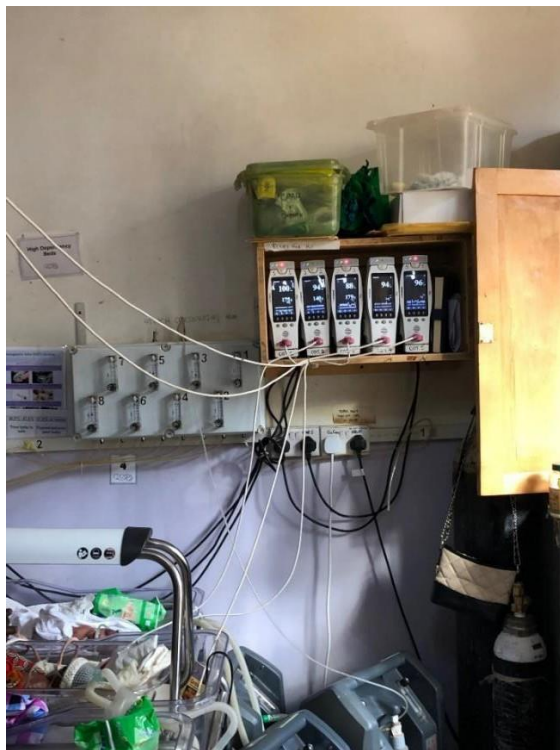
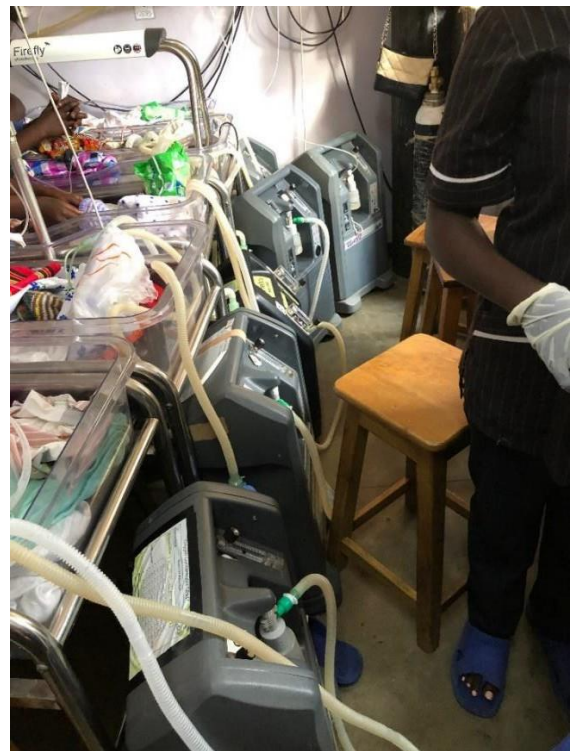
## NICU:

The NICU, NHCU and nursery are all located one department due to a lack of space and infrastructure. The room currently being used for this unit is too small for the number of babies been cared for. The unit was found to be extremely busy and overcrowded. Space to move between babies is restricted thus resulting in inefficiencies in nursing care to patients. There is a shortage of equipment for the number of babies being treated and the equipment that is available has reached end-of-life and is in need of replacement.

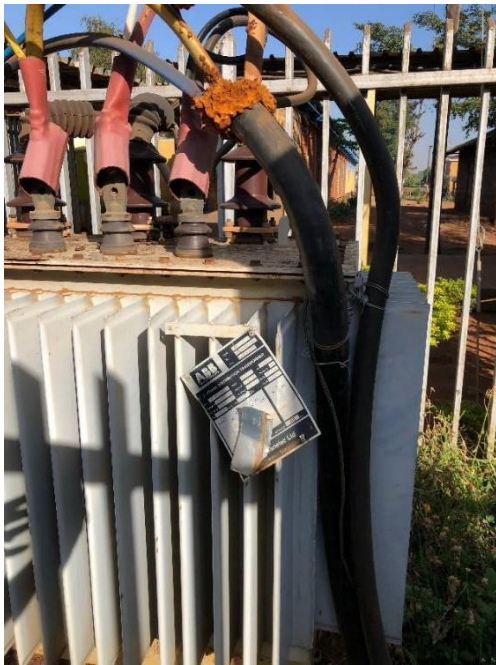
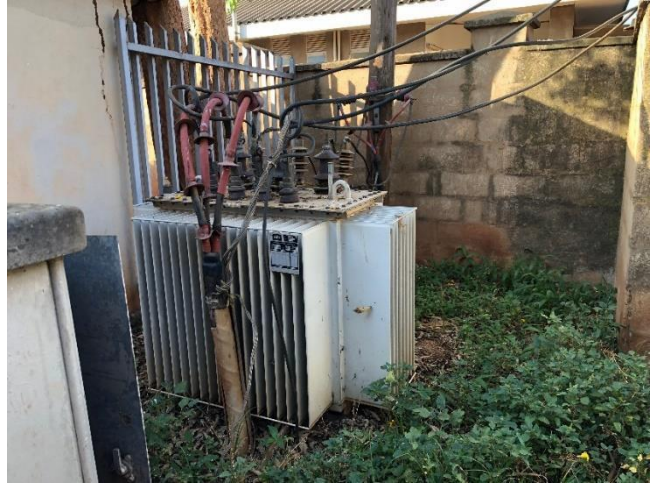
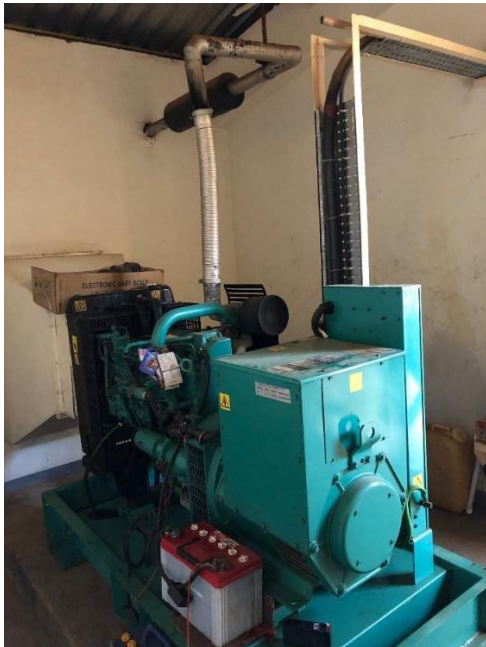
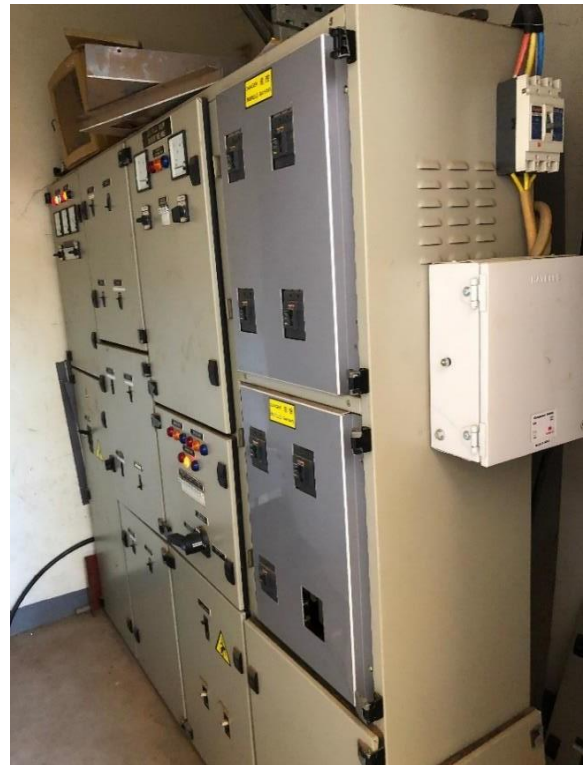
## Infrastructure:

Electrical power to this hospital is provided via a 500kVA and 315kVA transformer. There is only one 50kVA generator installed at this hospital, which is a high risk to patients in the event of a power failure.

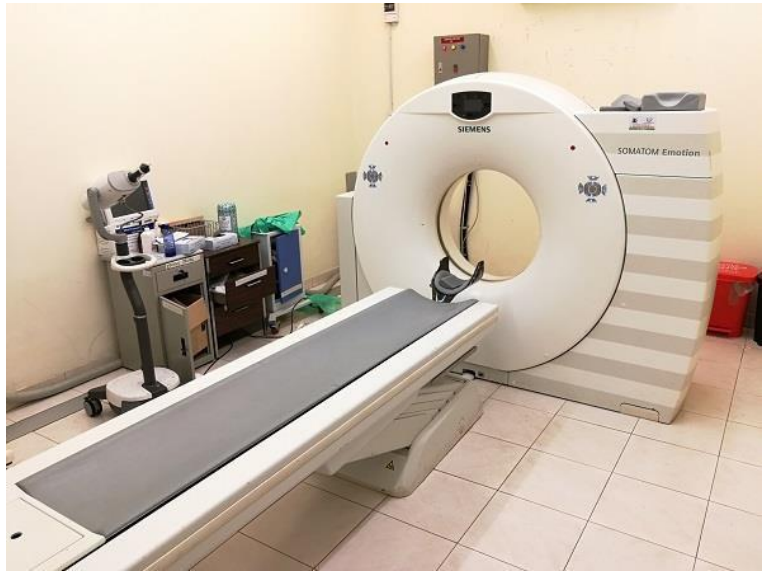
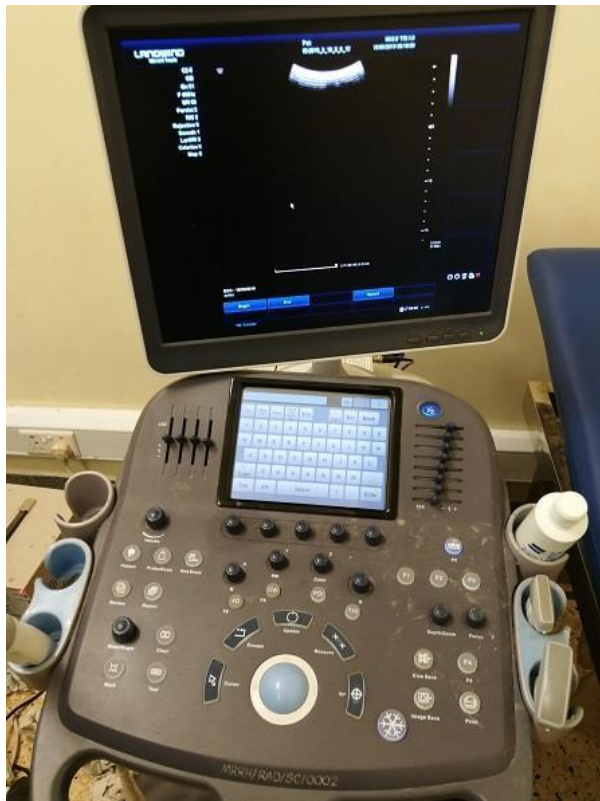
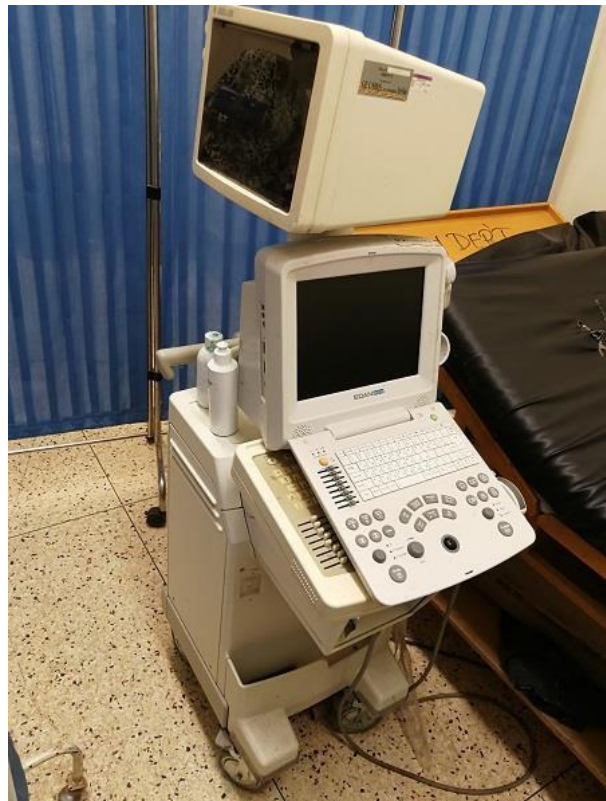
## Radiology:

The radiology department is split over 2 floors in a relatively new building and is extremely busy.

They have a 16 slice CT scanner which was extremely busy and in use, however it was not able to give the clarity on the scans required for some of the neuro and cardiac work being undertaken. The injector is also faulty and needs replacement.

Mbarara is in desperate need for new ultrasound scanners with a long queue for scans and out of necessity a portable scanner has been placed on a broken cart based ultrasound as in interim solution to attempt to serve the waiting patients.

There is a partially functioning general X-ray unit which is 7 years old and a mobile X-ray.

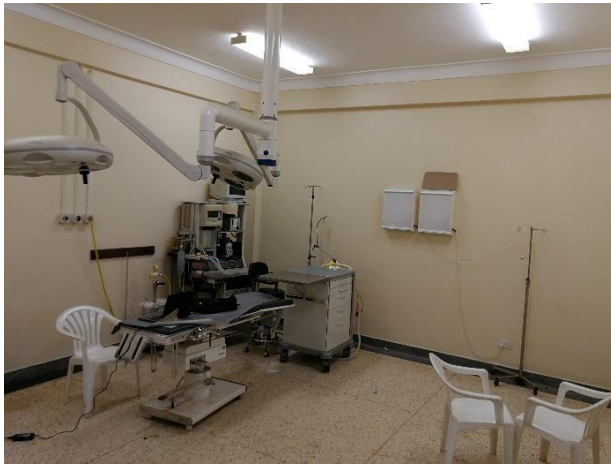
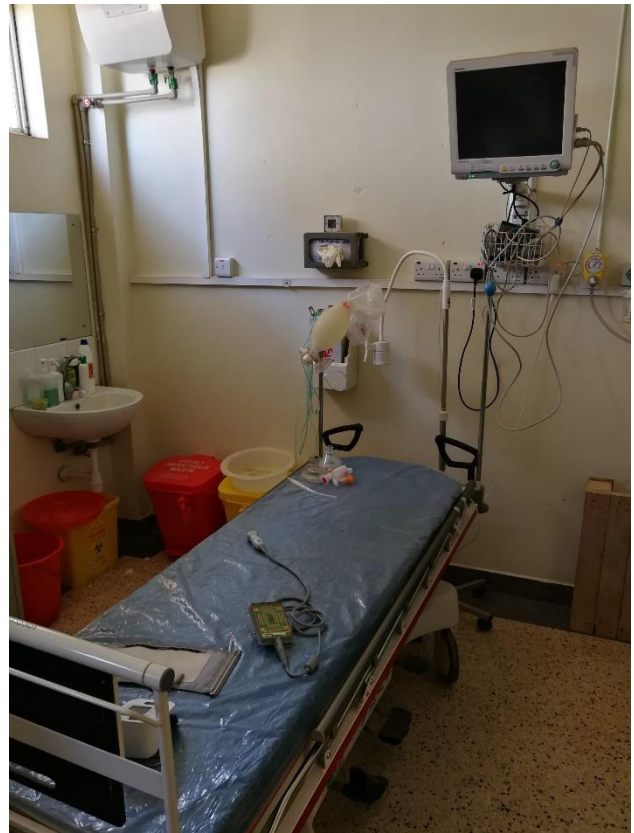
## Accident & Emergency:

Casualty is extremely busy and despite being designed for 10 beds had almost 30 patients at the time of the survey with many lying on the floor. The unit serves more as a HDU/ICU and casualty department with many long stay patients and struggles from flow as there is nowhere else in the hospital to move patients on to once stabilized due to the lack of high care facilities in the other departments/wards and the fact that the ICU is not in use.

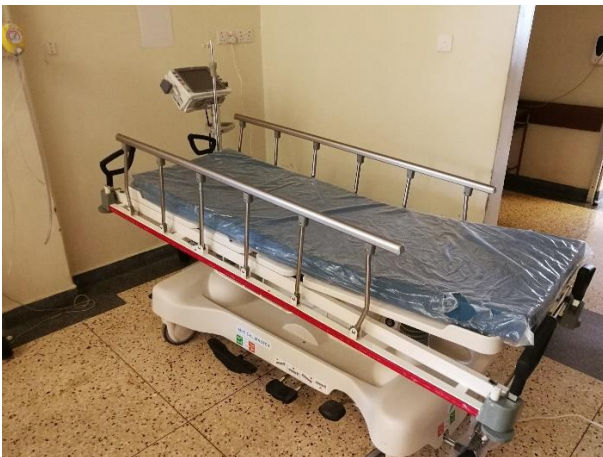
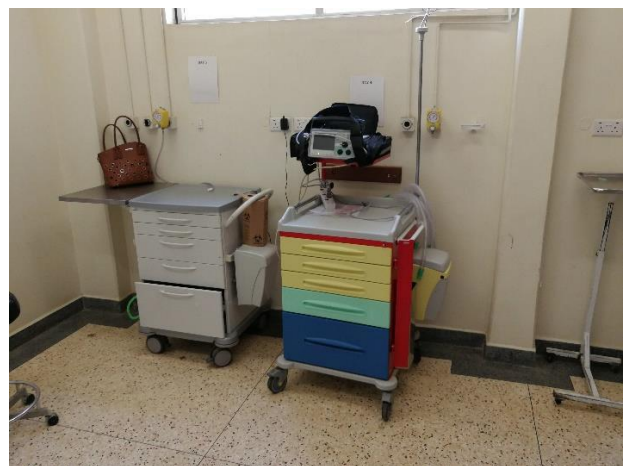
The casualty also has a fully fitted out minor operating room, however this was not in use and appeared to be being used more as a study/rest area for the students. The department is critically short of staff and relies on the patients “helpers” to assist with some of the more basic tasks as there simply are not enough nurses to care for all the patients.

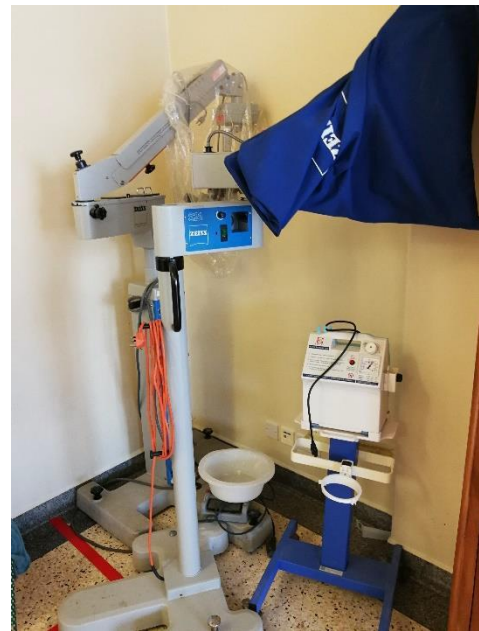
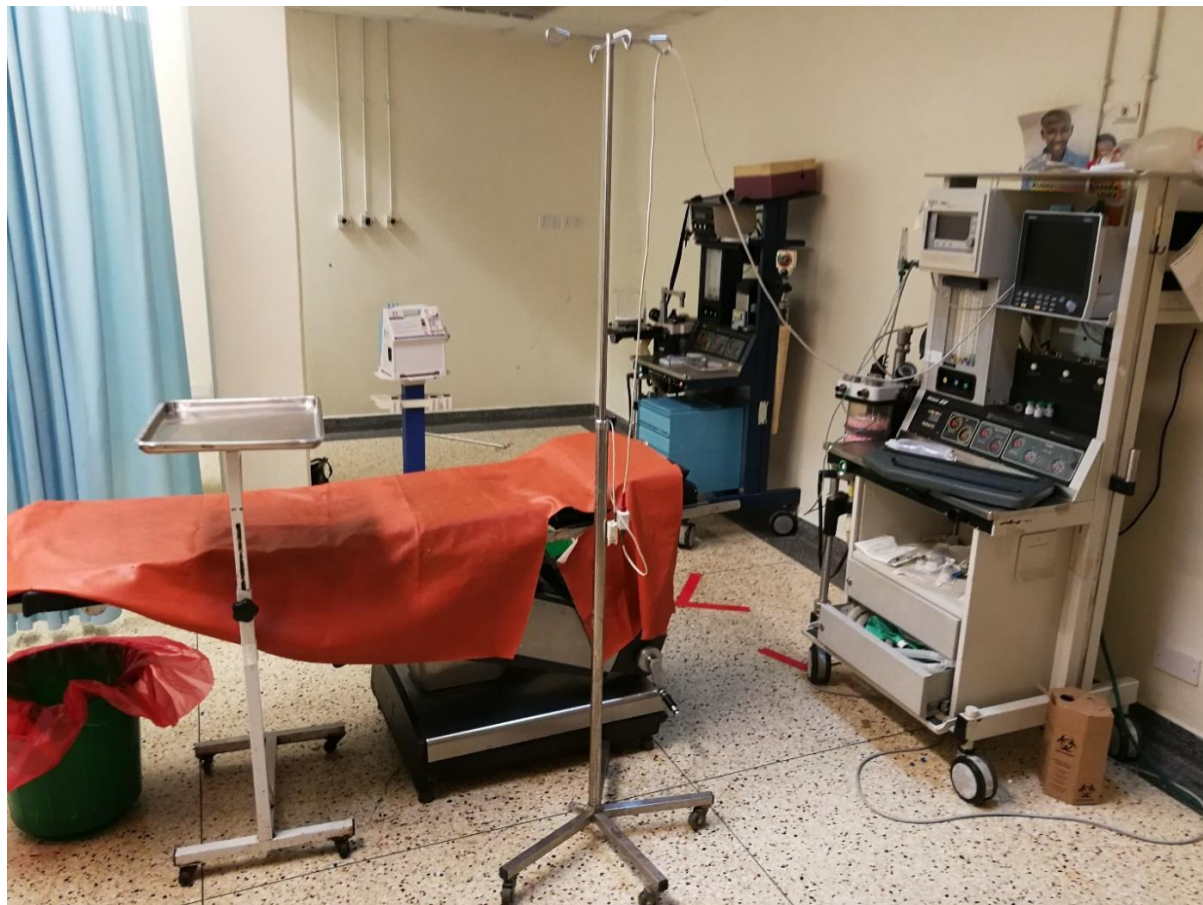
## Main Operating Theatres:

The operating department was extremely busy and conducts a full range of surgical procedures covering all major disciplines. The recovery area has even been converted into a makeshift cesarean theatre and is used as an overflow when the 5 main theatres are full.

Anesthetic machines are problematic with many faults such as no automatic ventilation or no monitors. A big problem is the lack of routine maintenance and calibration on the machines. Significant variances were noted on a machine in use during a procedure.

The building condition is good, however there is a lack of ventilation and filtration where even neuro procedures are being undertaken with no laminar flow or clean air system in place which created an extreme risk of infection.

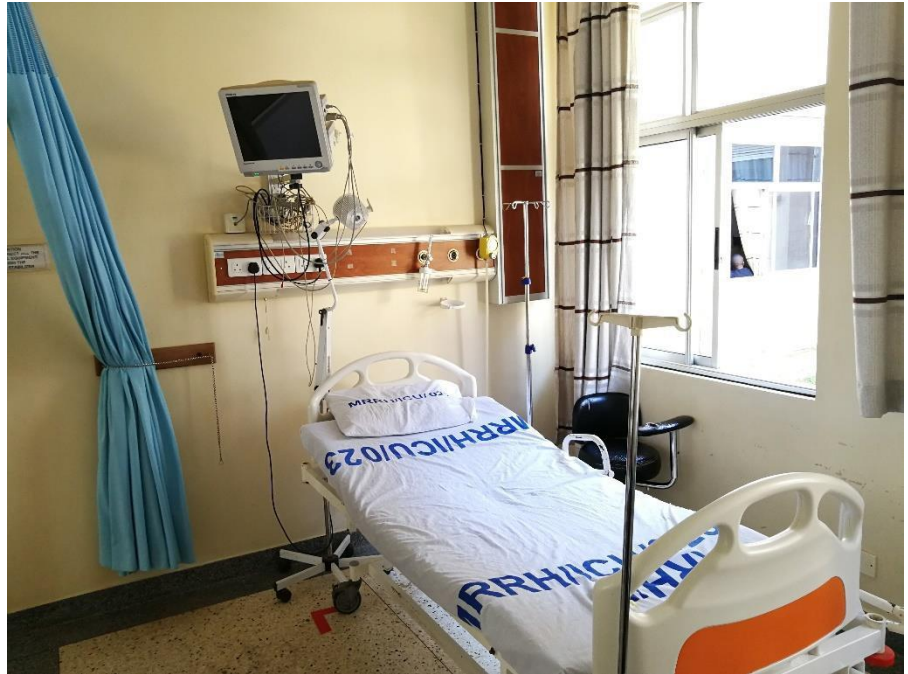
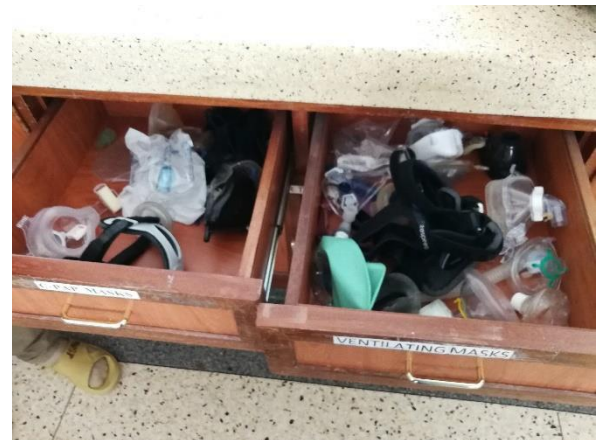
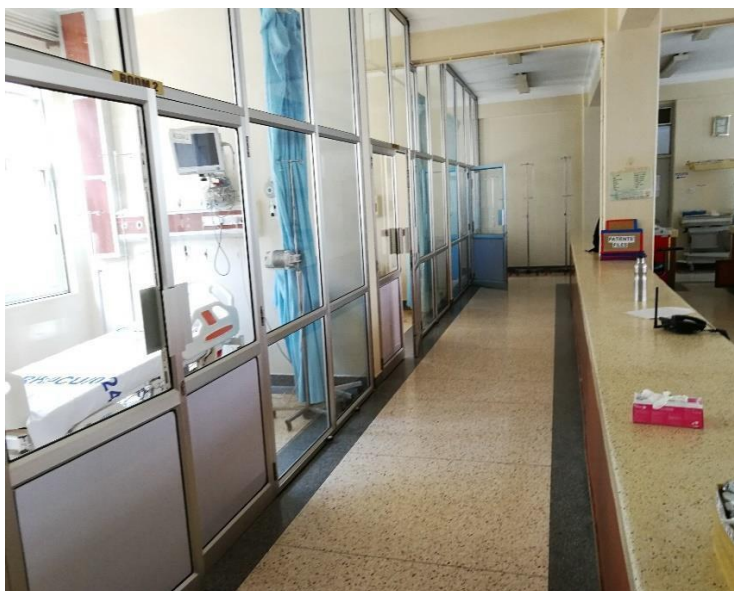
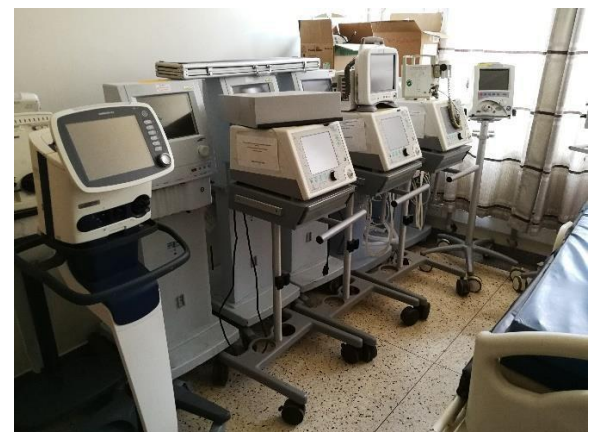
## ICU:

The hospital is one of few regional referral hospitals that has a fully equipped 8 bed ICU, however the unit was locked up and empty.

Despite having several ventilators and CPAP machines none were working according to the unit manager, but all looked relatively new and most likely only required minor repairs.

Apparently ordering of parts for some brands of equipment is problematic if not stocked or on catalogue with the central purchasing department.

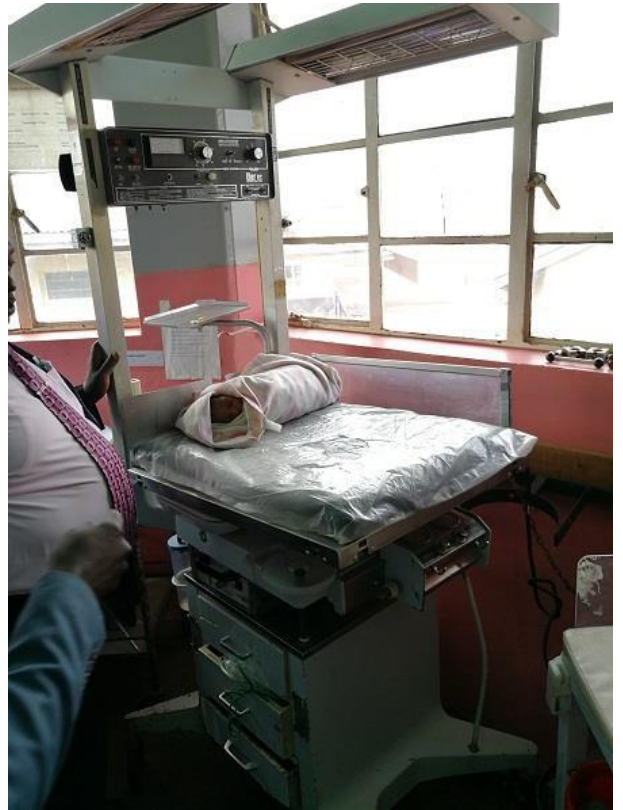
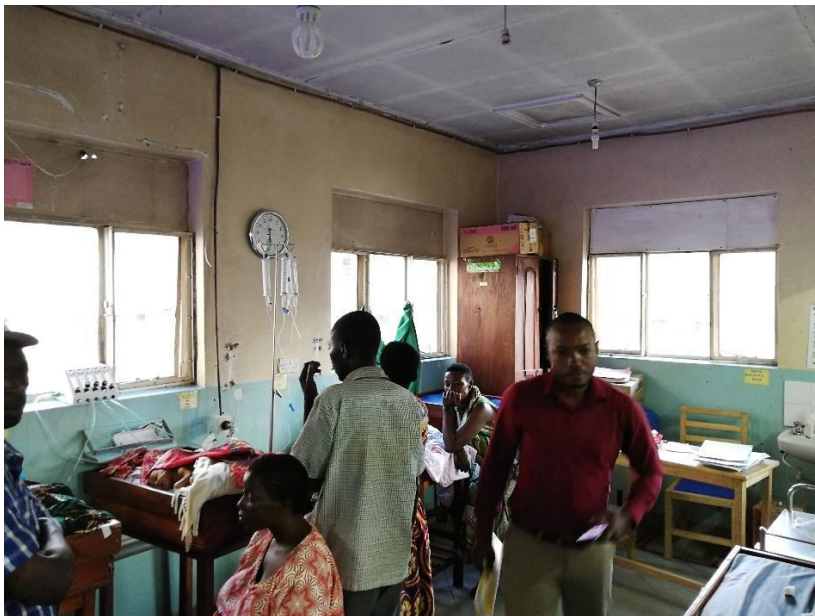
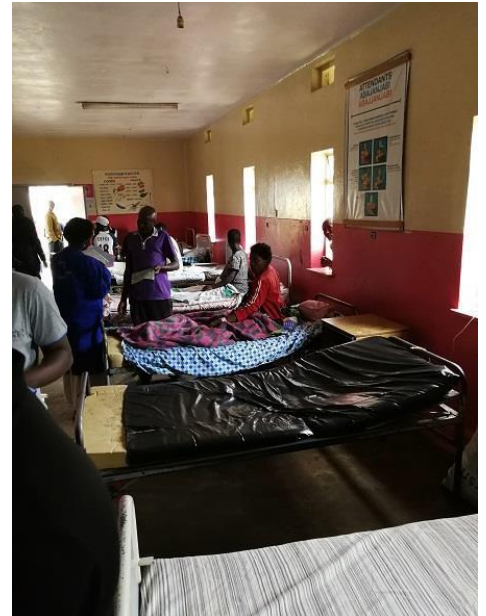
## Maternity:

The maternity department is in a very old building in poor condition and only has 2 delivery beds for up to 40 babies per day.

The unit has virtually no functional equipment such as warmers or resuscitation tables and is not equipped to deal with any complications during birth.

The delivery room has virtually no lighting and no ventilation or heating and is not suitable for the number of babies being delivered every day. There is space outside to expand the unit and it would be recommended to rebuild a new bigger unit.
