## 1. Executive Summary

The March 2019 survey of all 14 regional referral hospitals in Uganda conducted by representatives from MOH Uganda confirmed a clear need for intervention into the 6 core departments identified in the 2017 AMPC feasibility study report.

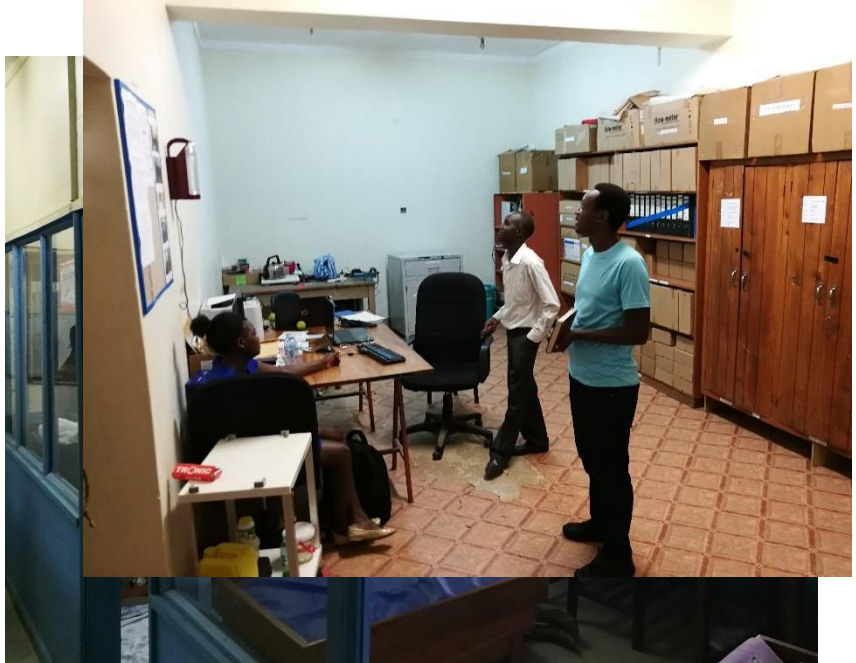
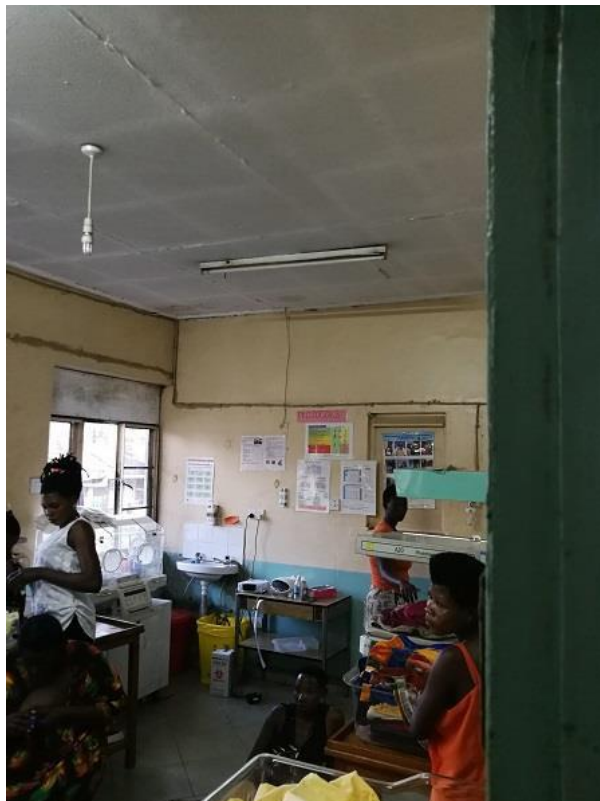
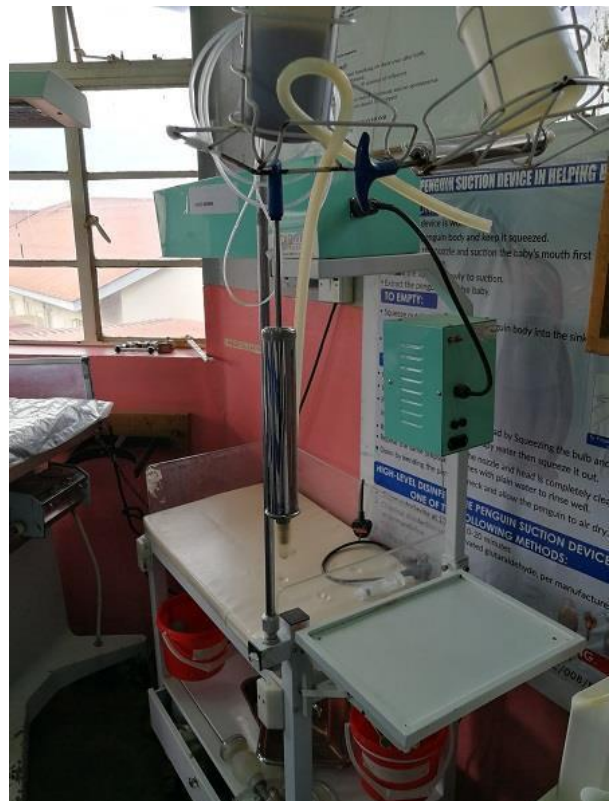
## NICU:

The neonatal ICU is also in the same old building as the delivery rooms and general maternity wards and is in desperate need of an upgrade. The unit functions more as a high care unit due to a lack of equipment and staff to effectively run a dedicated neonatal ICU. The unit receives referrals from other hospitals and can hold anywhere from 30 to 70 babies at any one time. The space is critically small and careful consideration should be given to what the correct capacity should be and where to house the new/refurbished unit.

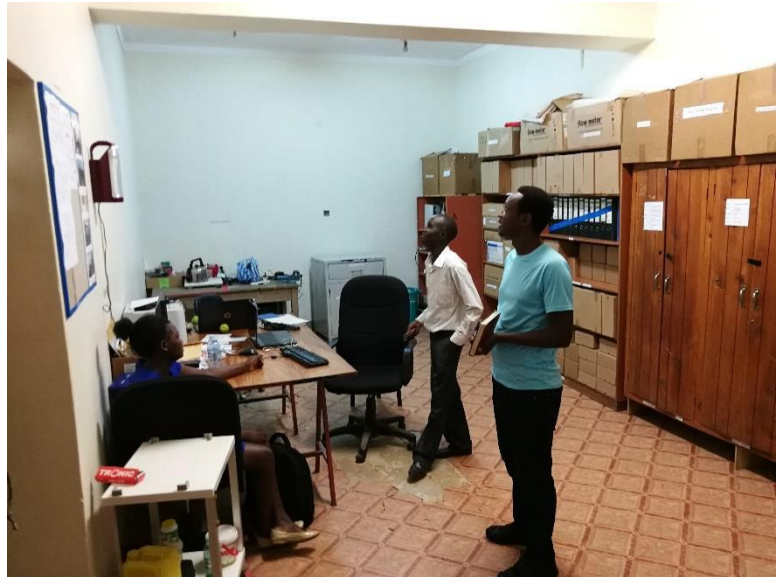
## Maintenance Workshops:

The current maintenance workshop is located adjacent to the CT scanner and would be the ideal space to house the proposed MRI for this hospital so would need to be relocated elsewhere on the site.

There were limited tools and testing equipment available and only basic hand tools available.

Ordering of spare parts and consumables is problematic and hinders repairs to equipment on site.

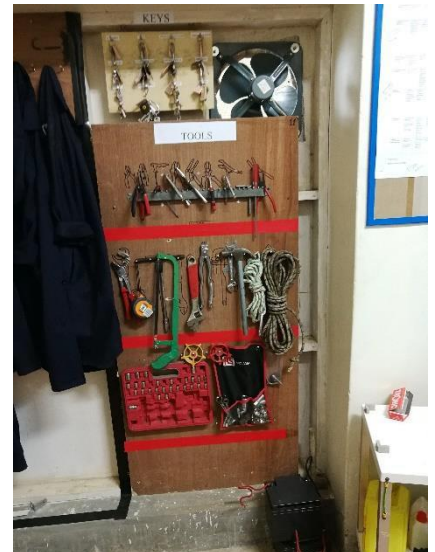
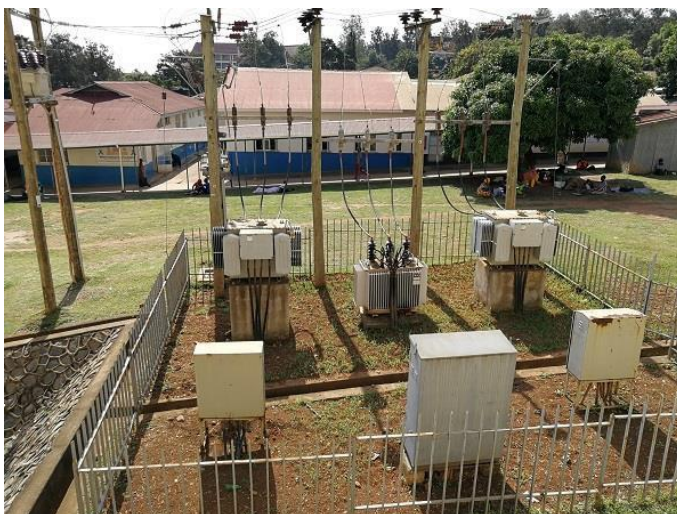
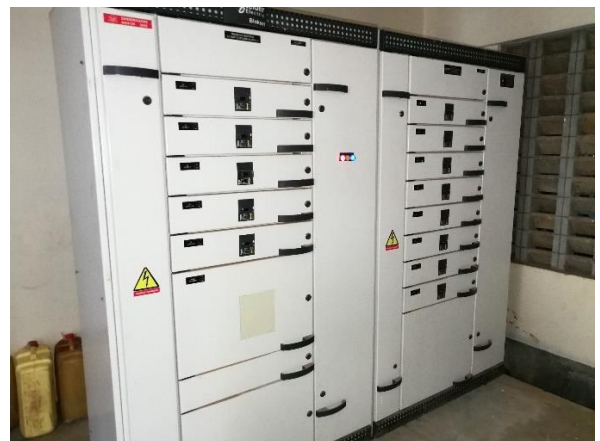
## Infrastructure:

The hospital has 3 by 500KVA main transformers on site and is expecting an upgraded dedicated main line to the site as part of other upgrades. 1 of the 500KVA transformers is not in use yet so there is sufficient capacity on site for upgrades and expansions, there is also a brand new main distribution board and switchgear in the basement of the X-Ray and operating theatre building with spare capacity for the addition of the MRI and upgraded CT scanner.

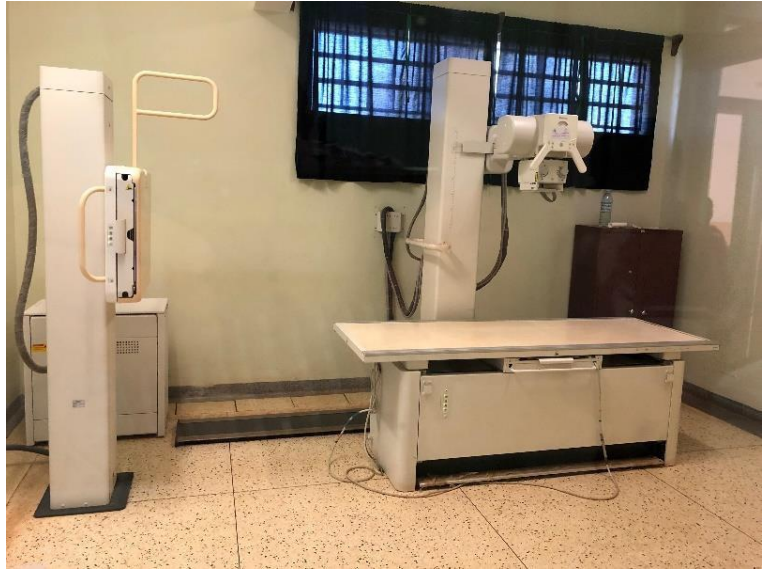
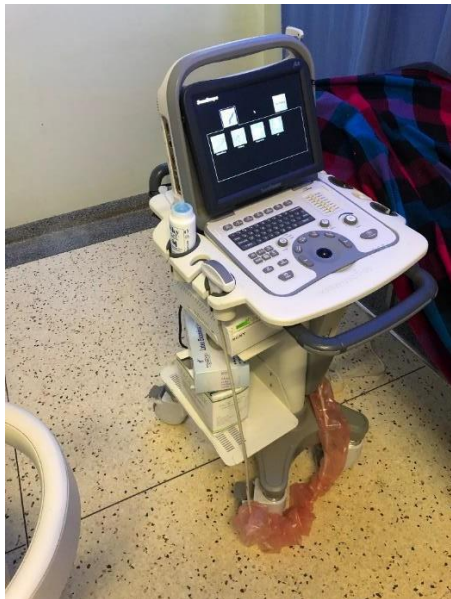
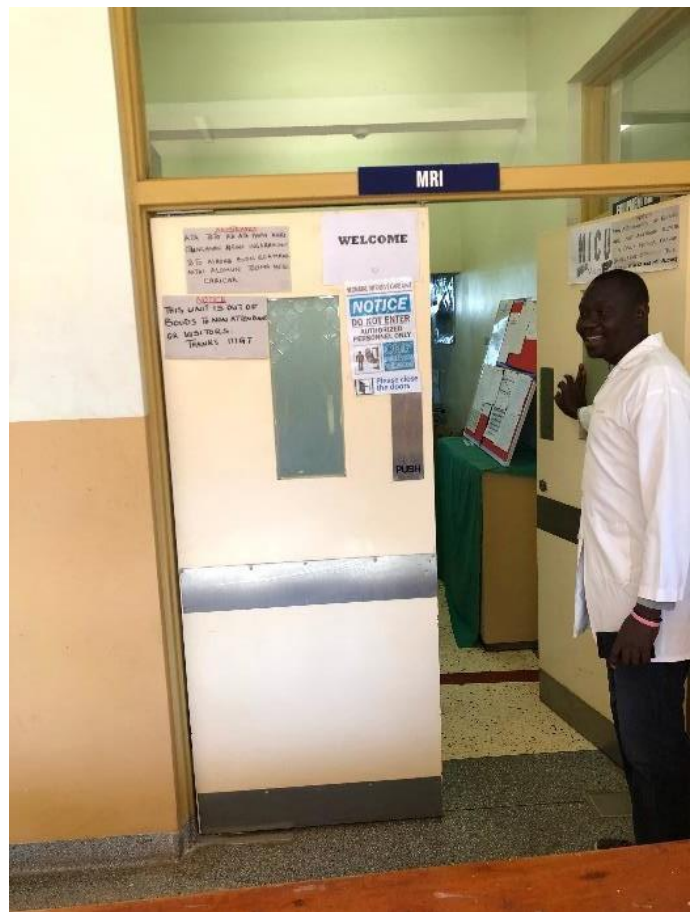
## Radiology:

The Radiology Department is located in the new A&E Wing and houses an ultrasound room, X-ray/Fluoroscopy room, a Mammography room, a CT scanner room, and a MRI room. Only the Ultrasound and X-Ray/Fluoroscopy rooms were equipped with no equipment found in the remaining rooms. Equipment that was present was found to be in a good condition

Current infrastructure is sufficient to install Fluoroscopy, Mammography and a CT scanner. It is recommended that the existing MRI room be utilized to install a Fluoroscopy unit. The X-ray unit was found to be in good working condition is used to service approximately 15 patients per day. The ultrasound is a very basic model, only providing black and white images, and is used to conduct approximately 20 scans per day.

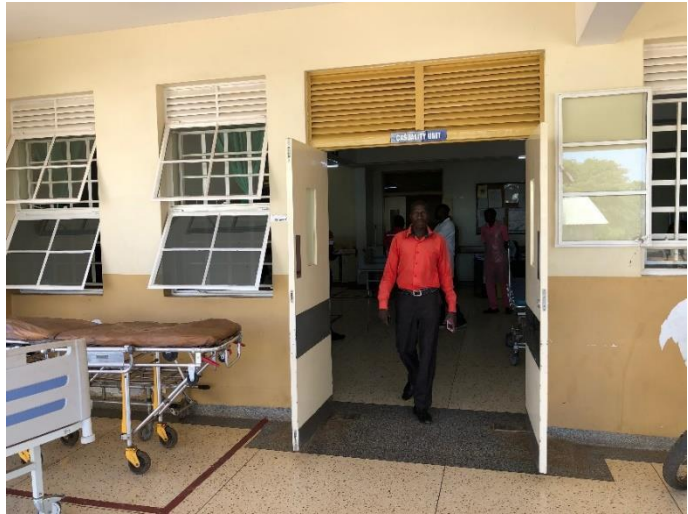
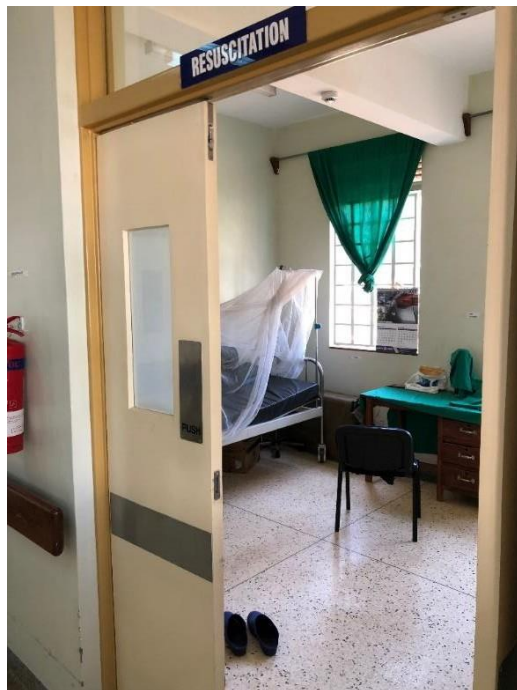
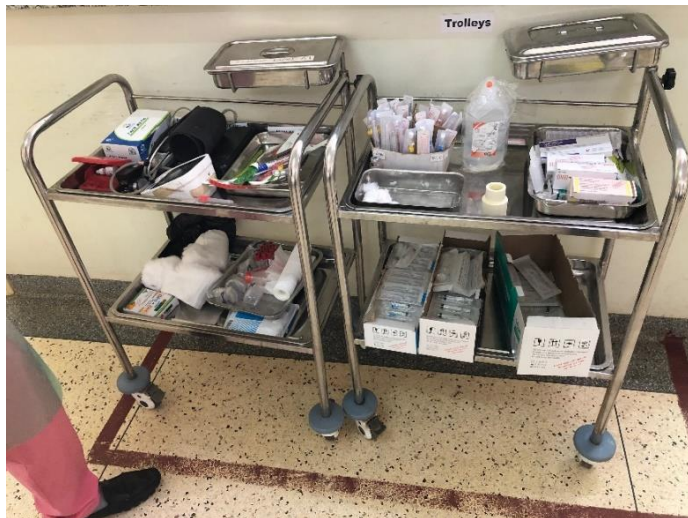
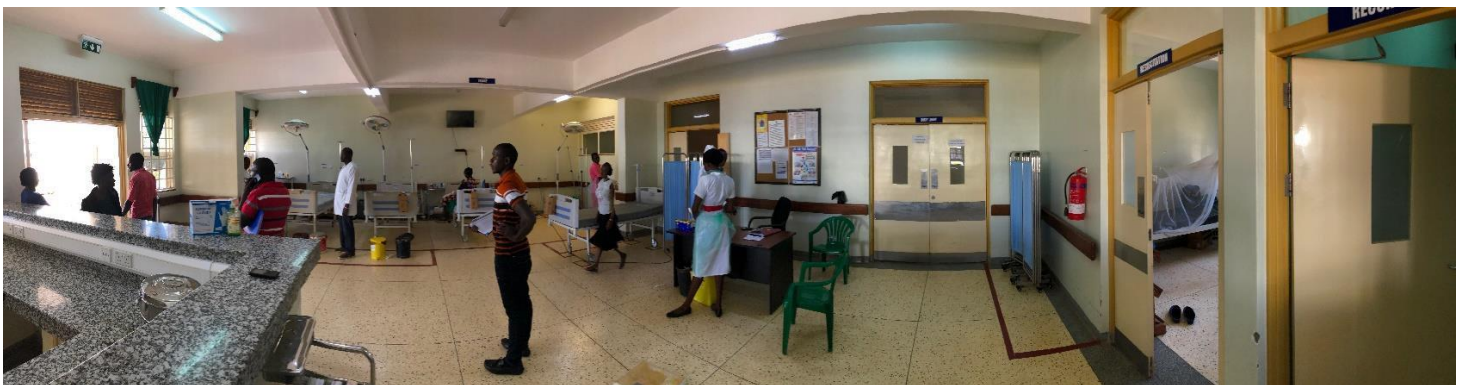
## Accident & Emergency:

The A&E Department is a 5 bed unit and is part of a new wing that was built in 2015. The equipment that is available within this department is in a good condition, however the unit lacks some critical equipment.

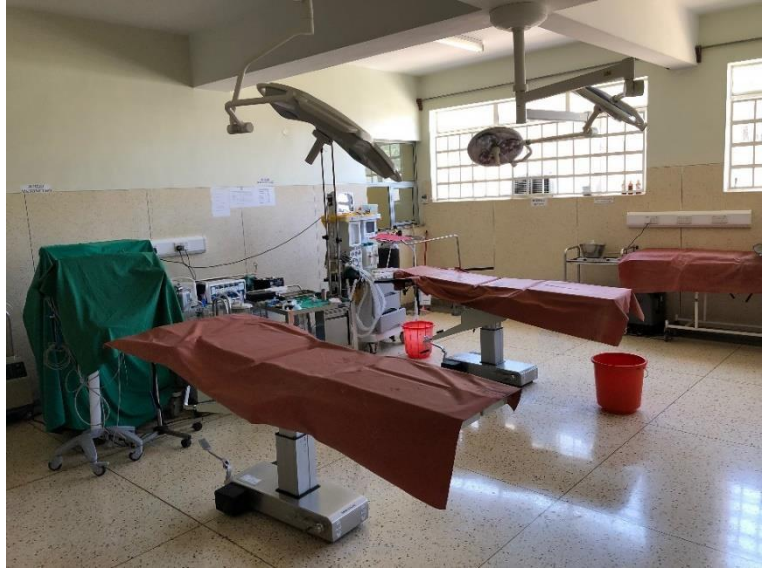
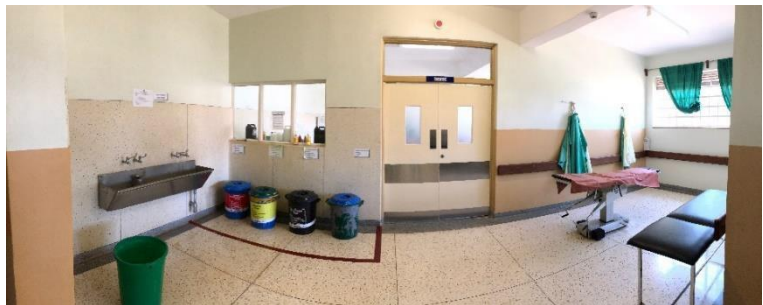
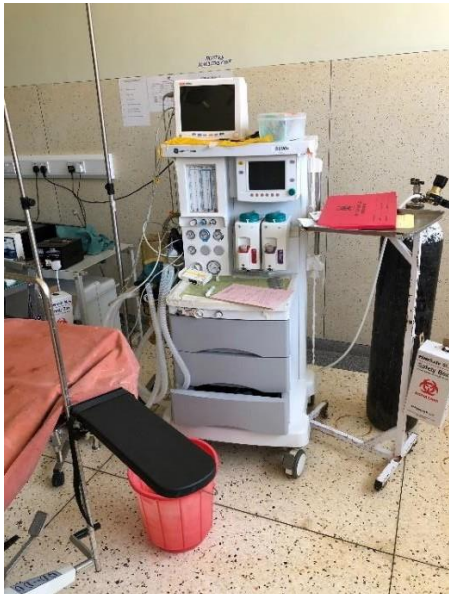
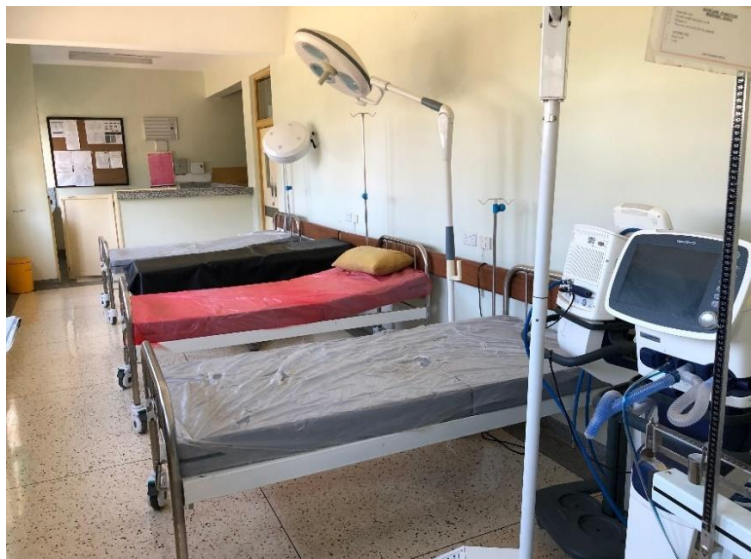
## Main Operating Theatre:

There is no Theatre Complex at Moroto Hospital and the theatre located within A&E Department is currently being used to perform all surgical procedures. Due to the lack of functional operating theatres, multiple procedures are being undertaken simultaneously. An average of 100 procedures are being undertaken in this theatre per month.

All the equipment within the theatre was found to be in a good condition and functional.

The designated Recovery Area was found to be in a good condition but is, however, missing critical equipment in order to provide the required level of care.

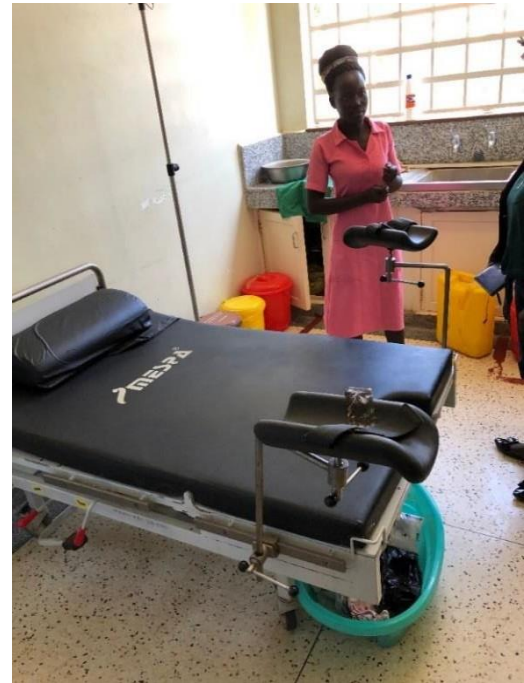
## Maternity:

The delivery unit is currently in a temporary room in the new OPD wing. A new maternity building is under construction and is scheduled for completion by the end of 2020. All the equipment in this unit was found to be in a good functional condition. The Maternity Unit delivers on average 70 - 80 babies per month.

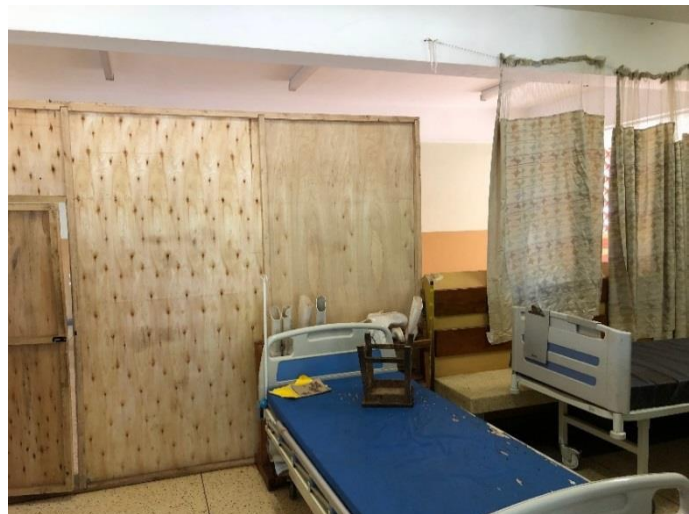
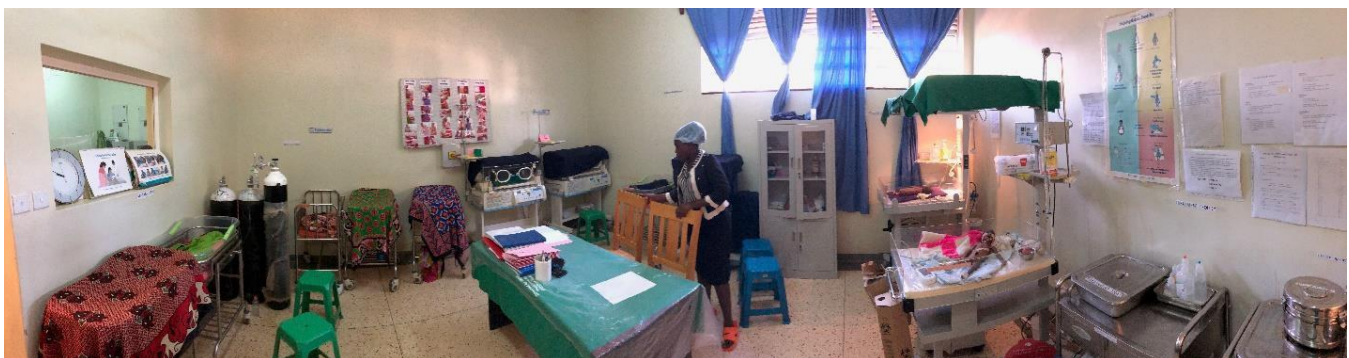
The NICU, NHCU and nursery are all located in a temporary room in the new OPD Department. A new NICU is currently under construction and scheduled for completion by the end of 2020 as part of the new Maternity Wing. The majority of the equipment is in working condition and functional, however critical life support equipment (such as patient monitors and ventilators) is not available.

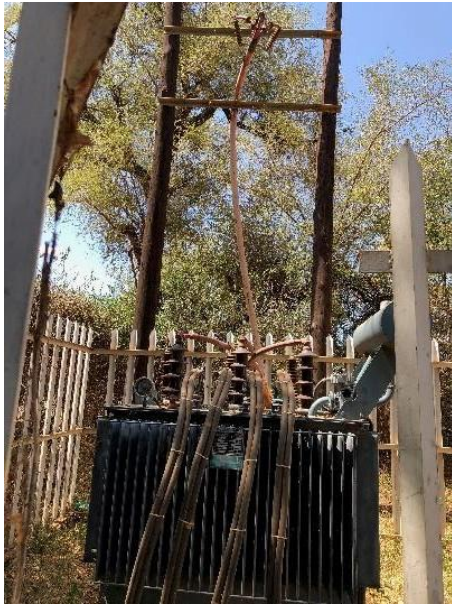
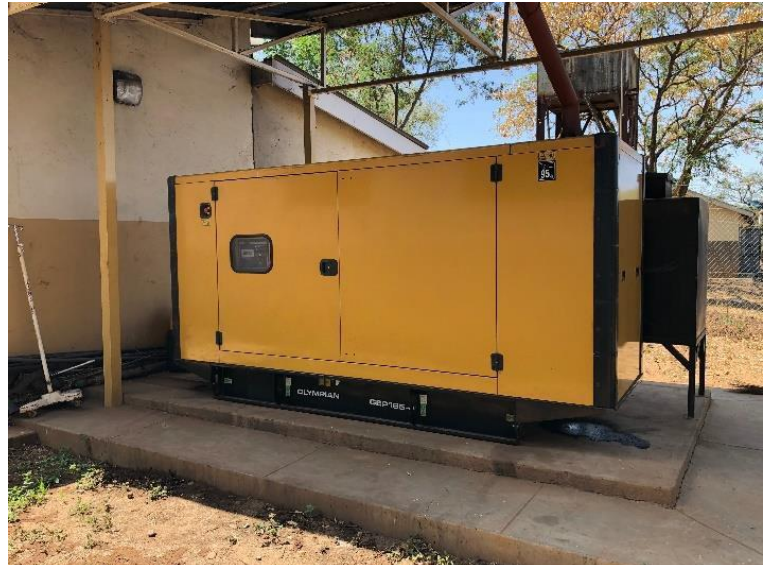
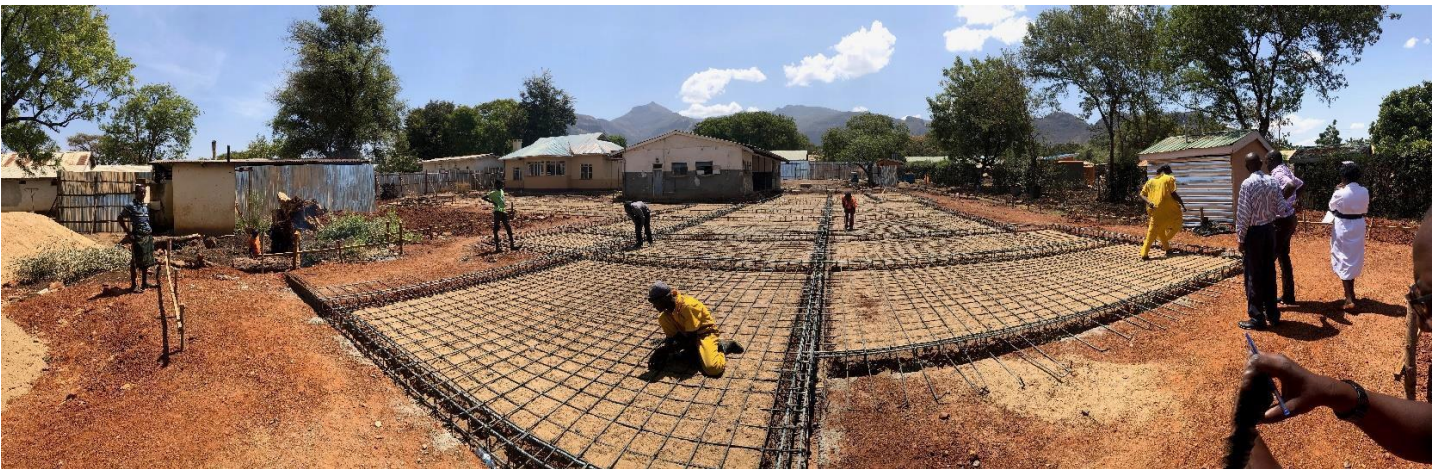
Power to the hospital is provided via a 630kVA overhead transformer, which is adequate for a hospital of this size and should be able to accommodate the additional load by the new construction project. In addition to this a 150kVA generator provides backup power to the hospital, however this generator will not be able to provide sufficient backup power to the new Building when completed.

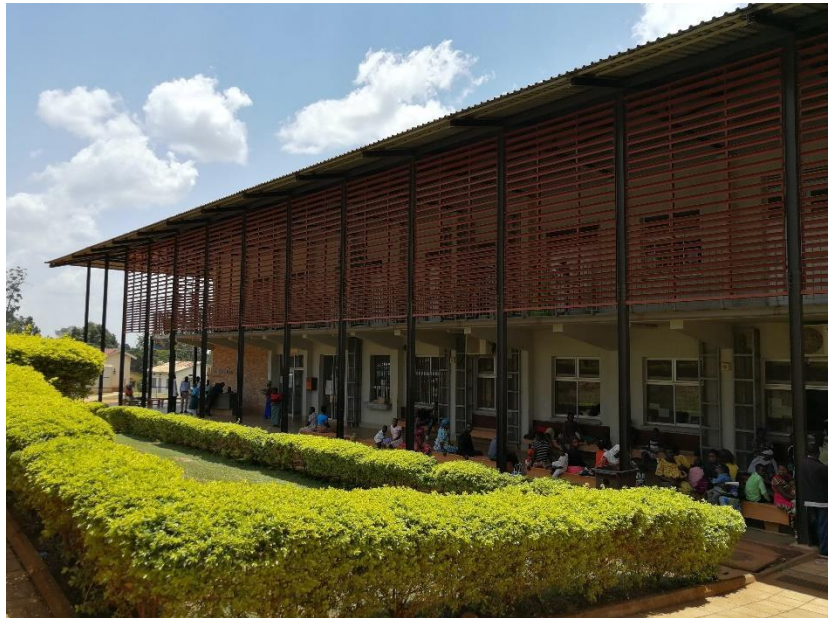
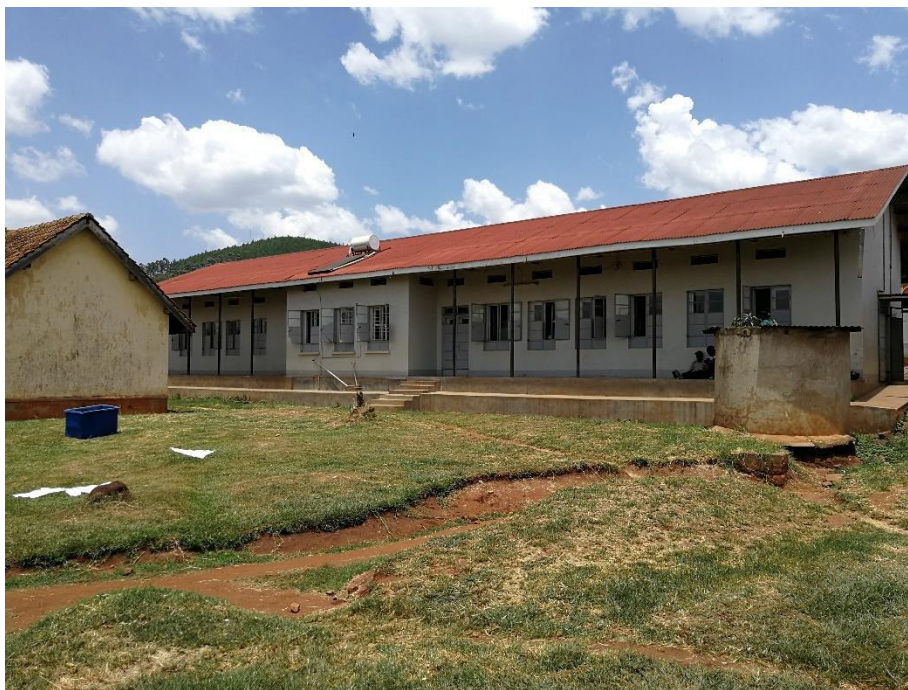
Mubende RRH has been partly rebuilt by a JICA funded project with the new buildings being in good condition while the remaining original buildings are in an extremely dilapidated state.

The hospital has an extremely busy A&E department, maternity and neonatal ICU. Unfortunately the antenatal consulting rooms and waiting area were not included in the recent upgrade by JICA and are totally unsuitable for the high volume of pregnant woman attending the hospital.

This is one of few RRH that does not have any maintenance workshop and associated tools and spares available resulting in even simple maintenance tasks going unattended for months at a time.

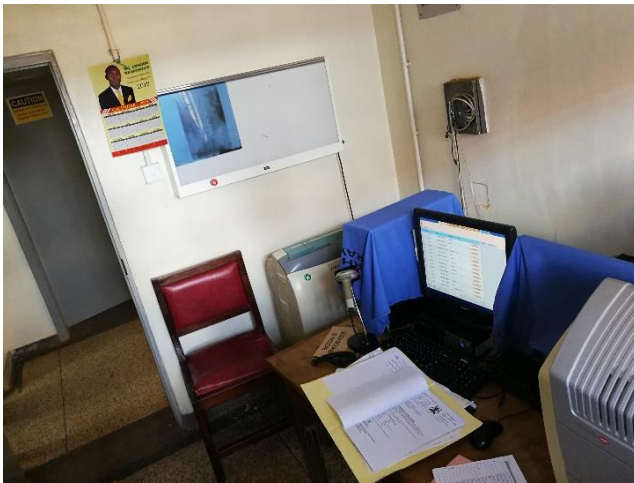
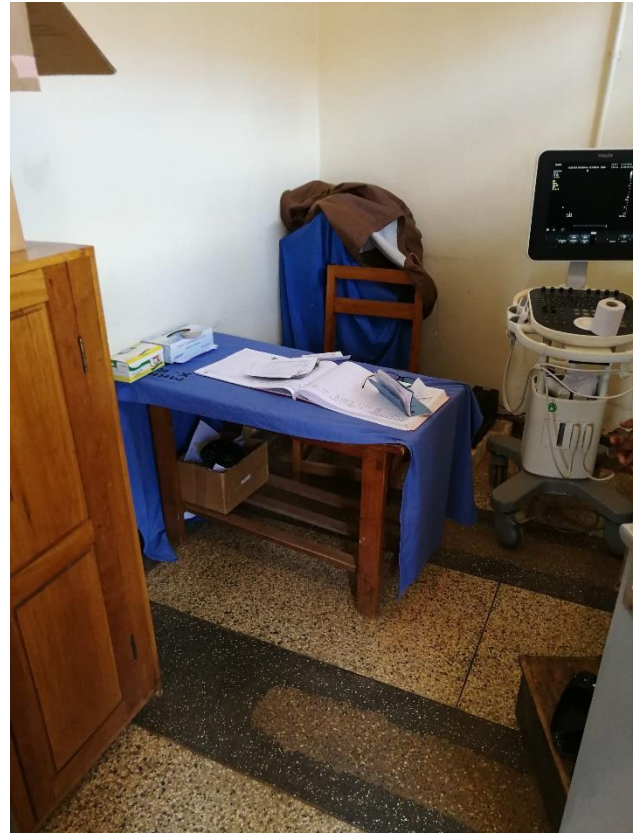
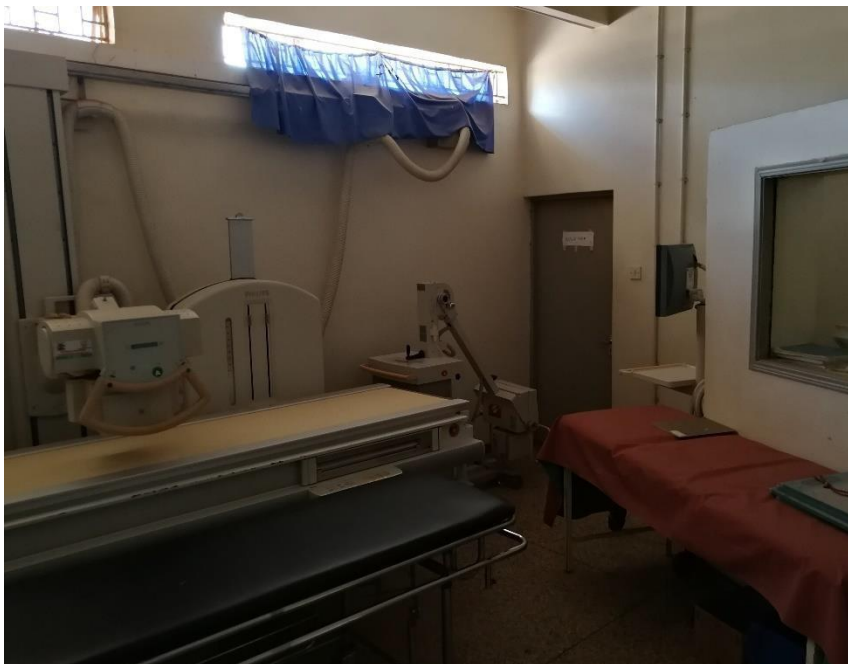
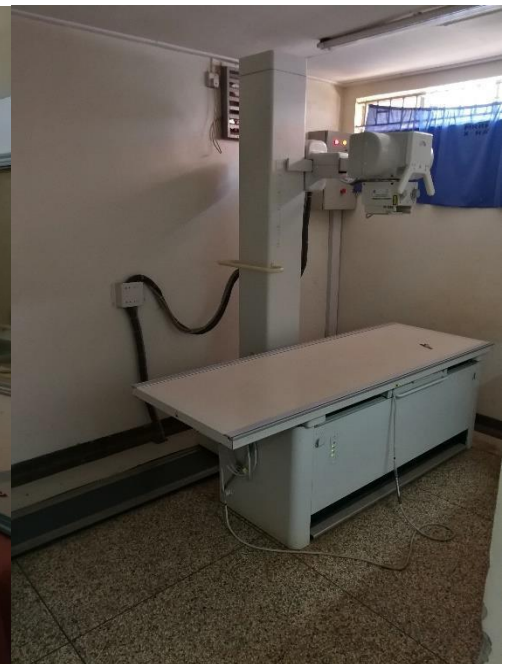
The radiology department is housed in one of the old buildings and has not been refurbished recently. There is only 1 working ultrasound machine but this requires additional/new probes. A fluoroscopy machine is partially functional and at end of life, there is a newer digital general diagnostic machine, which is functioning well, but the department has challenges obtaining films to print.

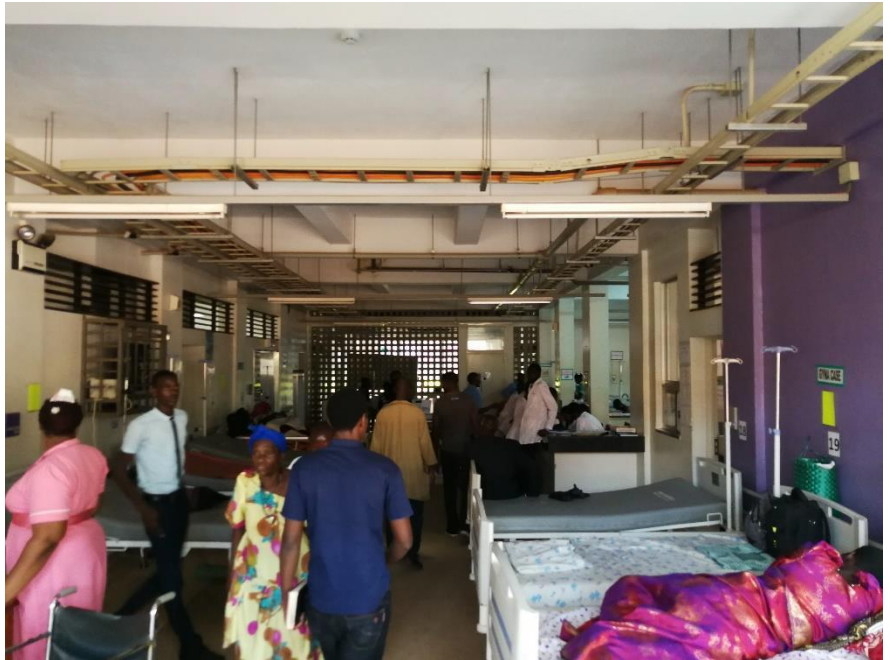
The casualty department is housed inside the new JICE building, however it is being used for at least double the number of patients for which it was designed. Extra beds have been squeezed into every available space and most were occupied at the time of the inspection. A make shift ICU/HDU unit has been setup in the corner of the unit, however there are no monitors or ventilators etc and the beds are pushed right against each other making it impossible for the nursing staff to effectively see to the patients. The unit appears to be being used more as a general outpatient type facility with some genuinely sick patients mixed in between.

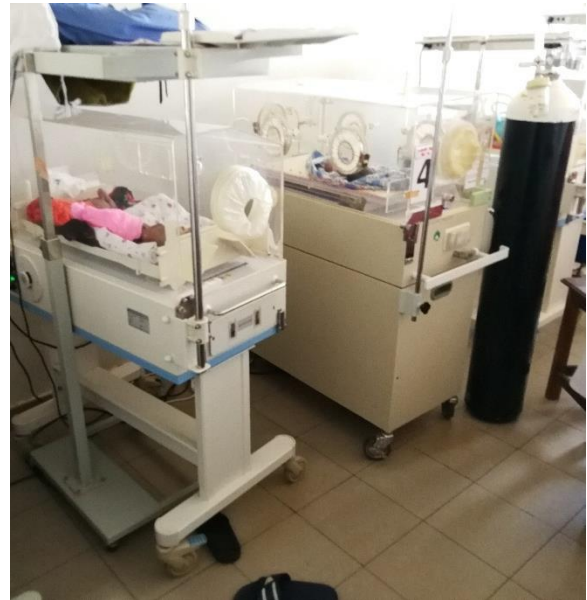
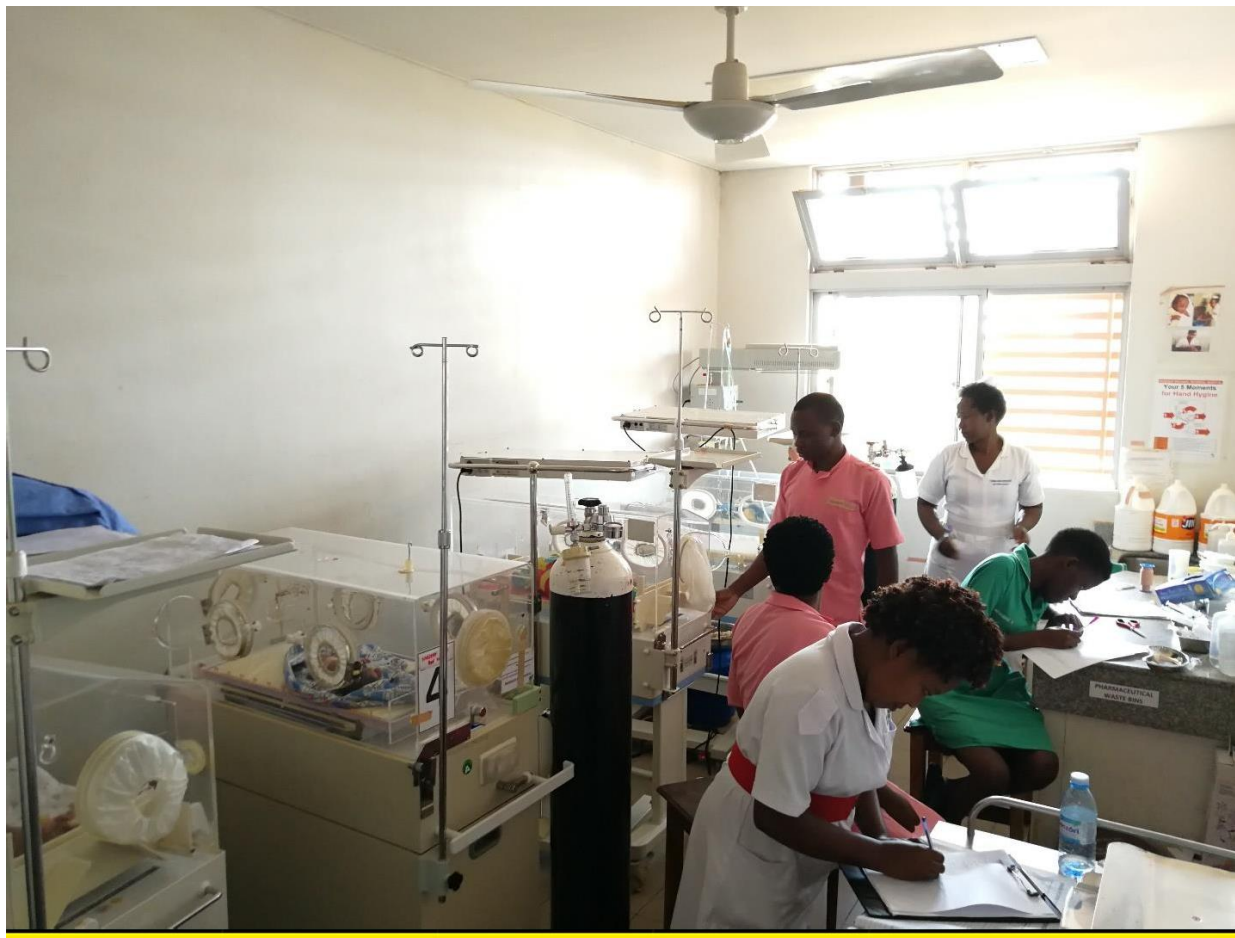
Although very crowded, the NICU unit is well staffed and fully occupied with infants.

The nurses in this unit are doing extremely well considering the lack of space and critical equipment, most notably a piped oxygen system would be of significant benefit to reduce the space needed for large oxygen cylinders in such a small already crowded unit.

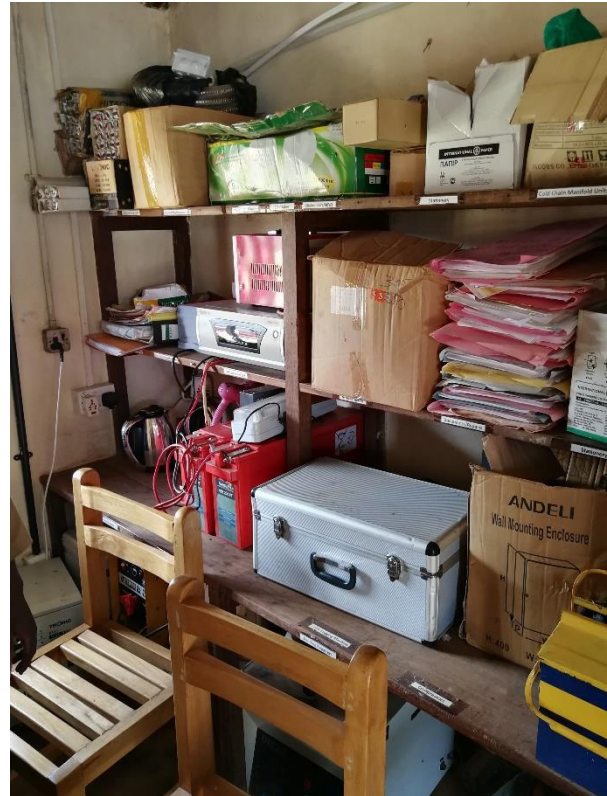
This hospital does not have a dedicated maintenance workshop and the local engineers only have a very small room which is mainly occupied by paperwork and the very few tools they have.

The hospital has no spares or materials on site for even simple repairs to electrical wiring for example.

Priority should be given to improving the facilities for this department as even new areas of the hospital are falling into disrepair due to lack of maintenance.

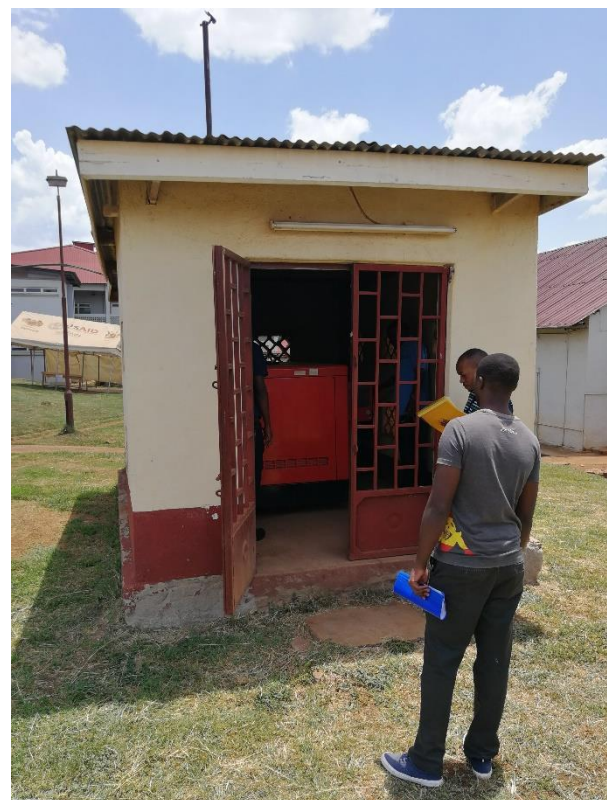
The hospital is only served by 1 small 150kVA transformer and a 50kVa generator. There is a new 200kVA transformer and associated distribution board, but this is dedicated for the new JICA building and is already at capacity.

Additional main power capacity will be required to cater for additional equipment under this project.

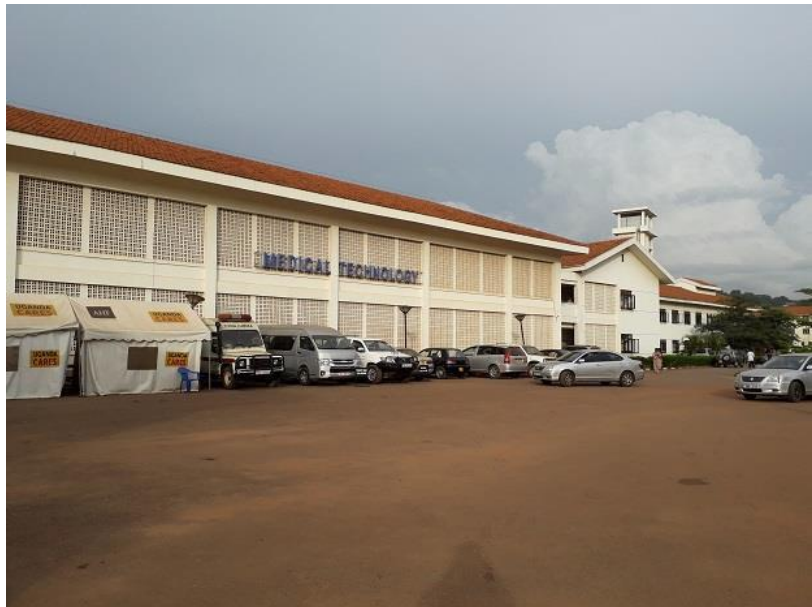
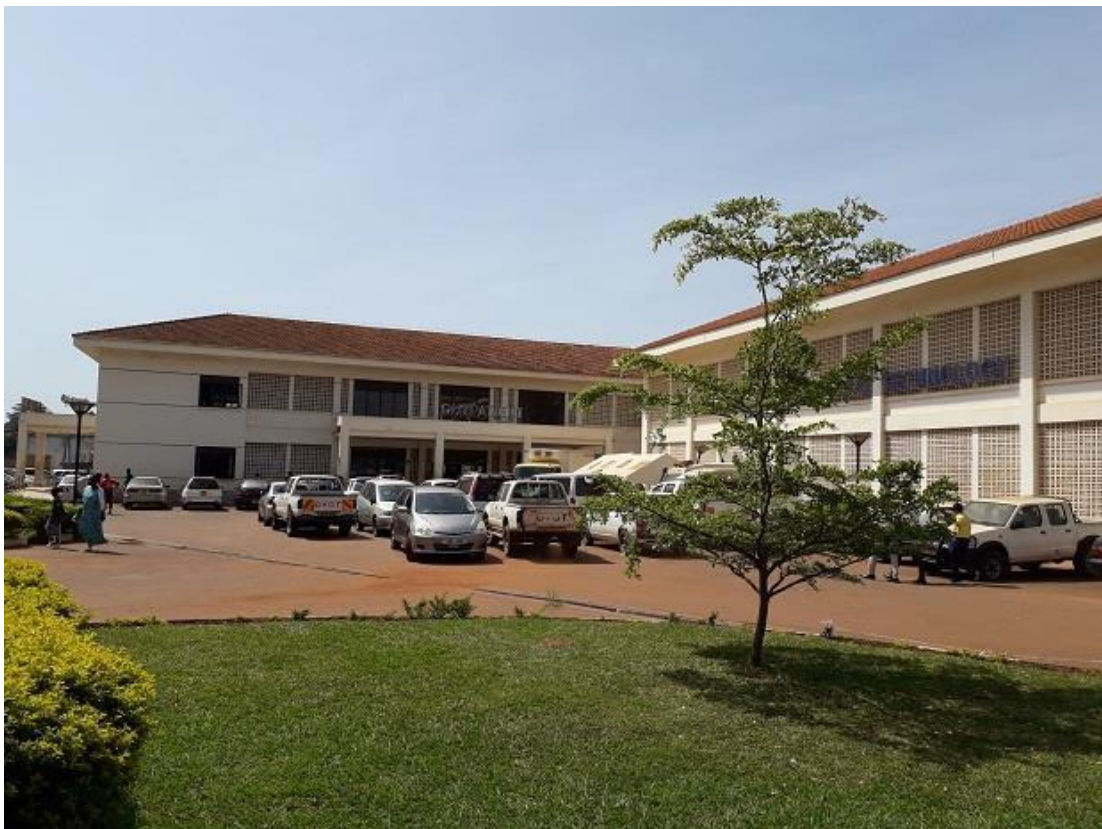
The Hospital is a new facility, with construction being completed in 2012. Due to its centralized location, Naguru General Hospital benefits from new infrastructure to support the facility and the building was found to be in a fair state of repair, however there is a critical shortage of operational medical equipment and staff to run the facility effectively and efficiently.

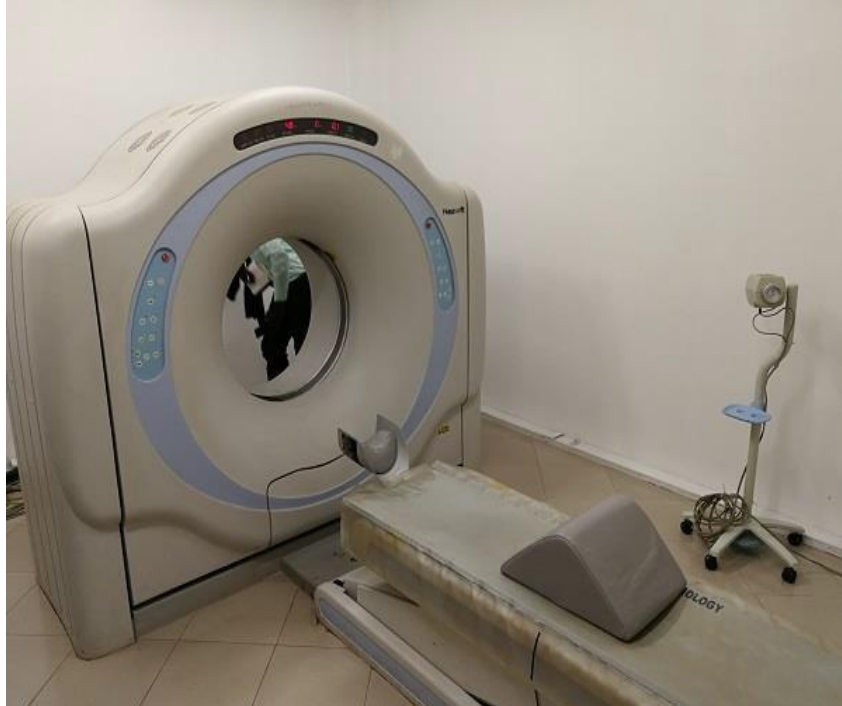
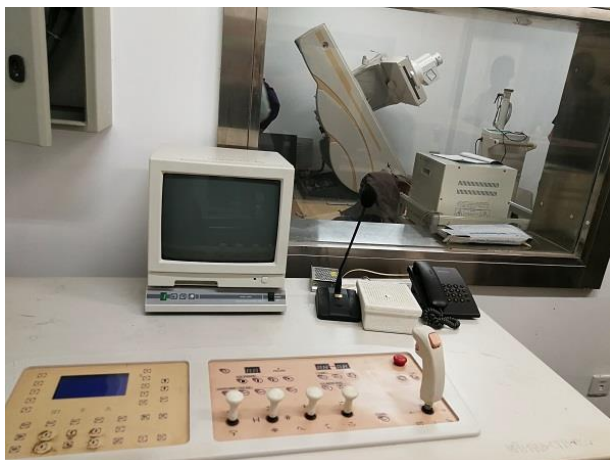
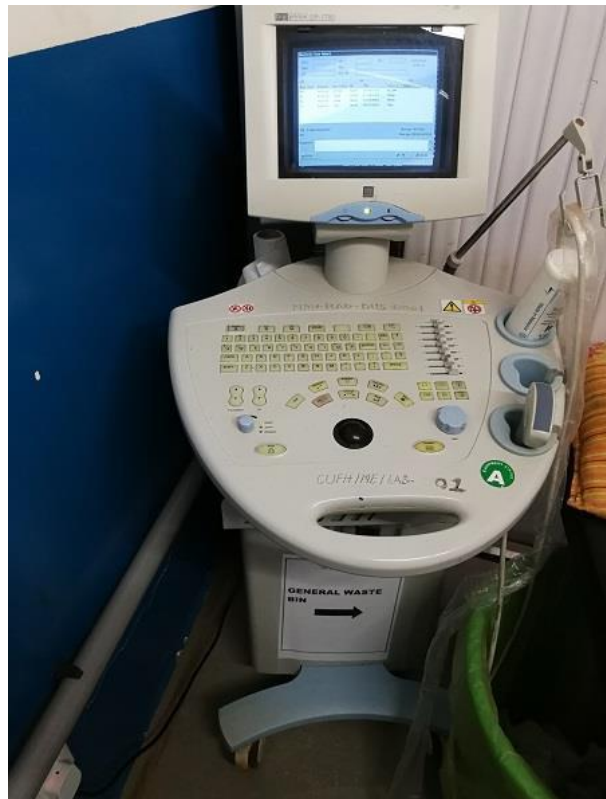
The Radiology department, located on the ground floor in close proximity to the A&E department and almost directly below the theatre Complex, was found to be in a good condition and housed a CT scanner and X-Ray machine. Both imaging devices are functional.

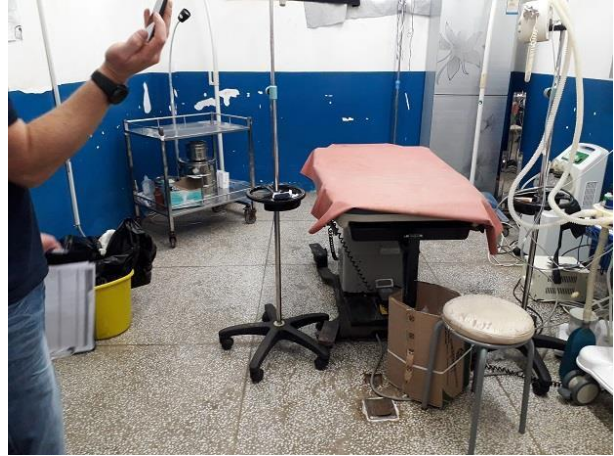
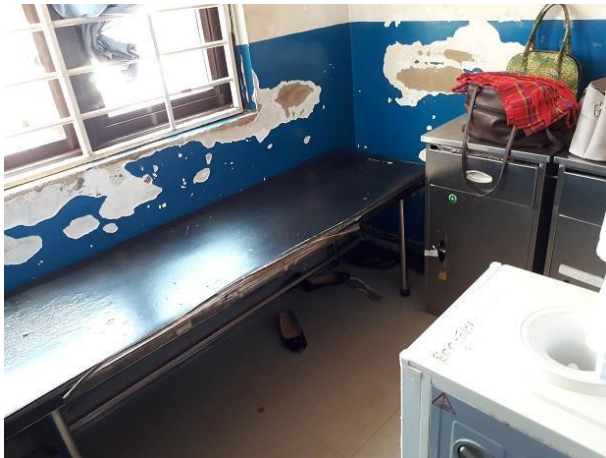
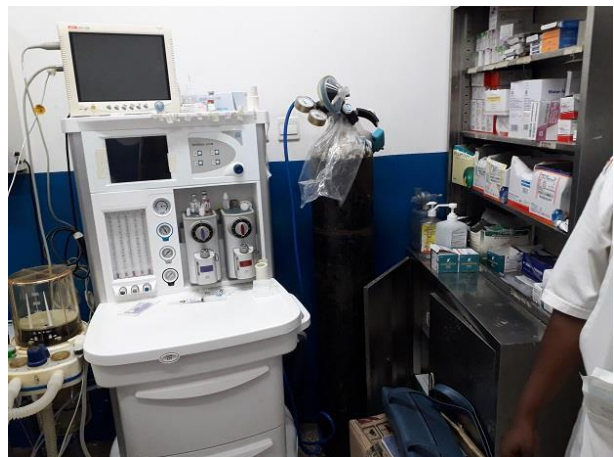
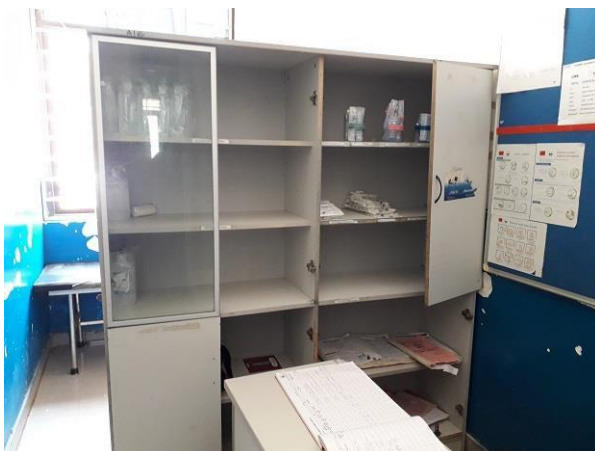
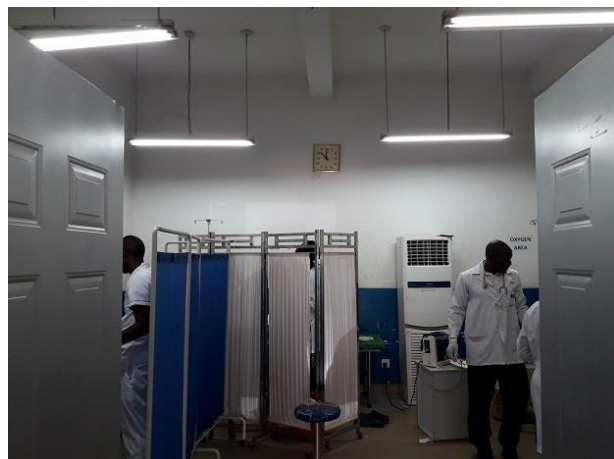
The A&E department was designed to have a waiting area/reception, resuscitation room, recovery area, procedure room, orthopaedic room, recovery room and a consultation room, however the spaces are not being utilized as was originally designed, with the resuscitation room being used to provide triage/treatment services.

Equipment within the A&E Department was found to be at the end-of-life and in need of replacement
