## 1. Executive Summary

The March 2019 survey of all 14 regional referral hospitals in Uganda conducted by representatives from MOH Uganda confirmed a clear need for intervention into the 6 core departments identified in the 2017 AMPC feasibility study report.

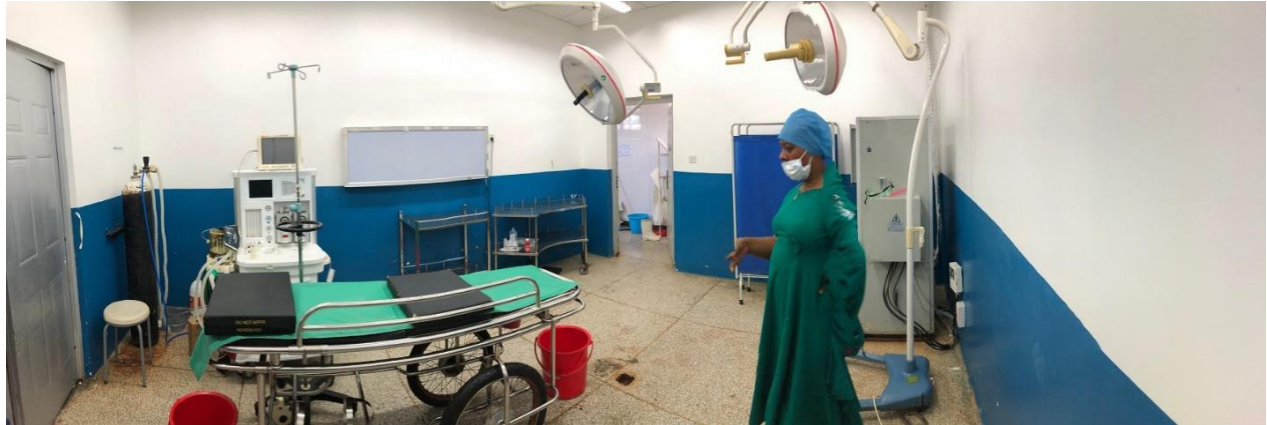
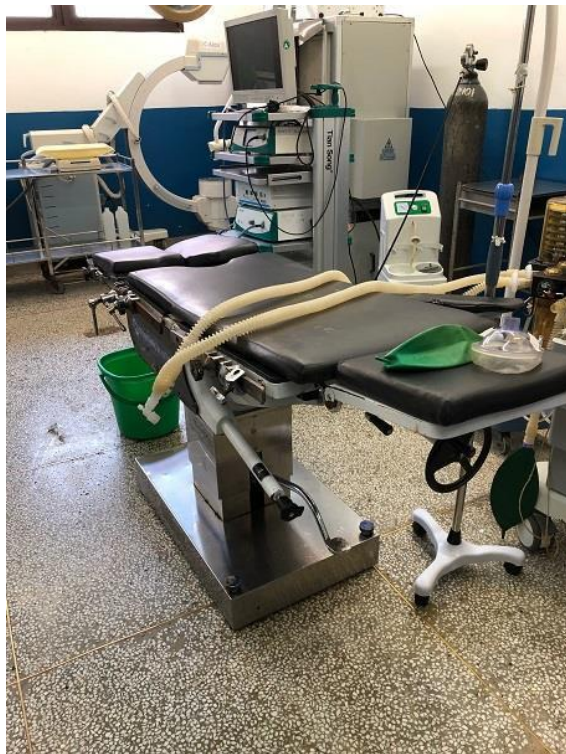
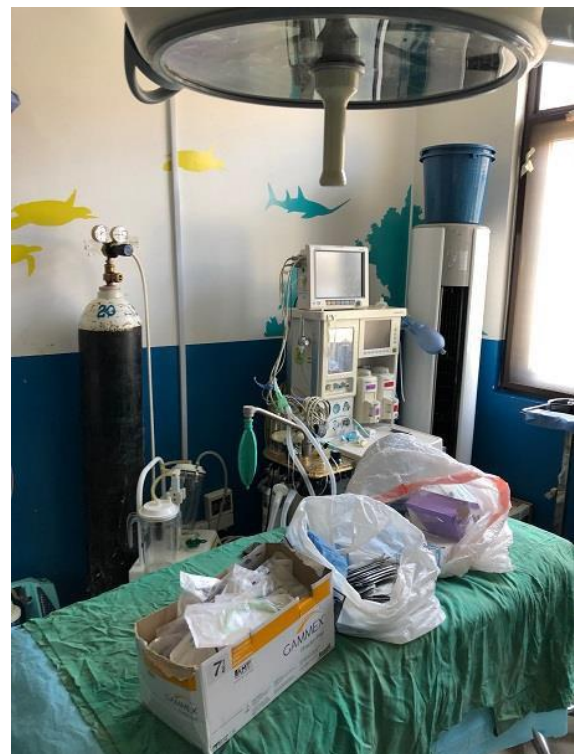
Three theatres are located centrally on the first floor of the hospital. Theatre 1 is currently operational and equipment, provided by China, was found to be at end-of-life condition and in need of replacement. A Second theatre is currently not in use due to a lack of equipment and the Third is used for ARCHI Foundation procedures only. The Recovery area within the Theatre complex was found to be underequipped and there is no Pre-Operation space available.

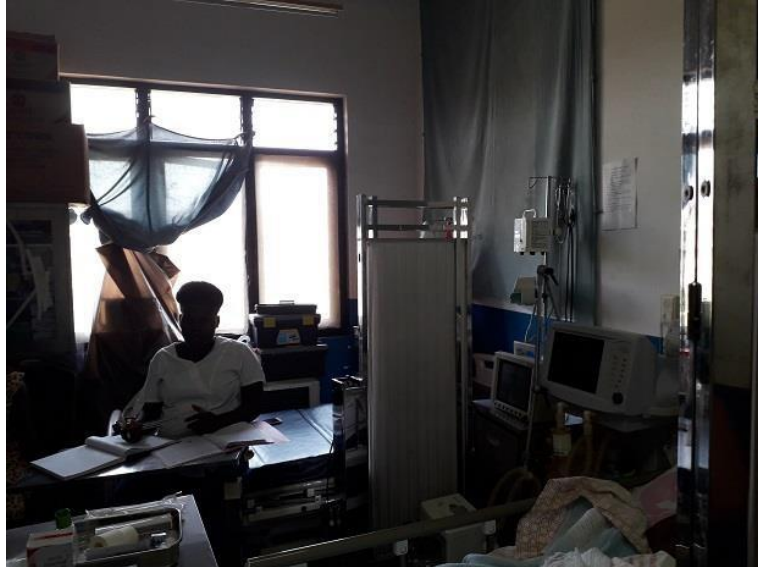
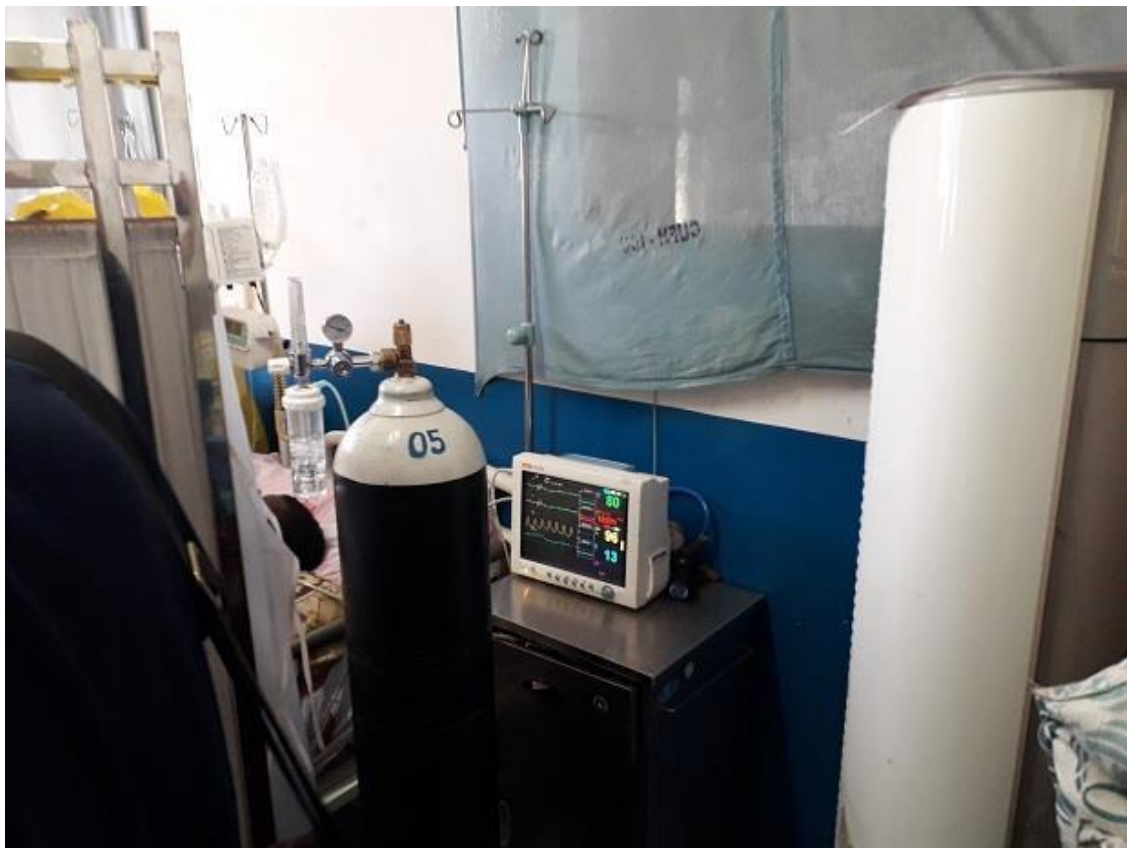
A small room dedicated to Intensive Care is located adjacent to the Maternity Ward and in close proximity to the Theatre Complex. The ICU currently accommodates 2 beds.

The room is cluttered with end-of-life equipment and grossly undersized with insufficient space to move around the patient beds in cases emergencies.

The ward can be expanded into an adjacent room containing 4 beds, or into an adjacent waiting area, however the ICU would need to be decanted to an alternative location and beds/space sacrificed in order to achieve this.

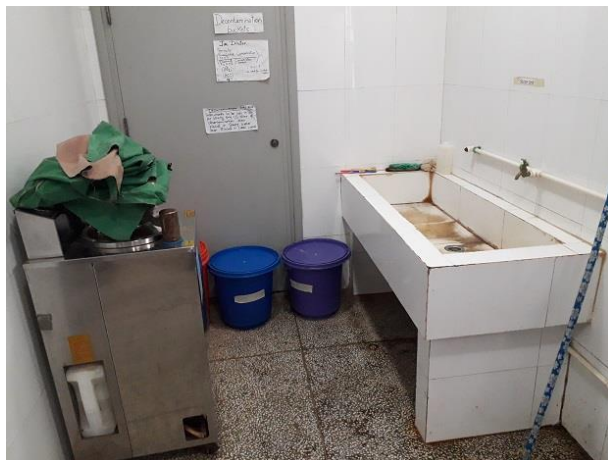
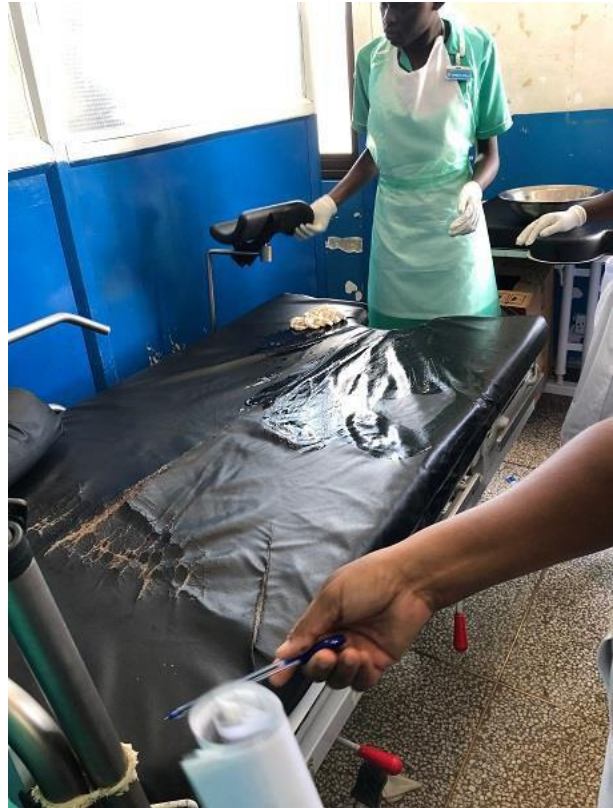
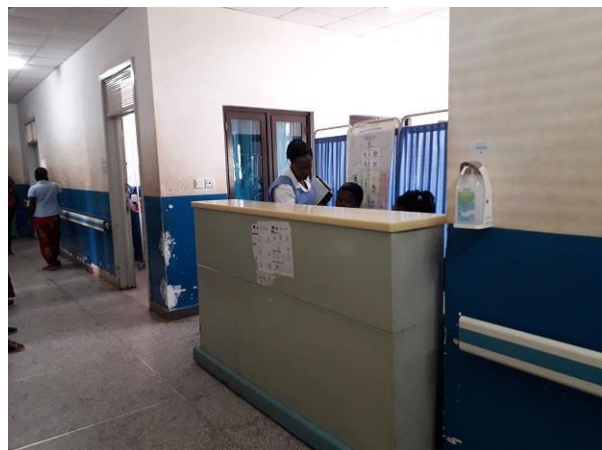
The Maternity Ward is located on the first floor, adjacent to the ICU. The Maternity is extremely busy with 100% occupancy and numerous patients being assisted on the floors in the passages.

The condition of the ward was found to be in a poor condition, most likely due to the high occupancy rate of this ward. Equipment being utilised to facilitate birthing is at end-of-life and is in need of replacement.

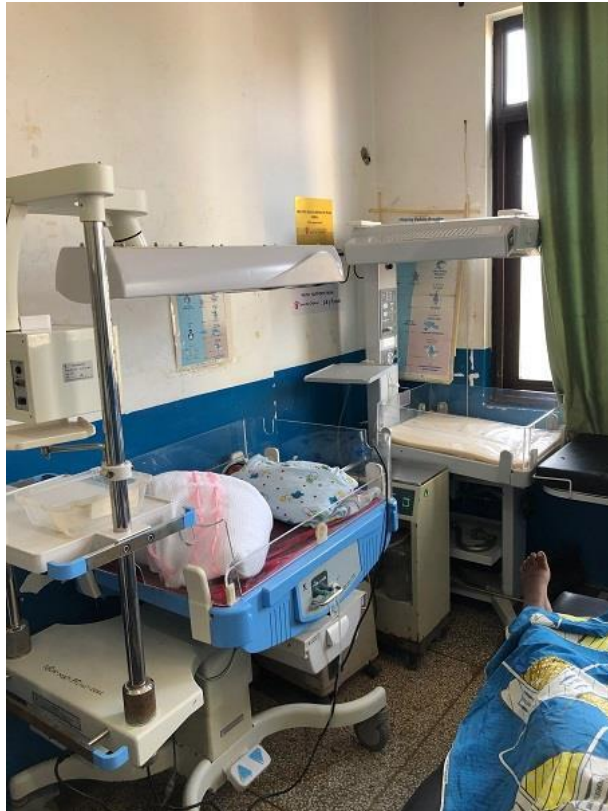
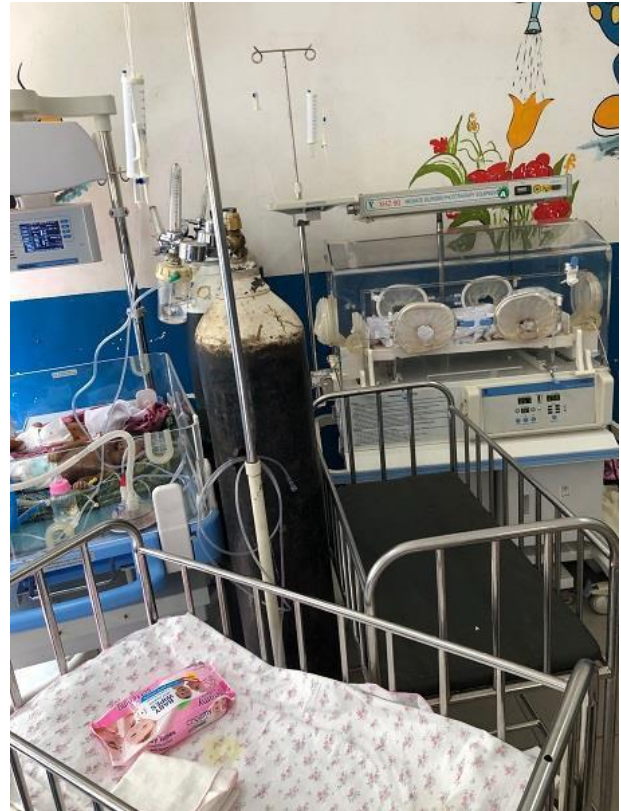
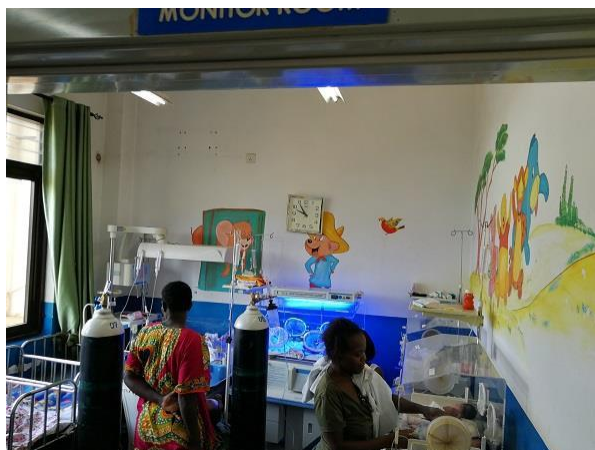
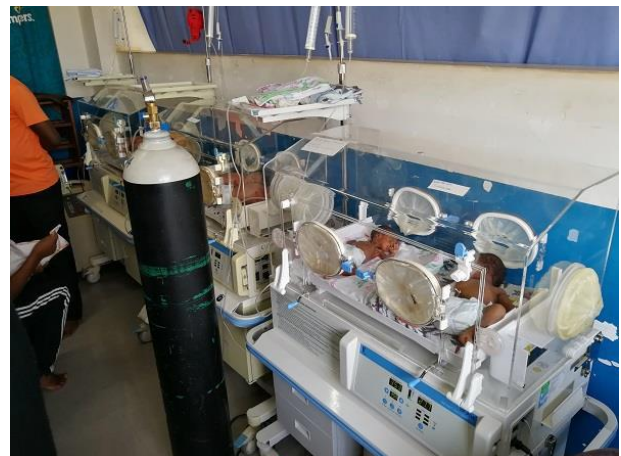
## NICU:

As was observed in the Maternity Ward, the NICU also has a very high occupancy rate with the space being over utilized with end-of-life equipment that is in need of replacement.

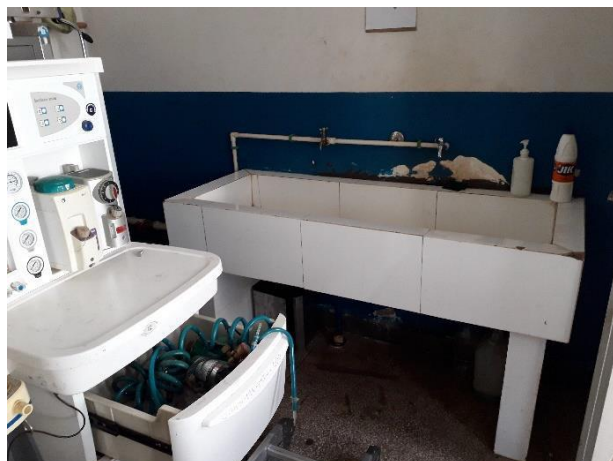
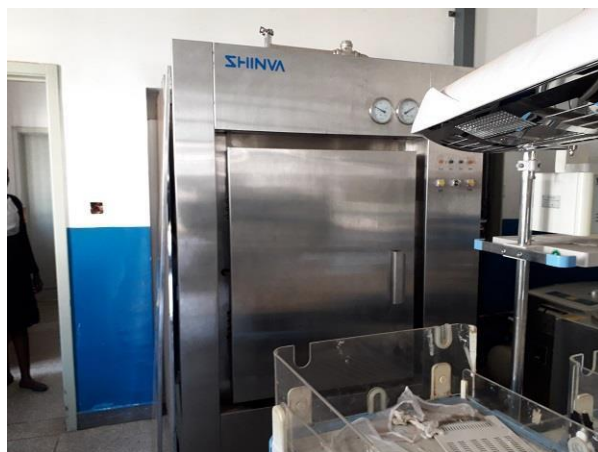
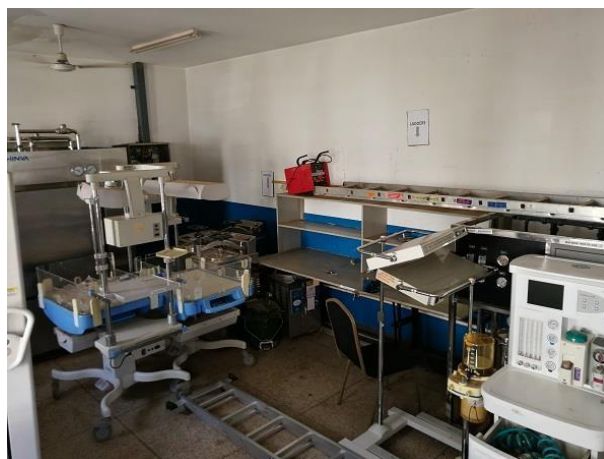
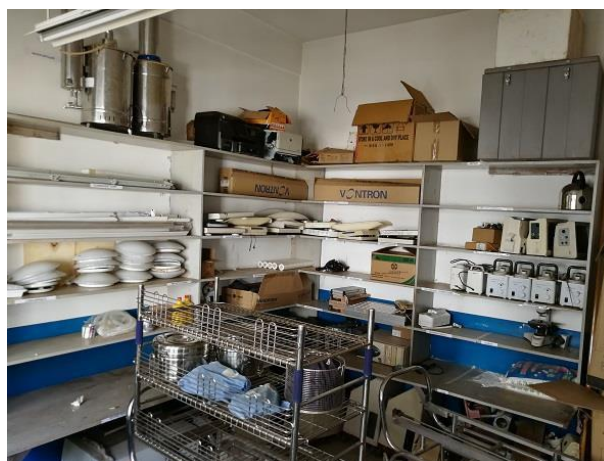
## Maintenance Workshops:

At present there is no dedicated workshop at the Naguru Hospital and this service is currently being rendered from within the existing (unused) CSSD department, located adjacent to the Radiology Department. The workshop was found to be underequipped and in an inadequate space to conduct general maintenance services to the hospital services and equipment.

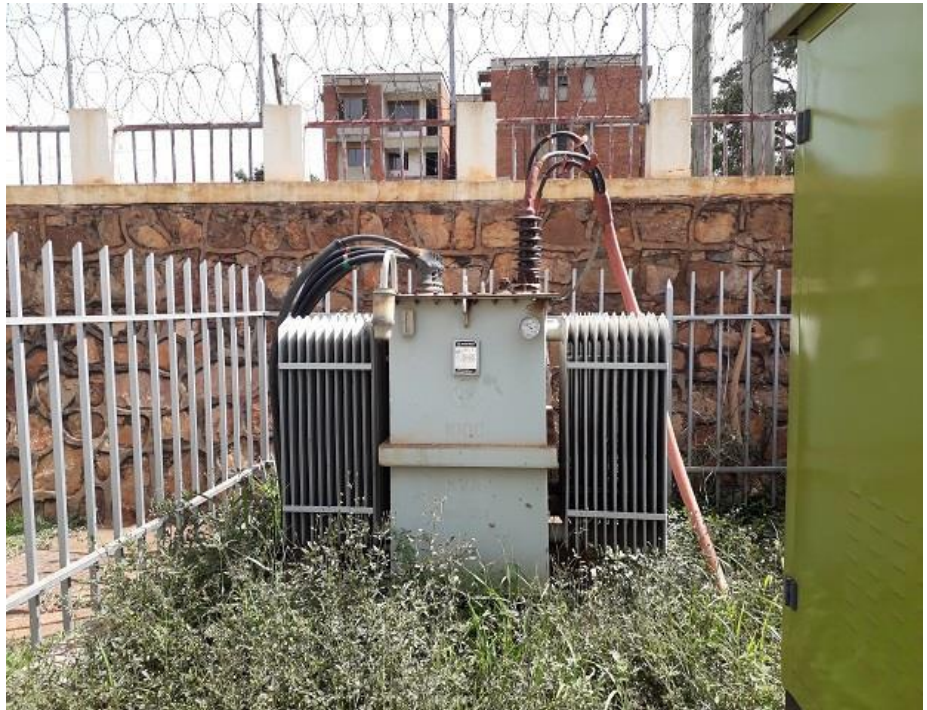
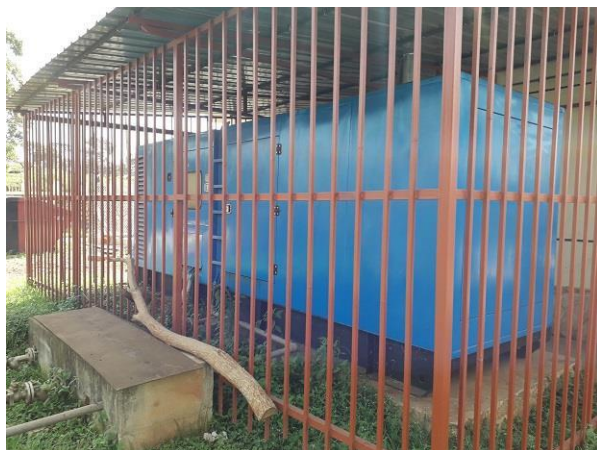
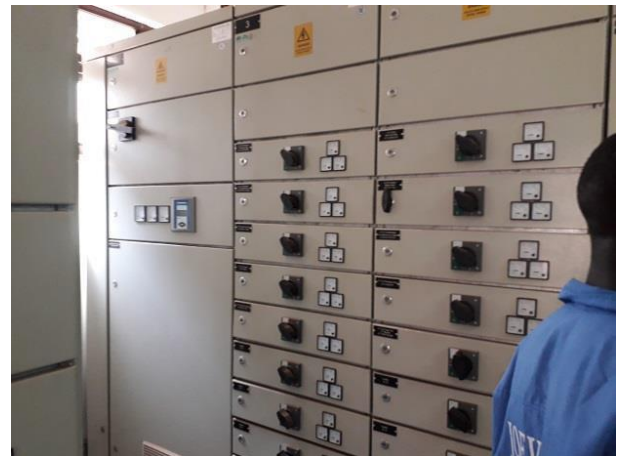
## Infrastructure:

As Naguru is still a new facility the internal infrastructure was found to be in a good and compliant condition. A 350kVA generator is installed on the West end of the hospital grounds and was found to be in a good condition. It is, however, recommended that additional backup generator capacity be installed to accommodate any new equipment that will be provided to the hospital.

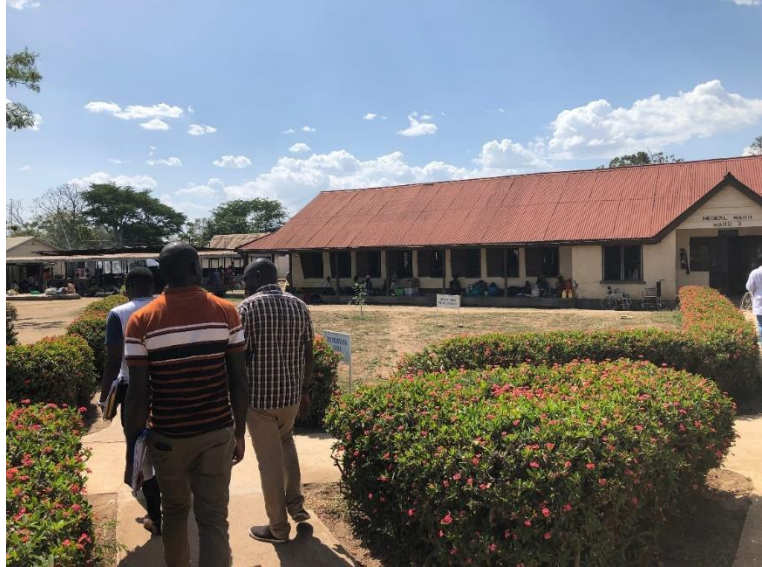
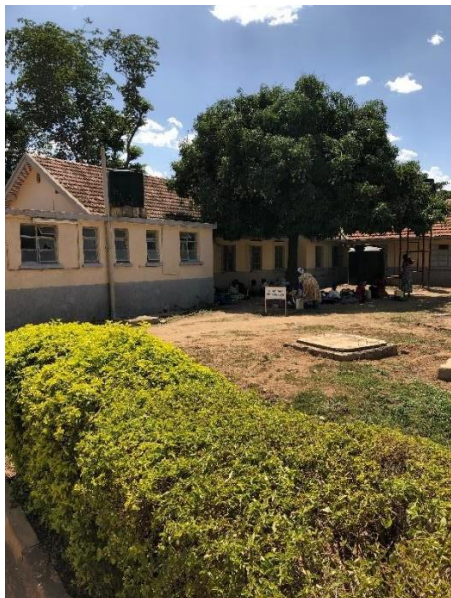
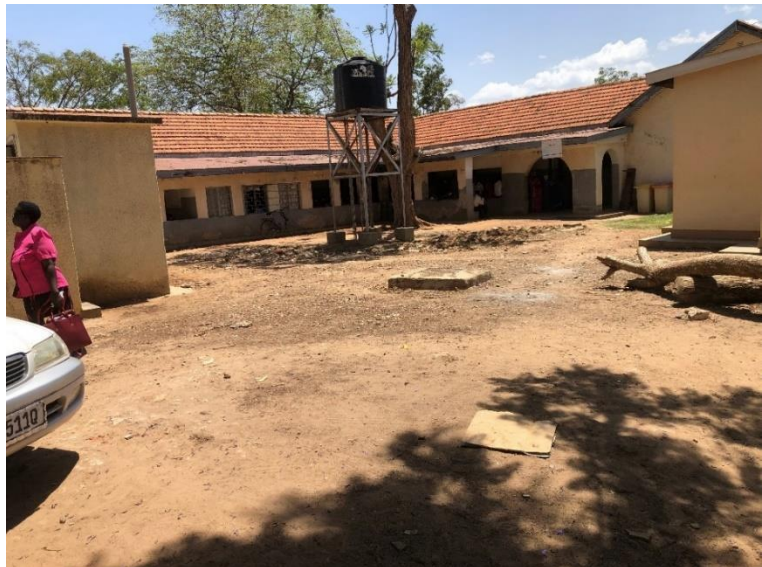
Due to the age of the hospital, and the lack of regular preventative maintenance, the buildings were found to be dilapidated and in urgent refurbishment. The hospital also requires additional beds/facilities in order to accommodate the needs of the growing surround Districts.

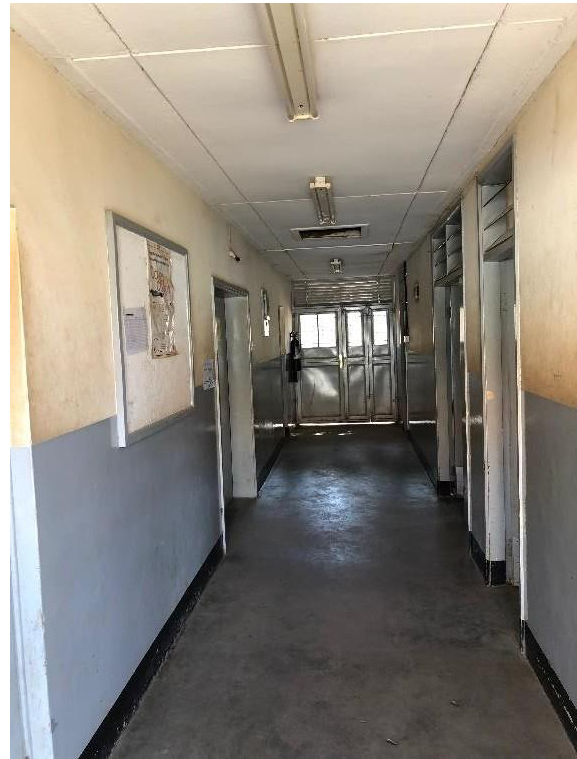
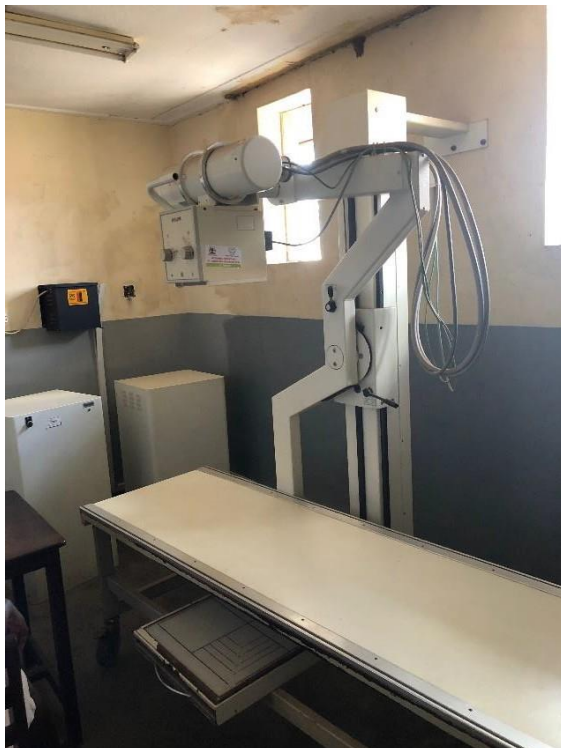
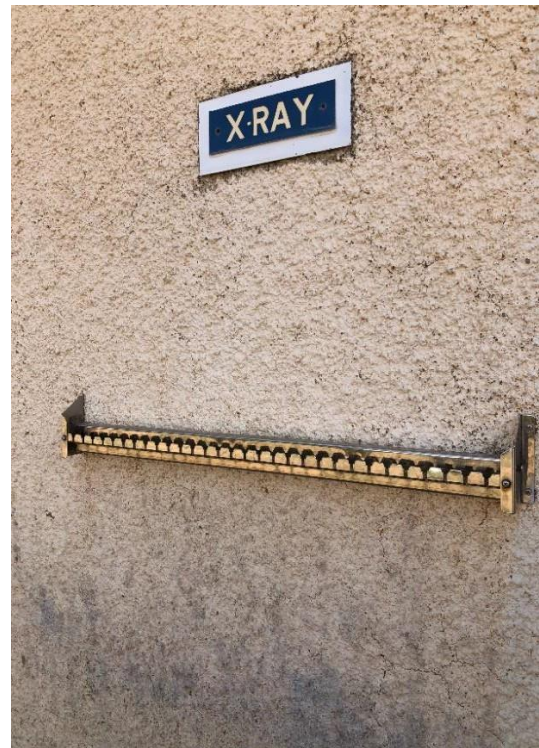
## Radiology:

The Radiology Department currently houses a Bucky X-Ray System and a mobile X-ray, however this equipment is nearing end-of-life and is in need replacement. The general X-Ray machine is an analogue unit, which is obsolete and software updates are no longer supported for this unit. Approximately 20 scans per day are conducted on this machine and film processing is done manually and hung to dry outside. An Ultrasound unit is available, but is however faulty, thus providing an intermittent service to patients. 50 to 60 Ultrasound scans are conducted daily when the unit is operational.

The Radiology Department comprises of an X-Ray room and two Ultrasound Rooms. Space within the existing building is limited and will not allow for expansion to accommodate Mammography and a CT scanner. It is therefore recommended that a new Radiology Department be built to facilitate the provision of these services.

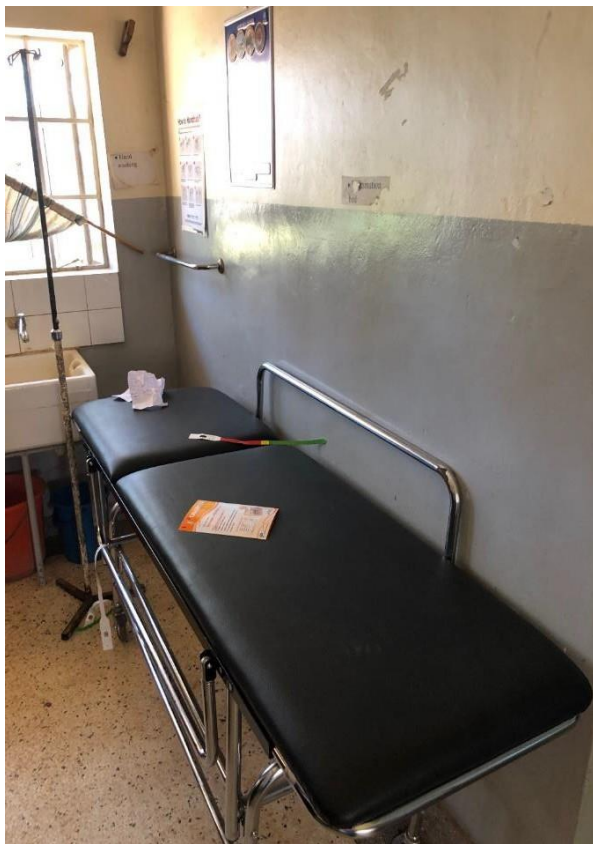
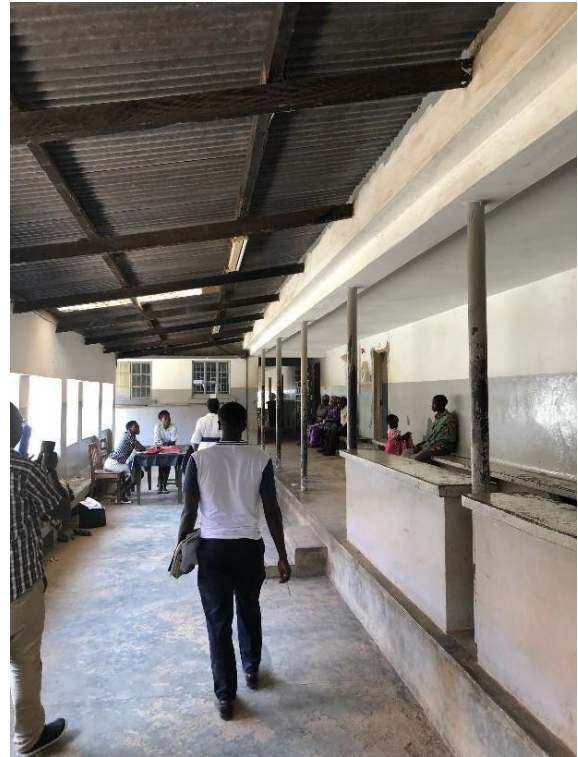
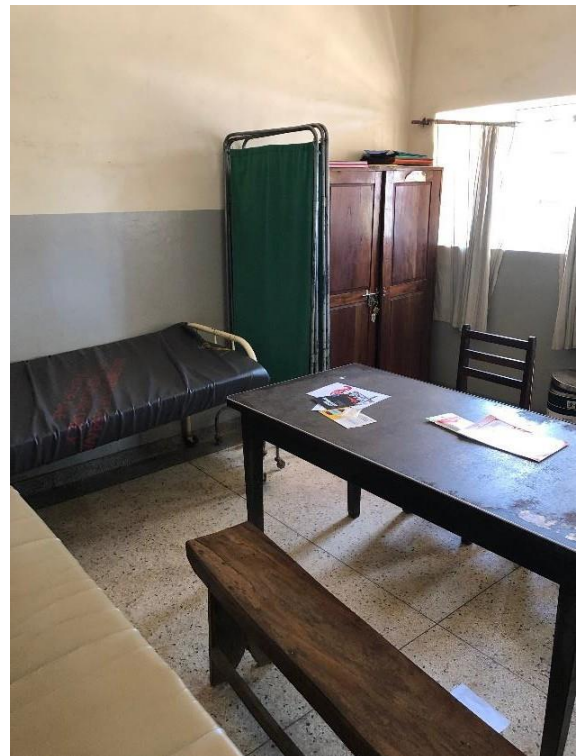
## Accident & Emergency:

The A&E Department shares space within a building that is occupied by the OPD Department. Space in this department is limited and the layout of the A&E does not facilitate efficient and effective workflow for nursing and care to patients. The equipment within the A&E was found to be very old, with the majority not functioning, and in urgent need of replacement.

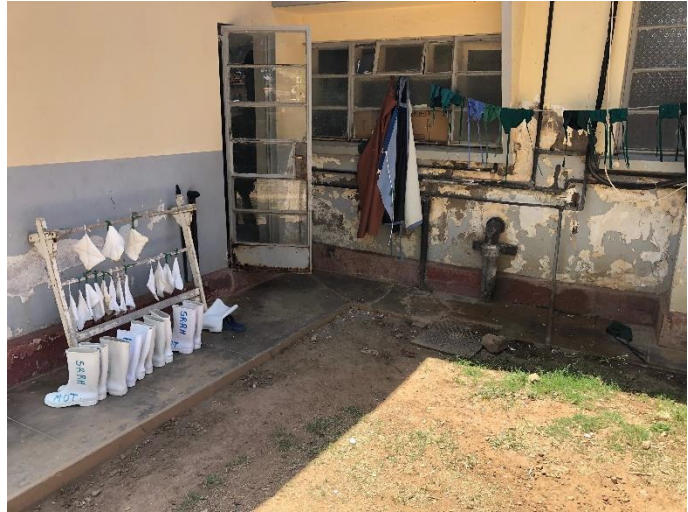
## Main Operating Theatre:

The Main Theatre complex houses two theatres, with only one being used due to a lack of equipment. This subsequently results in multiple surgical procedures being undertaken within the same theatre simultaneously. Approximately 350 - 450 surgical procedures are undertaken per month.

All the equipment is at end-of-life and in desperate need of replacement. The building was also found to be in a severely dilapidated state and in urgent need of refurbishment.

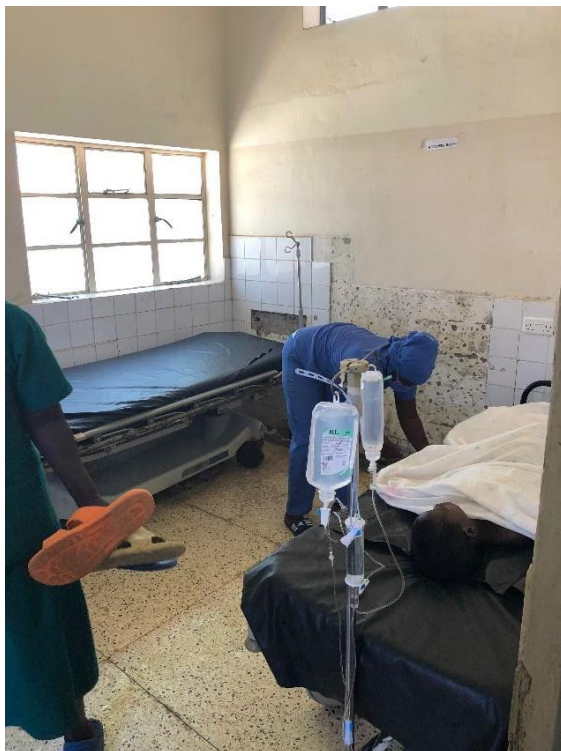
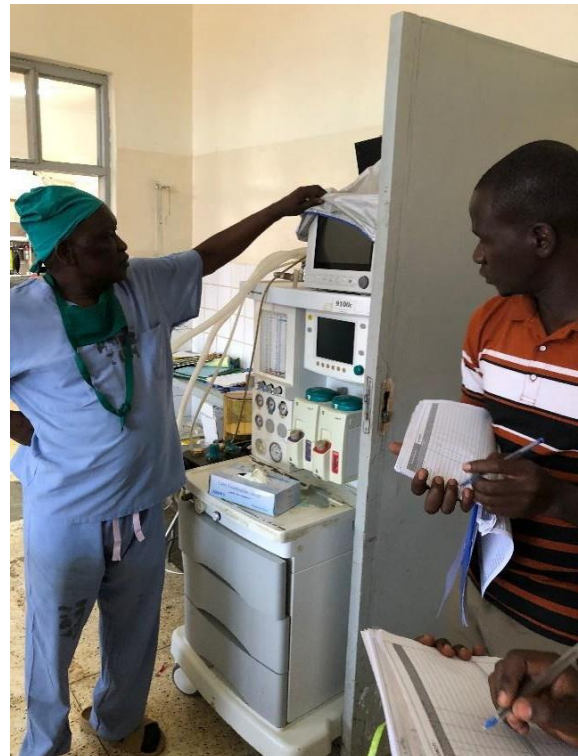
The Recovery Area was found to not have any equipment and can therefore not provide adequate recovery care to surgical patients.

Feedback by Theatre Staff highlighted a lack of surgical instrument sets that were a major concern for the surgeons.

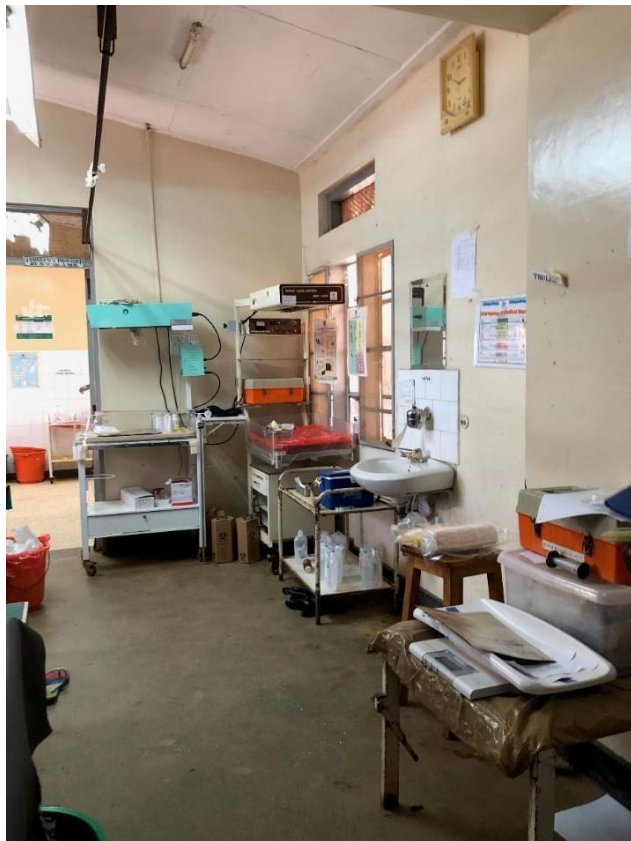
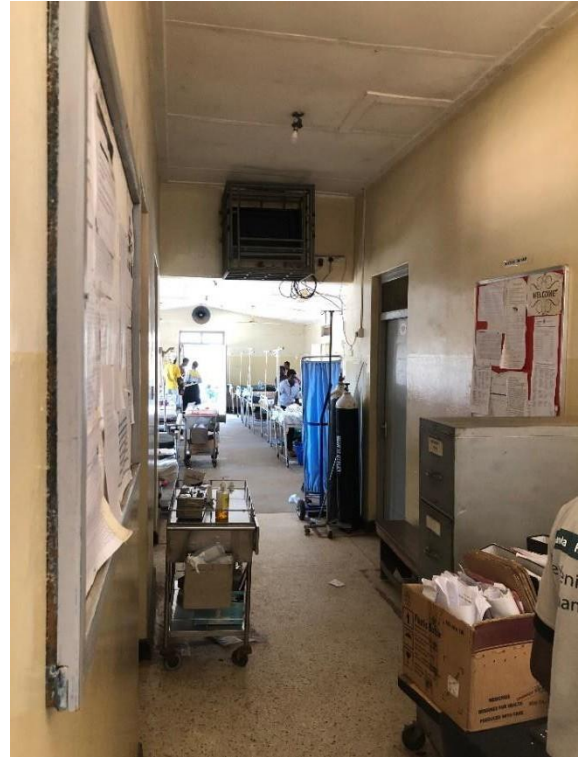
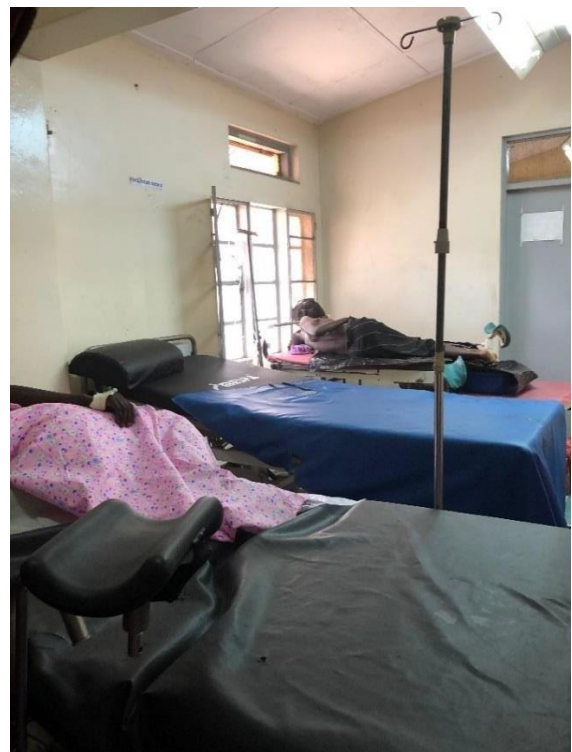
## Maternity:

The Maternity Unit houses a delivery room with 3 delivery beds, in which approximately 20 deliveries are done per day. The Obstetrics Theatre is not a part of this unit and is located in the Main Theatre complex. The Unit was found to be very busy and fully occupied at the time of inspection.

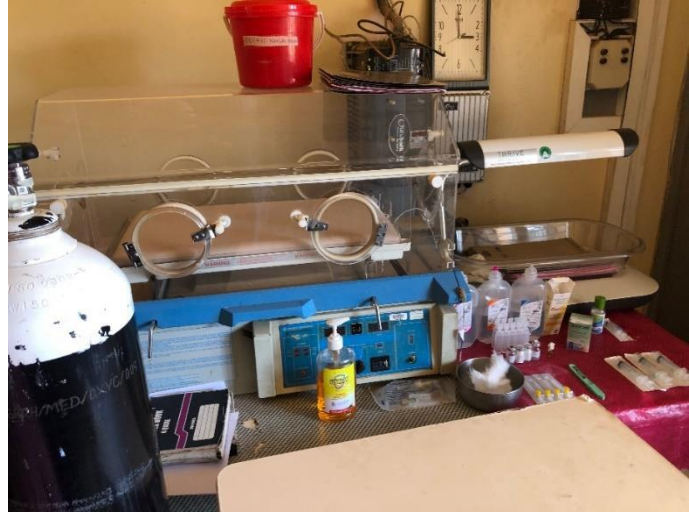
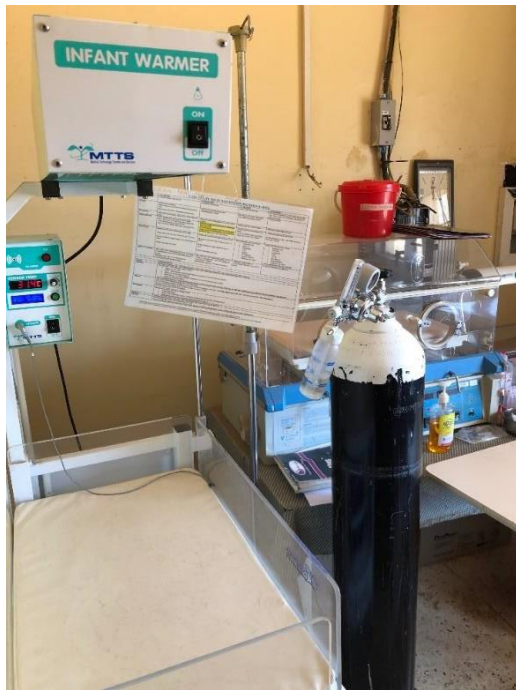
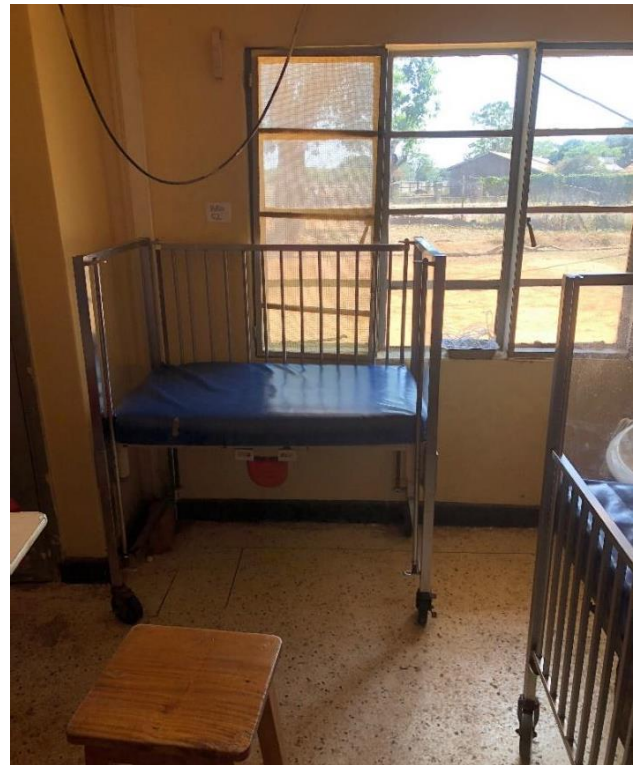
## NICU:

The NICU, NHCU and nursery are all consolidated in one department due to insufficient space and infrastructure. Space is very limited within the room and it can only accommodate 4 babies.

The available equipment is end-of-life and in urgent need of replacement. At the time of inspection there were no babies being cared for.
