# Risk Engineering Report

**TECHNISCHE UNIVERSITEIT EINDHOVEN**

**Date of Survey:** December 2, 2022

**Survey Type:** Site Summary Review

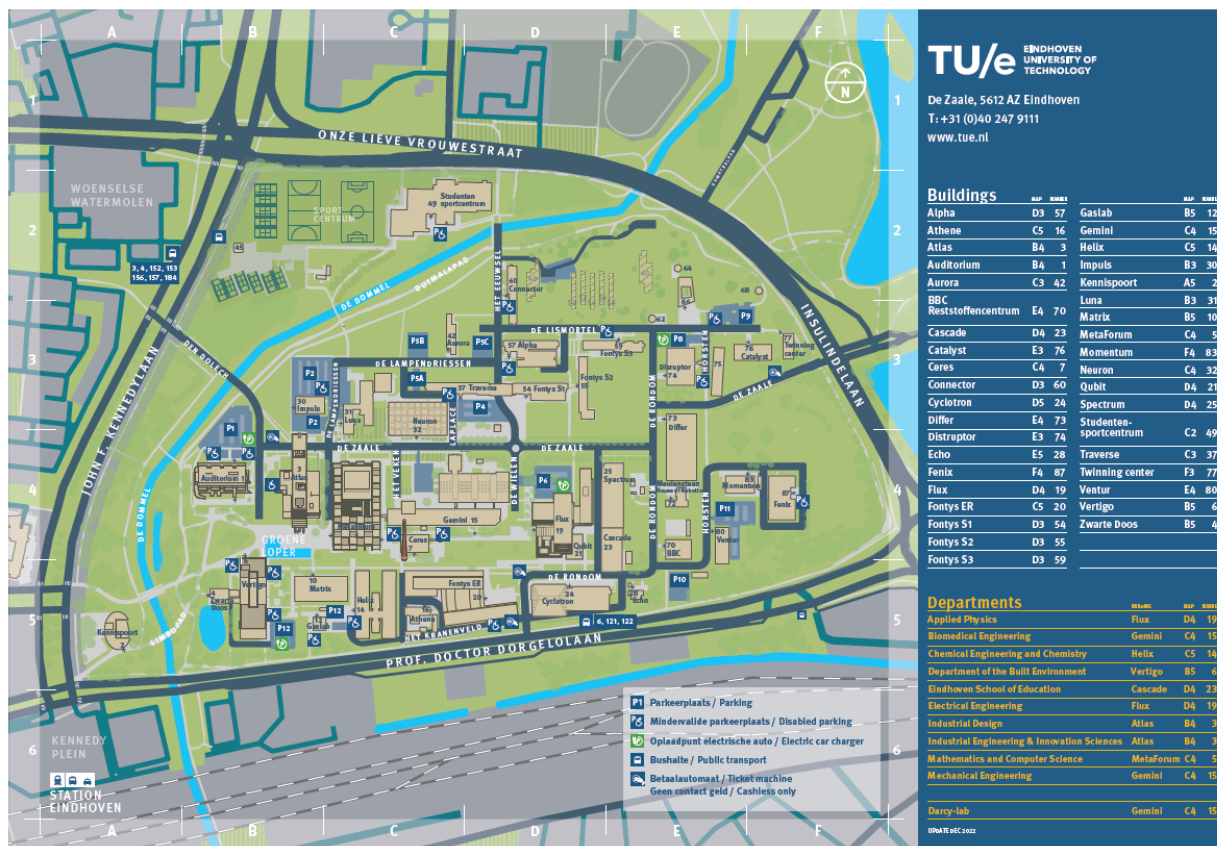
Campus Grounds:

The predominant construction is of reinforced concrete, most of the buildings date back to 1960s but have been renovated and restored over the years and were found to be in good condition during the visit. Only three buildings on campus have sprinkler protection. The rest of the campus relies on detection and manual fire fighting. The fire station is located on campus which houses both the private and public fire brigades which are both full-time paid and well equipped,the ERT comprises of the private fire brigade and the evacuation wardens.

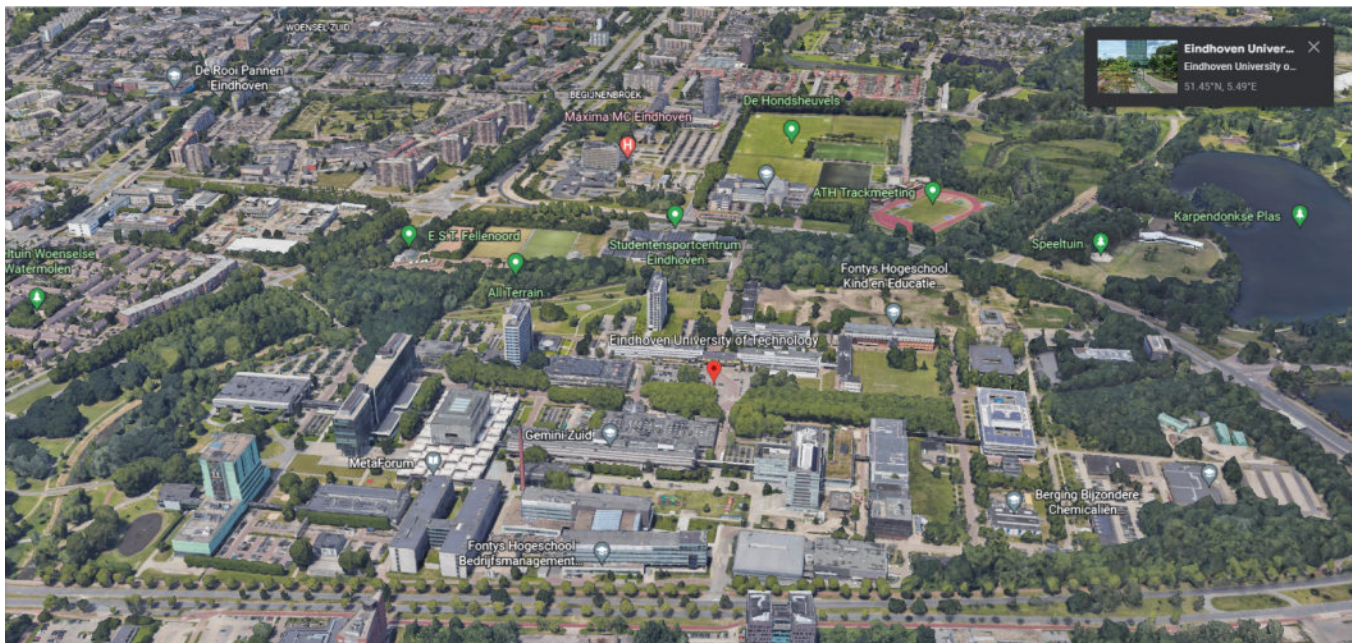
The campus is 1 km<sup>2</sup> in size and is situated northeast of the city centre of Eindhoven, with the Insulindelaan, Prof. Dr. Dorgelolaan, Onze Lieve Vrouwestraat, and John F. Kennedylaan as its borders. The campus is open, large, and unfenced. The campus grounds are comprised of number of buildings.

The campus also consists of the TNO and Fontys buildings. The distance from the central station in Eindhoven to the south is adequate.

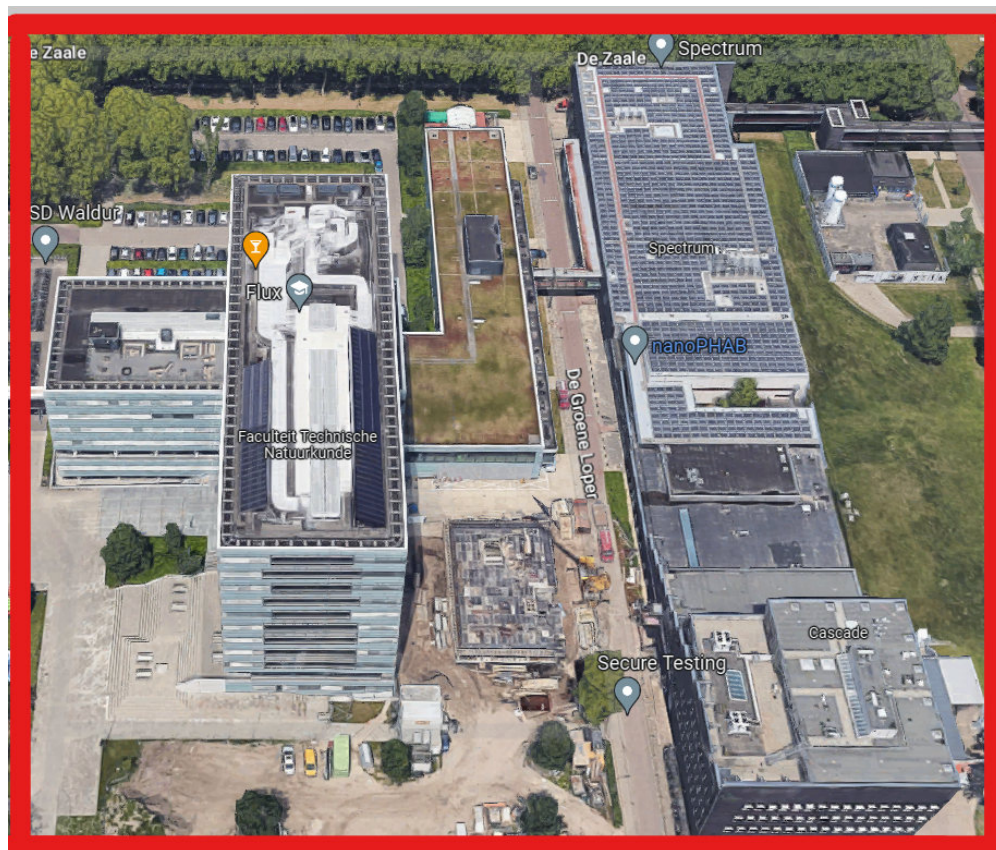
MFL Area:

The resulting damage from the fire is estimated to 165.5 Million based on AIG guidelines.
