# Risk Engineering Report

**Stichting BVE Zuid-Limburg**

**Site Name:** Schandelermolenvweg 21

**Survey Type:** Property All Risk - Initial

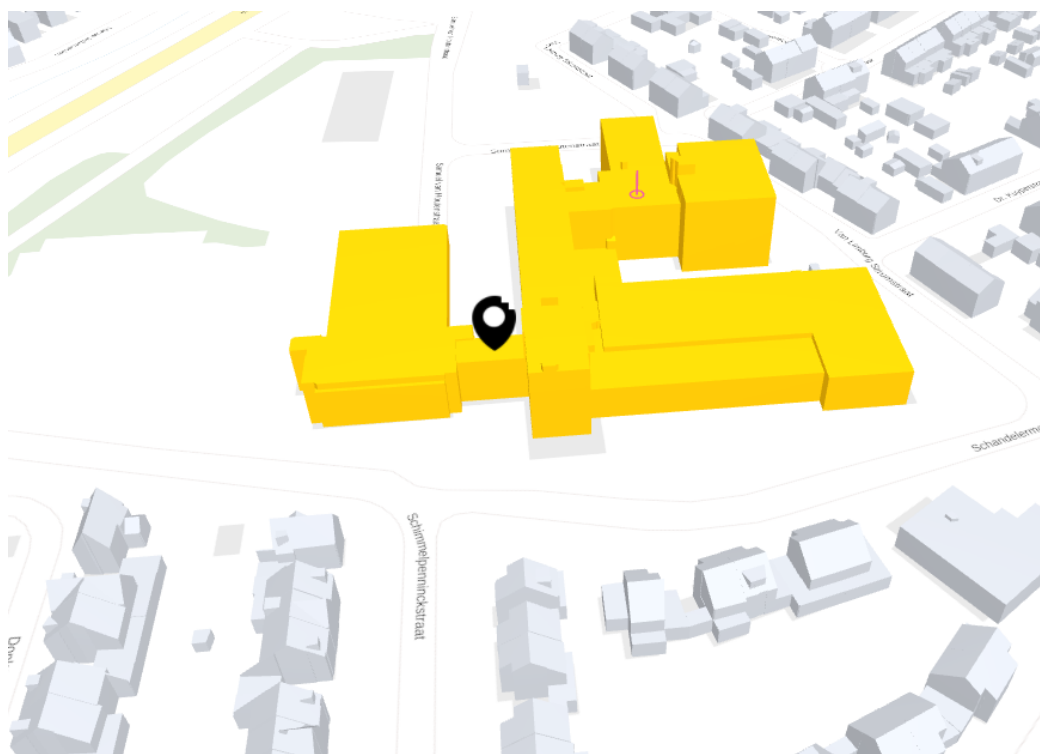
- North: houses at 11 meter.
- East: houses at 28 meter.
- South: parking lot of Vista and houses at >30 meter.
- West: apartment at about 50 meter

fig: site with exposures (source: [www.bagviewer.nl](http://www.bagviewer.nl)).
