# Risk Engineering Report

**Stichting BVE Zuid-Limburg**

**Site Name:** Valkenburgerweg 148

**Survey Type:** Property All Risk - Initial

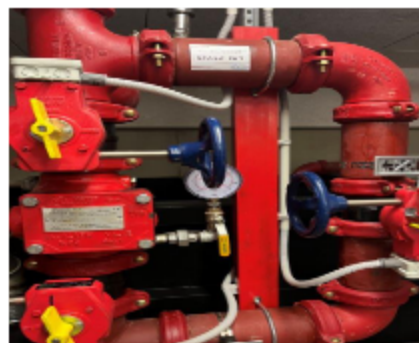
Alarmvalve bypass

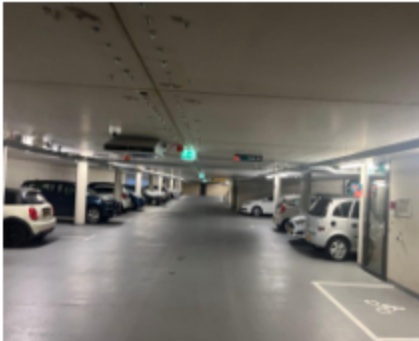
Parking

| Name | LE Before (EUR) | LE After (EUR) |
|---|---|---|
| Sprinklers- Extend sprinklers into the parking 23-06-01 | 14,941,460 | 1,000,000 |
