# NL Utrecht Nieuw Gildesteengebouw Risk Summary Report 2021 Aon

| <b>Location:</b> | Bolognalaan 50<br>UTRECHT |
| <b>Survey date:</b> | 2021-06-15 |
| <b>Report date:</b> | 2021-07-19 |

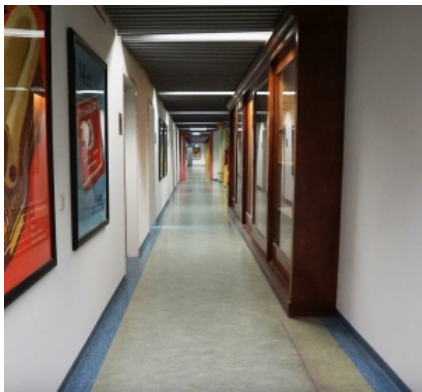
| Reception | Corridor | Evacuation plan |

| 2-08 | <b>Housekeeping</b><br>In general, housekeeping is at a excellent level. The corridors are free of any storage. There is no yard storage. Aisles & passageways kept clear of obstructions. All work and storage areas well controlled and in good state. Combustible materials cleared from hazardous areas. Fire protection equipment easily accessible. No excess storage in process areas. | Peter Uri |
