# Risk Engineering Report

**STICHTING FONTYS**

**Site Name:** Professor Goossenslaan 1 Tilburg

**Survey Type:** Property All Risk - Initial

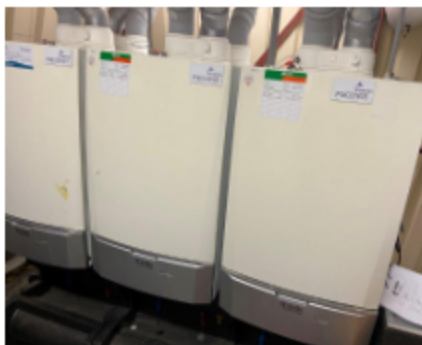
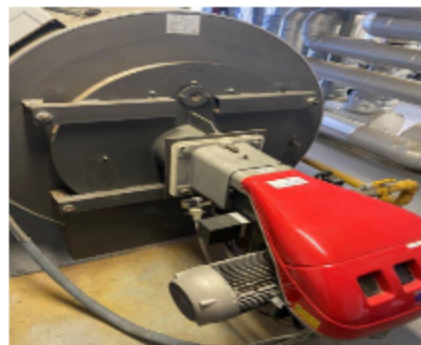
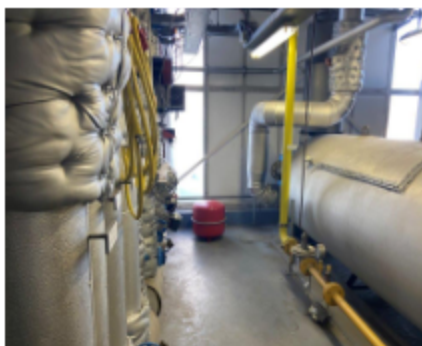
Status of installations are managed and monitored via the building management systems. Equipment appears visually in a good state of repair. Periodic maintenance is contracted out to specialized contractors.

Heating equipment

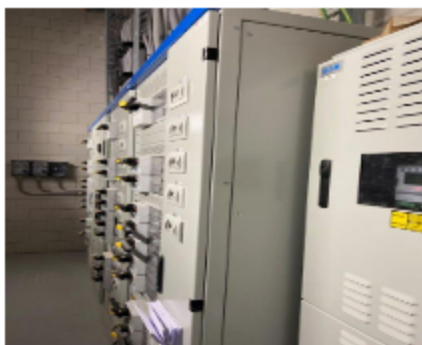
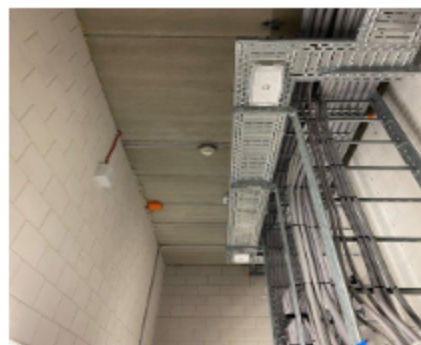
Main switch room (P8)

The electrical installations appear visually in a good state of repair. Penetrations for electrical cables were found to be adequately fire stopped, including inside vertical utility shafts. The electrical installation is subjected to inspection according to the Dutch standard NEN 3140, which comprises visual inspection of all installation parts and checks by measurements. The periodicity is set to according the NEN3140. Inspections are done by third party and include thermographic surveys. Recommendations are followed.

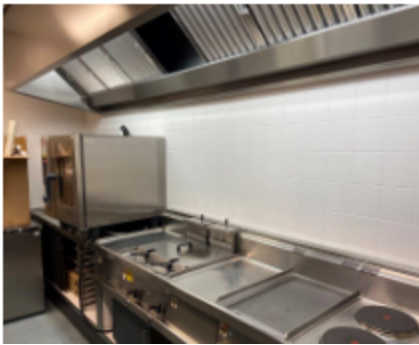
There is one professional kitchen in building P1 on the ground floor. It contains electrical and gas fired kitchen equipment like an oven (electrical) and deep fat fryer (gas). In other buildings there is only small electrical equipment, like ovens. The professional equipment in the kitchen is well maintained and is always operated under supervision of professionals. High temperature limit switches are reportedly available. Fire blankets and adequate portable fire extinguishers have been provided. Periodic inspection and cleaning of the exhaust ducts is subcontracted to a professional company (reportedly once every year). The kitchen is not provided with a local extinguishing system (recommended only as best practice).

Example of kitchen equipment (in building P4 taken out of order)

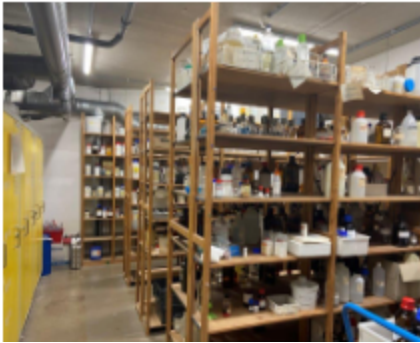
alkaline etcetera. The materials are stored in a separate compartment that is locked. In this compartment several PGS 15 cabinets and steel closed cabinets are present. Proper separation between the different kinds of chemicals is provided by storing them several separate PGS 15 cabinets. But also storage of limited hazardous material in wooden racks, like everyday household products.

Hazardous storage

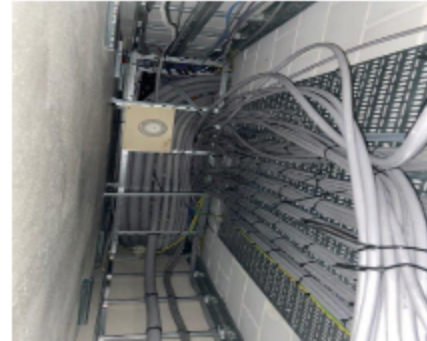
Detection in utility shaft

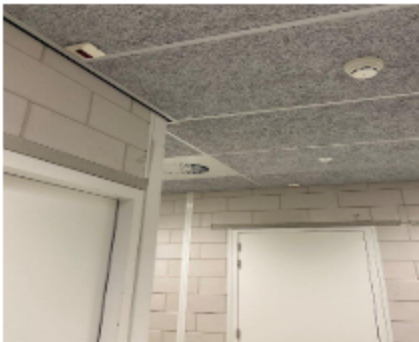
Spot smoke detector

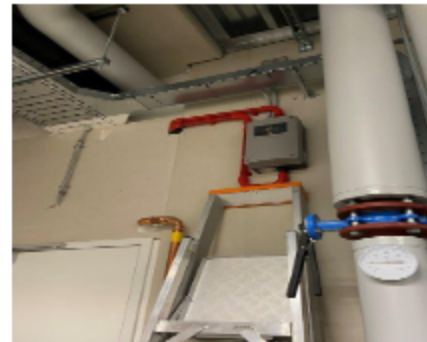
Aspiration detection
