# Risk Engineering Report

**STICHTING FONTYS**

**Site Name:** Mgr Claessenstraat 4Sittard

**Survey Type:** Property All Risk - Initial

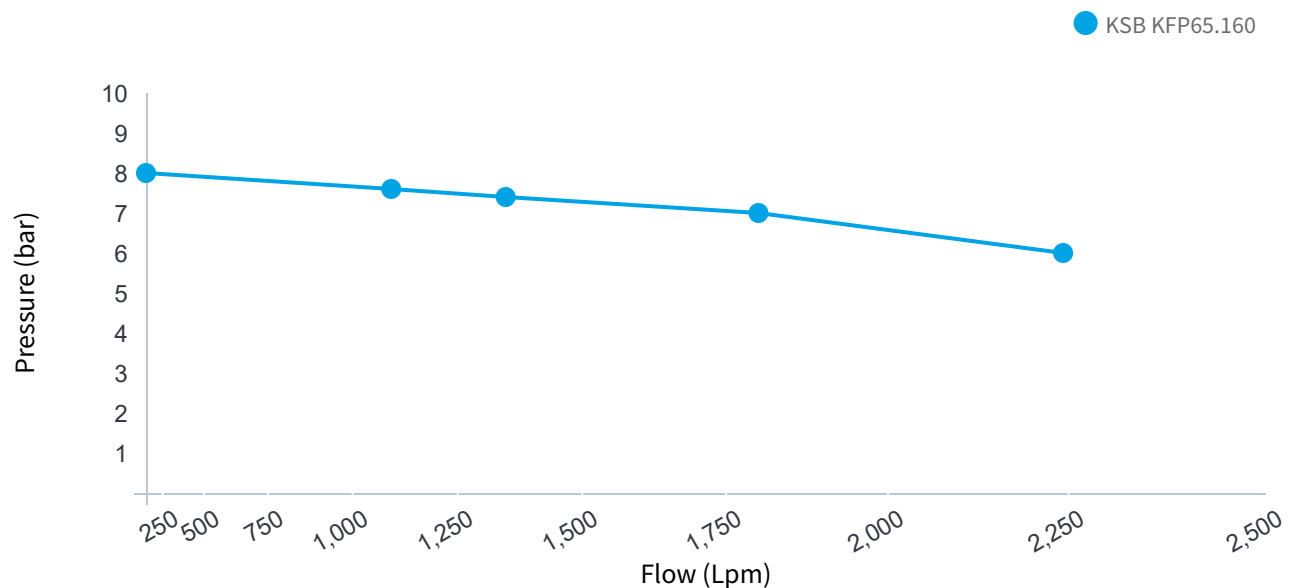
## Combined Water Supply and Sprinkler Demand Graph

*Note: The overall sprinkler protection rates NEARLY ADEQUATE according to AIG based on the LEs of the sprinkler protection deficiencies.*

| Name | LE Before (EUR) | LE After (EUR) |
|---|---|---|
| Sprinklers- Extend sprinklers into the parking 24-07-01 | 16,430,115 | 2,500,000 |
