# Risk Engineering

Risk Assessment and Risk Improvement

Helping you to understand and mitigate your risks

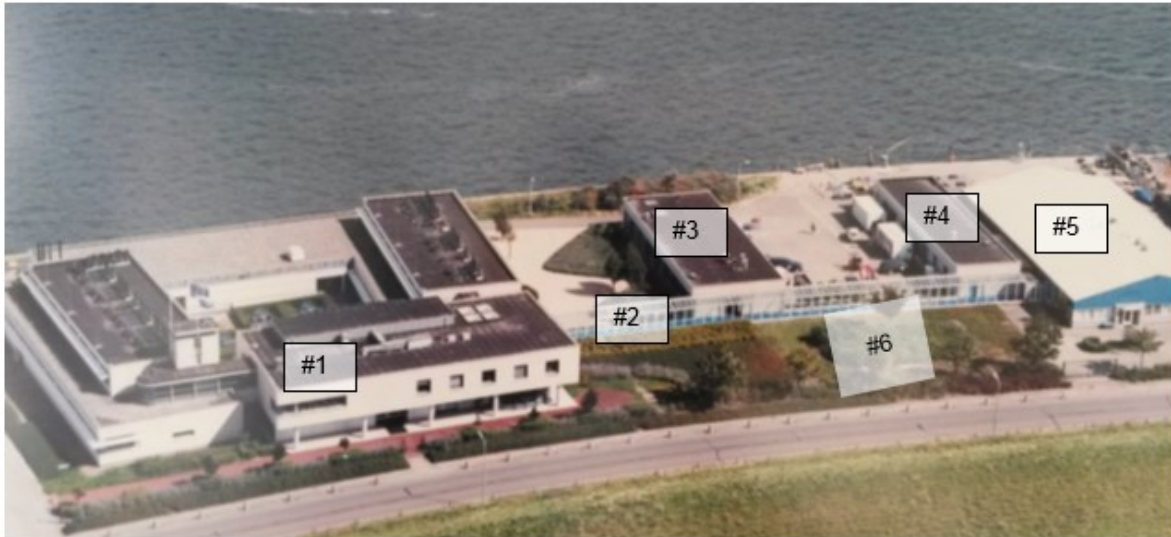
## Site Layout

1. Main building – offices and laboratory
2. Corridor
3. Maintenance shop
4. Storage building
5. MESO complex – test rooms
6. Green house
