## MUZIEKPALEIS TIVOLI VREDENBURG

*UTRECHT, The Netherlands*

*Underwriting information*

*PROPERTY DAMAGE*

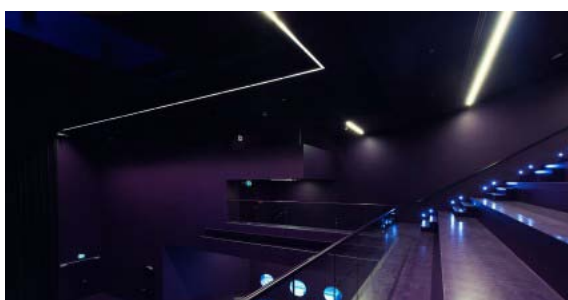
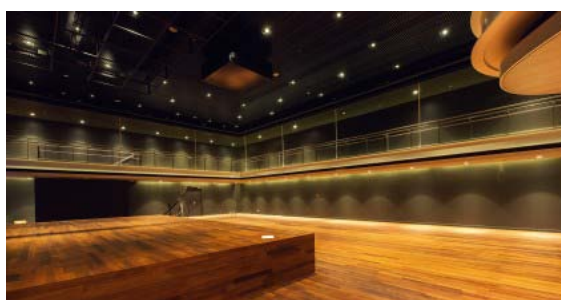
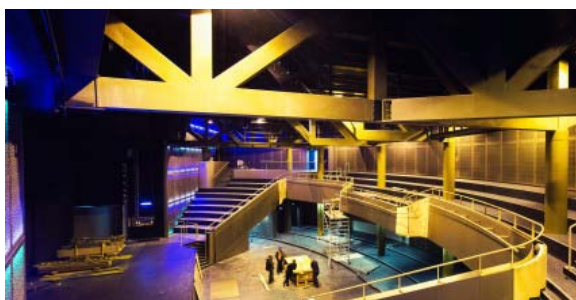
### Impression of the halls:

Besides the music halls there will be several café's, restaurants and established in the music hall. Moreover there will be several foyers established as part of the several music halls and several meeting and conference facilities. Also offices will be housed in the buildings.
