# Risk Engineering Report

**Site Name:** Stadhuis en Nationale Opera & Ballet

**Survey Type:** Property All Risk - Initial

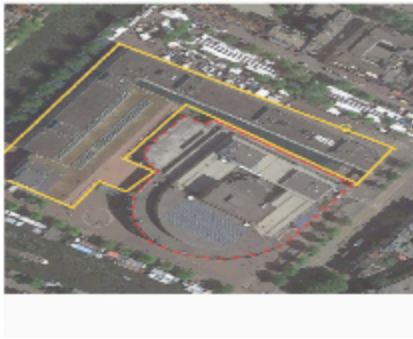
National Opera & Ballet in Red (doted line) and in Yellow  
Stadhuis Amsterdam complex
