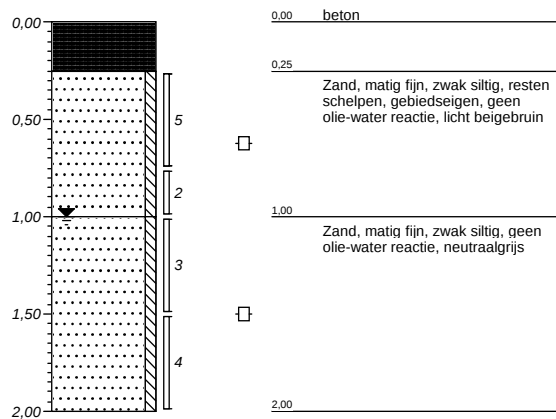
## Boring: 7029

Datum: 08-01-2016  
Grondwaterstand: 100

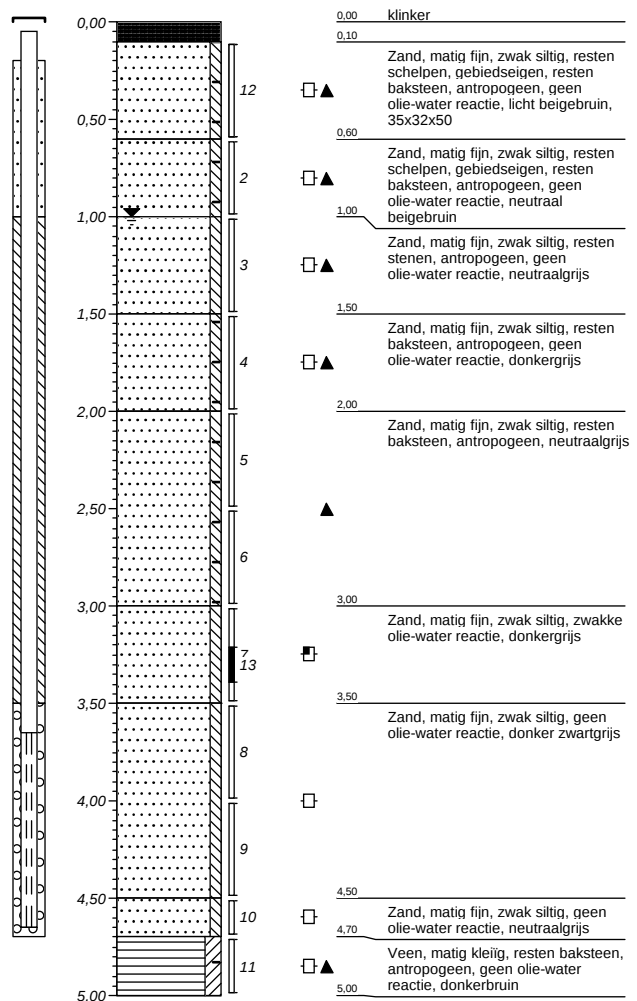
## Boring: 7031

Datum: 07-01-2016  
Grondwaterstand: 100

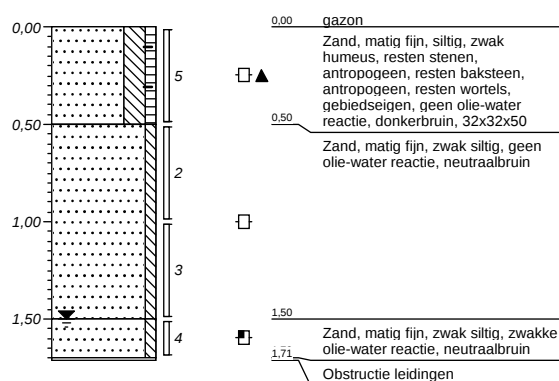
## Boring: 7032

Datum: 07-12-2015  
 Grondwaterstand: 150

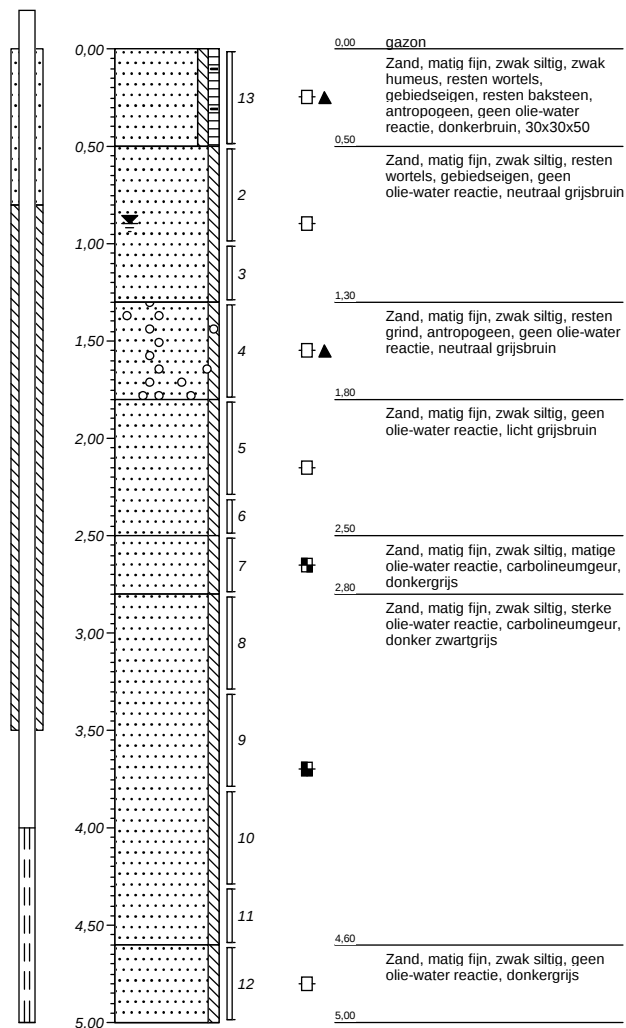
## Boring: 7033

Datum: 04-12-2015  
 Grondwaterstand: 90

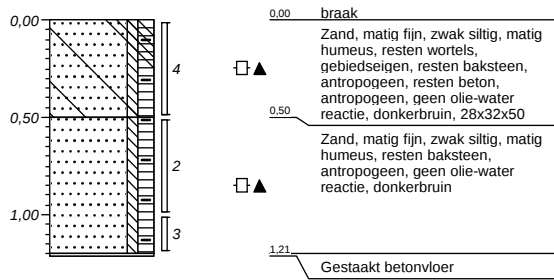
## Boring: 7034

Datum: 08-01-2016

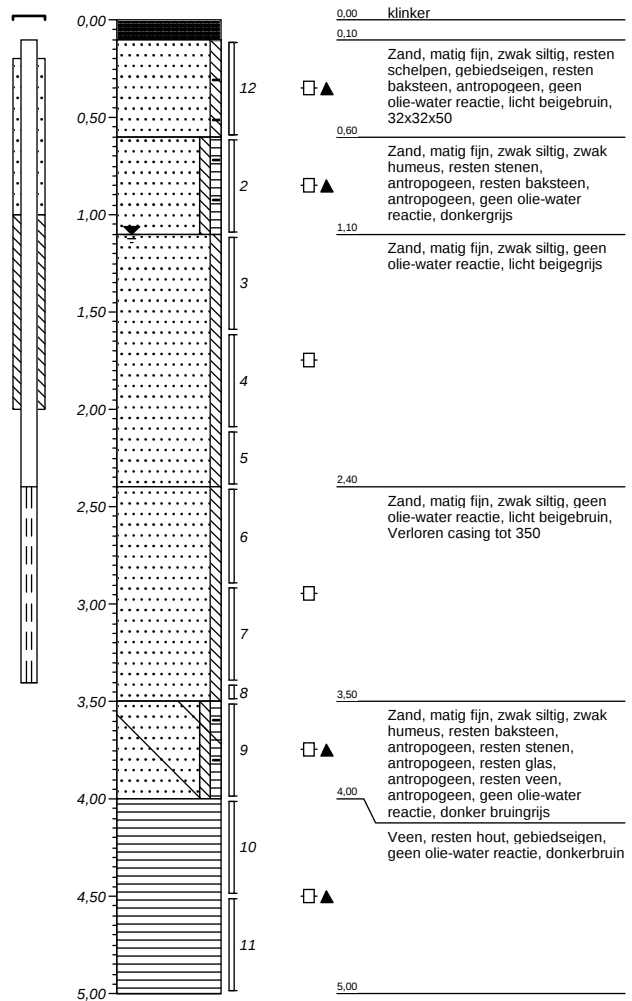
## Boring: 7035

Datum: 06-01-2016  
 Grondwaterstand: 110

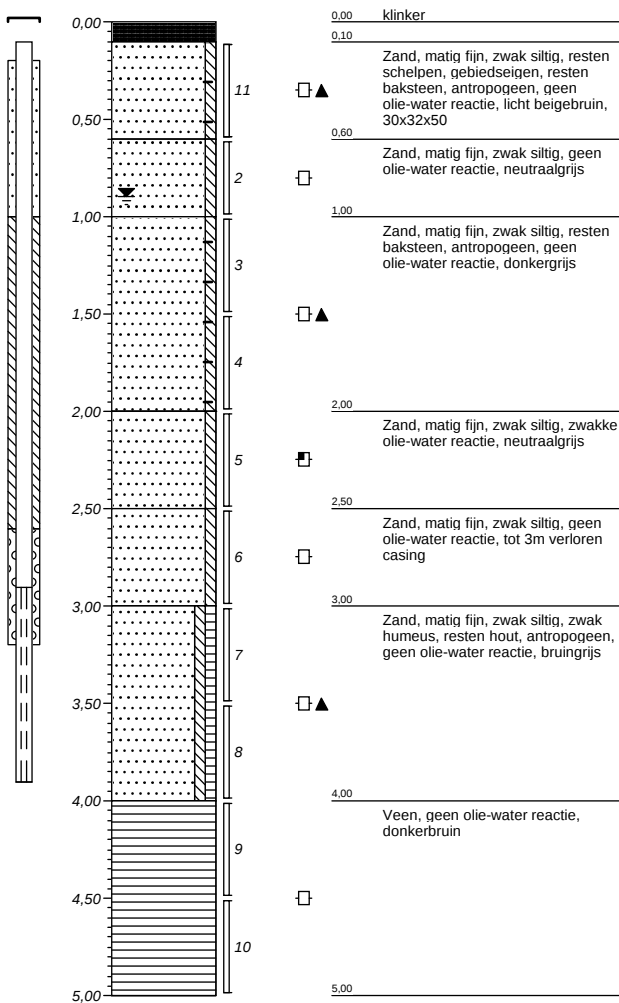
## Boring: 7036

Datum: 05-01-2016  
Grondwaterstand: 90

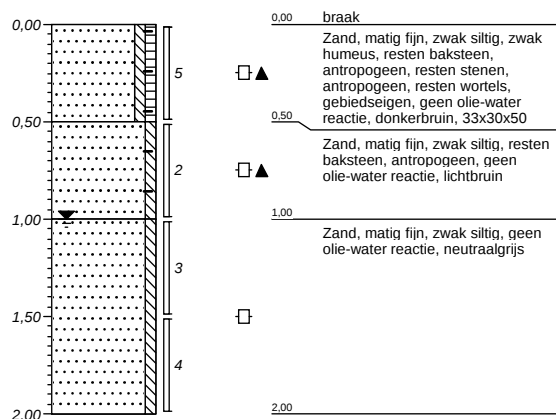
## Boring: 7038

Datum: 14-12-2015  
Grondwaterstand: 100

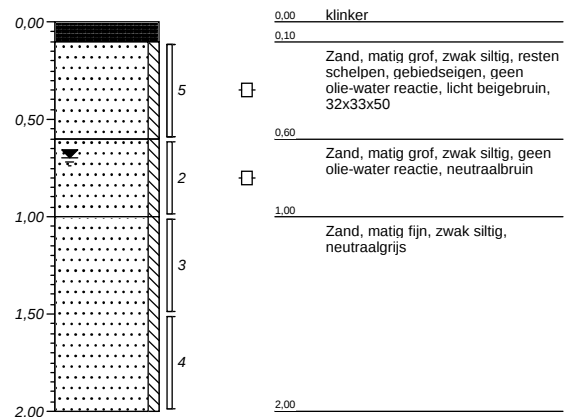
## Boring: 7037

Datum: 08-12-2015  
Grondwaterstand: 70

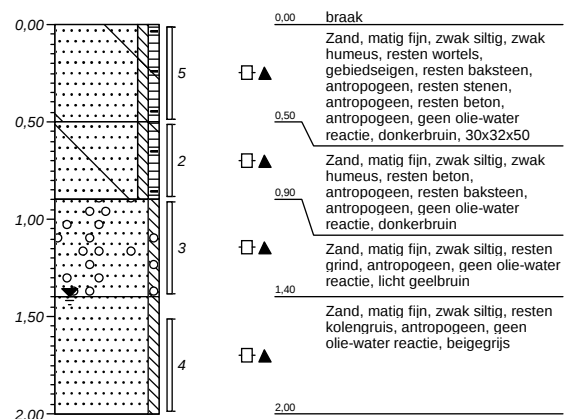
## Boring: 7039

Datum: 14-12-2015  
Grondwaterstand: 140

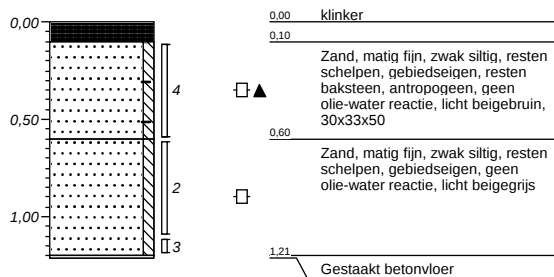
## Boring: 7040

Datum: 08-01-2016

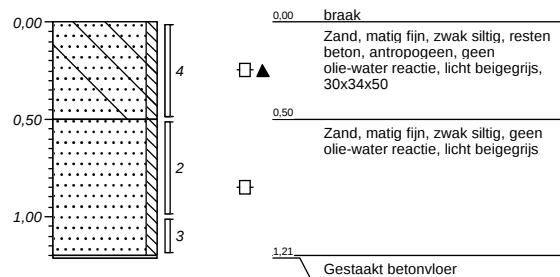
## Boring: 7041

Datum: 08-01-2016

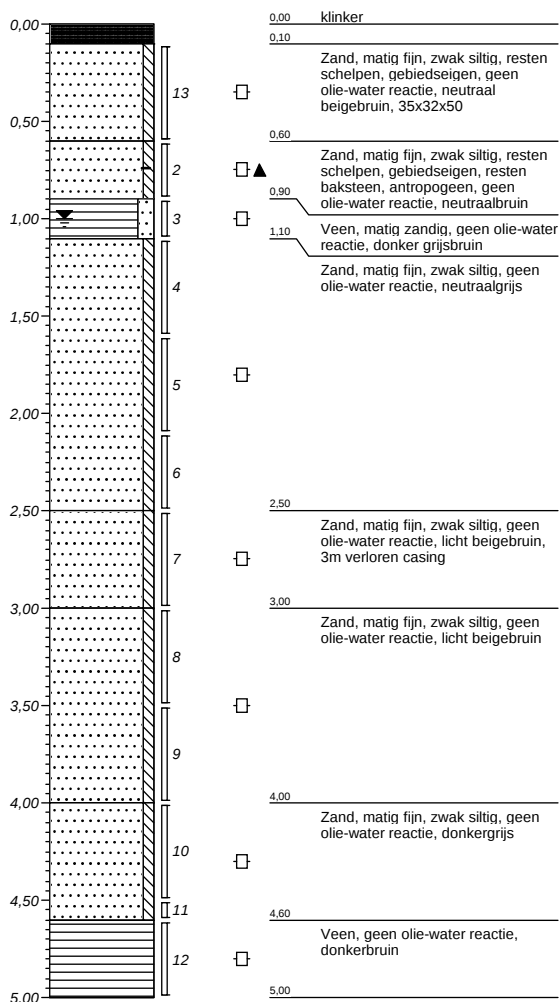
## Boring: 7051

Datum: 06-01-2016  
 Grondwaterstand: 100

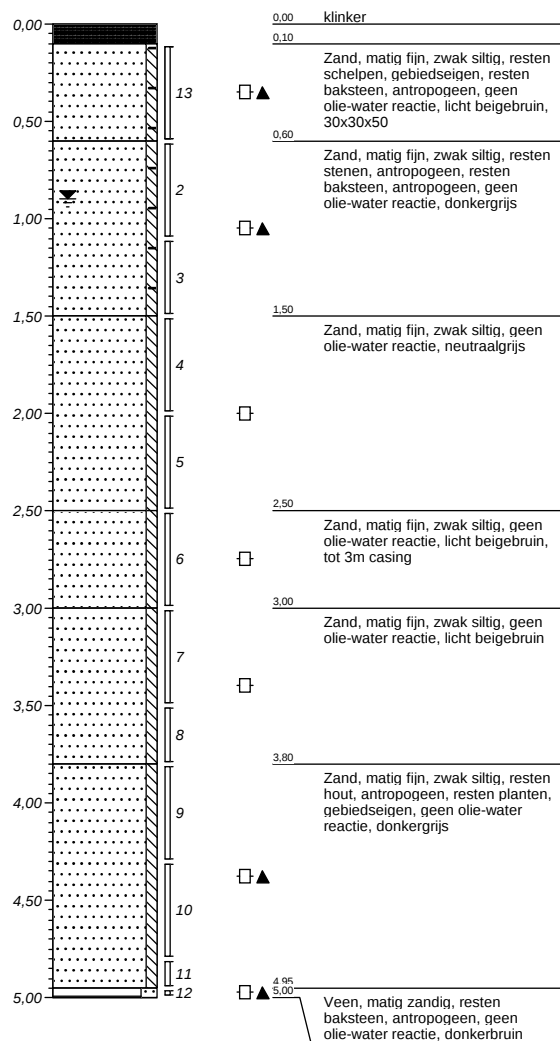
## Boring: 7052

Datum: 05-01-2016  
 Grondwaterstand: 90
