# Borescope Inspection Report

July 3, 2024

**Unit 52**

**ESN 192-229**

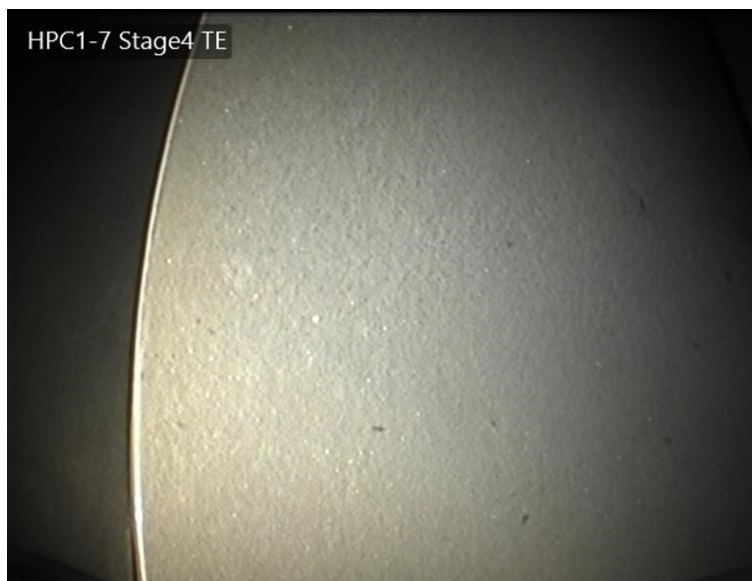
hpc1-7\_stage4\_te001.jpg

| Defect | BURN |

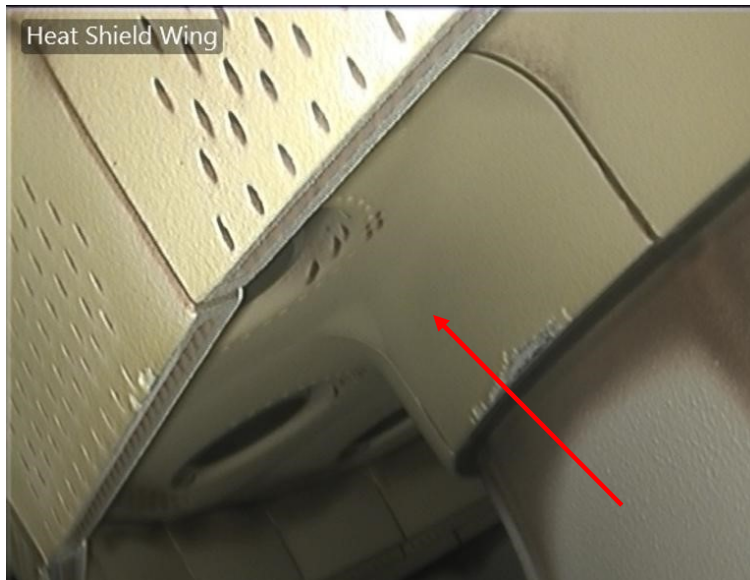
heat\_shield\_wing002.jpg

| Defect | TBC LOSS |
| <b>Comments:</b><br><b>TBC missing.</b> | |

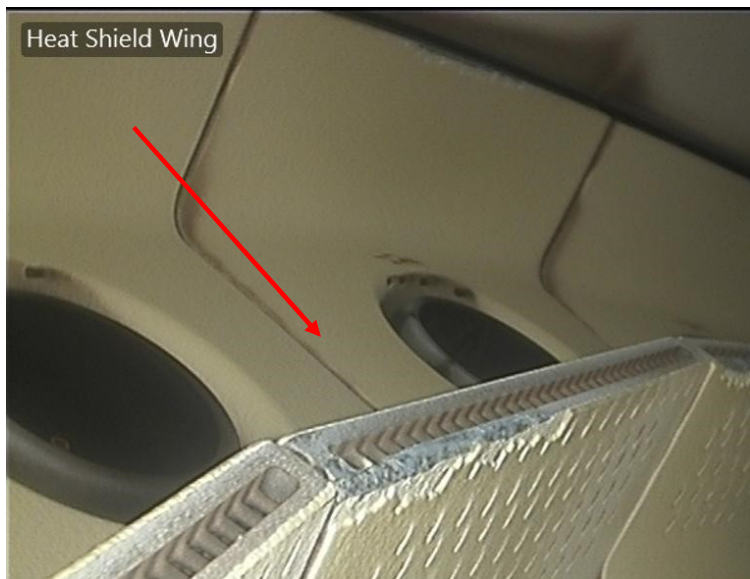
heat\_shield\_wing001.jpg

| Defect | TBC LOSS |
| <b>Comments:</b><br><b>TBC missing.</b> | |

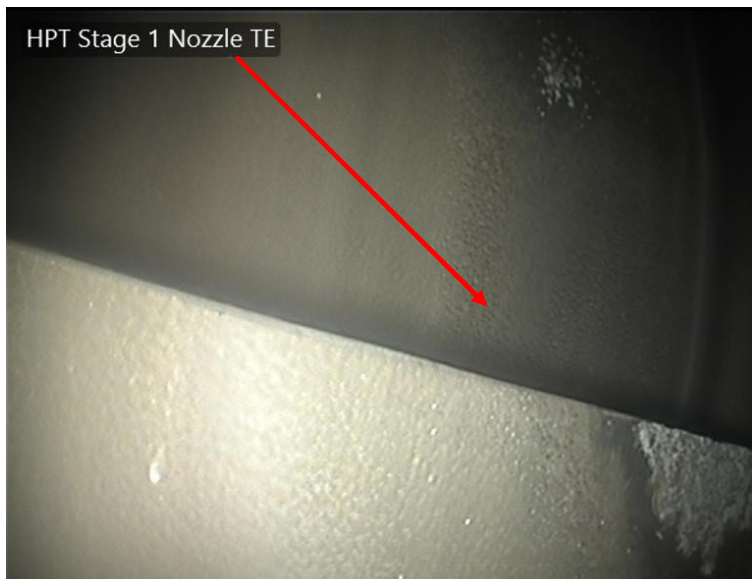
hpt\_stage\_1\_nozzle\_te002.jpg

| Defect | Erosion |
| <b>Erosion.</b> | |

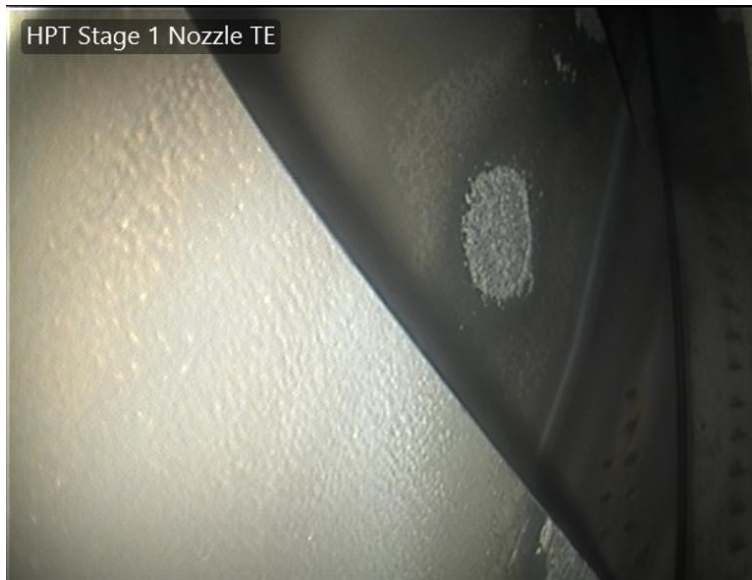
hpt\_stage\_1\_nozzle\_te001.jpg

| Defect | EROSION |
| <b>Comments:</b><br><br><b>Erosion.</b> | |

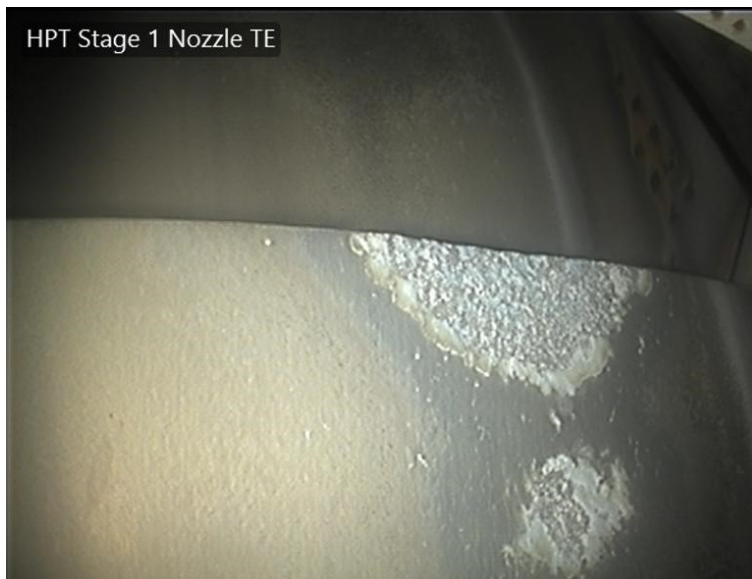
hpt\_stage\_1\_nozzle\_te003.jpg

| Defect | EROSION |
| <b>Comments:</b><br><br><b>Erosion.</b> | |

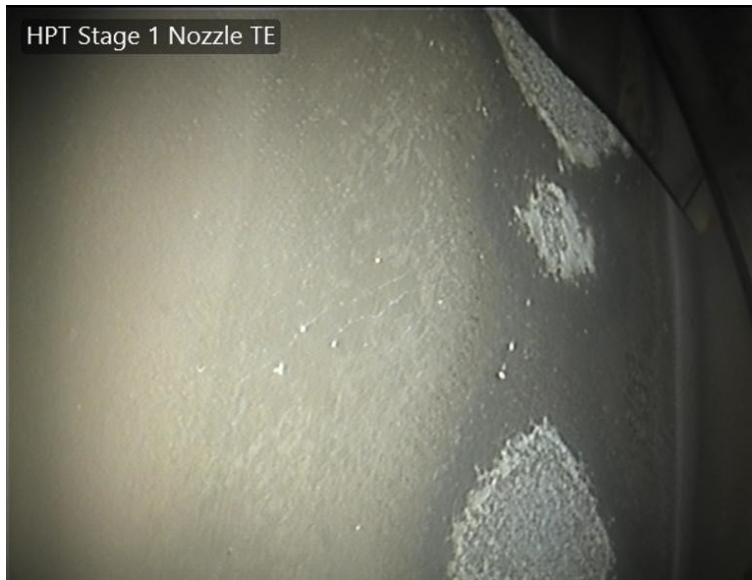
hpt\_stage\_1\_nozzle\_te004.jpg

| Defect | EROSION |
| <b>Erosion.</b> | |

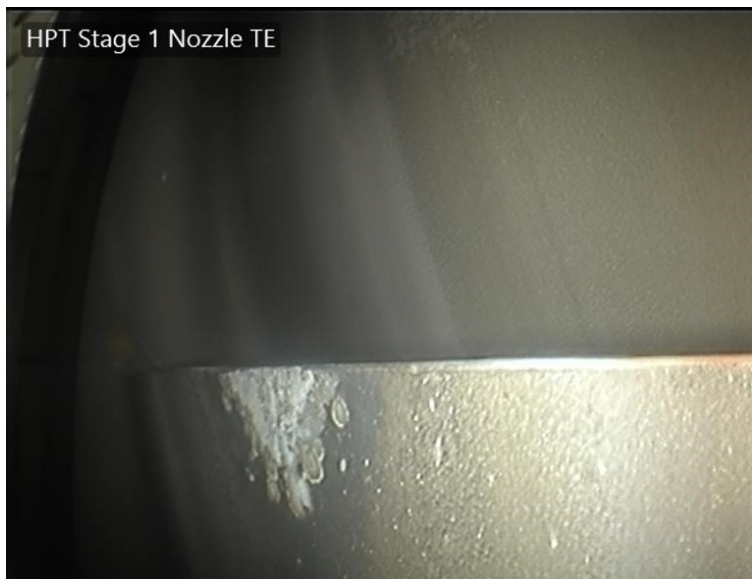
hpt\_stage\_1\_nozzle\_te005.jpg

| Defect | EROSION |
| <b>Erosion.</b> | |

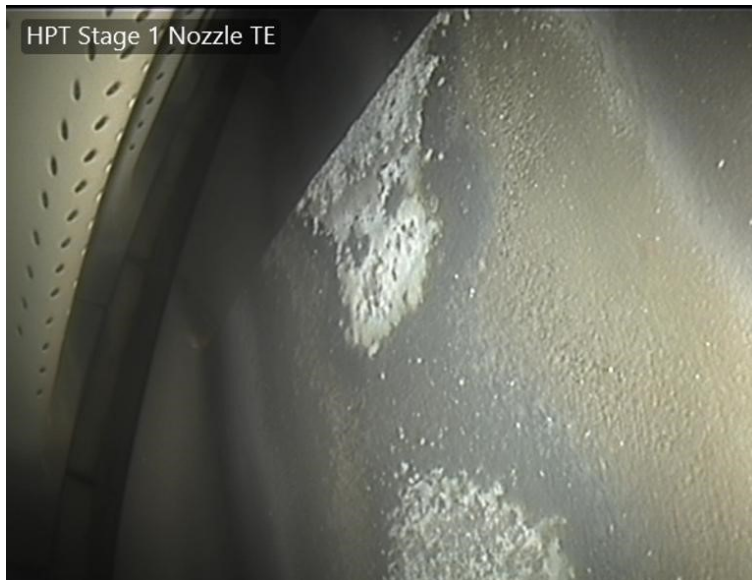
hpt\_stage\_1\_nozzle\_te007.jpg

| Defect | EROSION |
| <b>Erosion.</b> | |

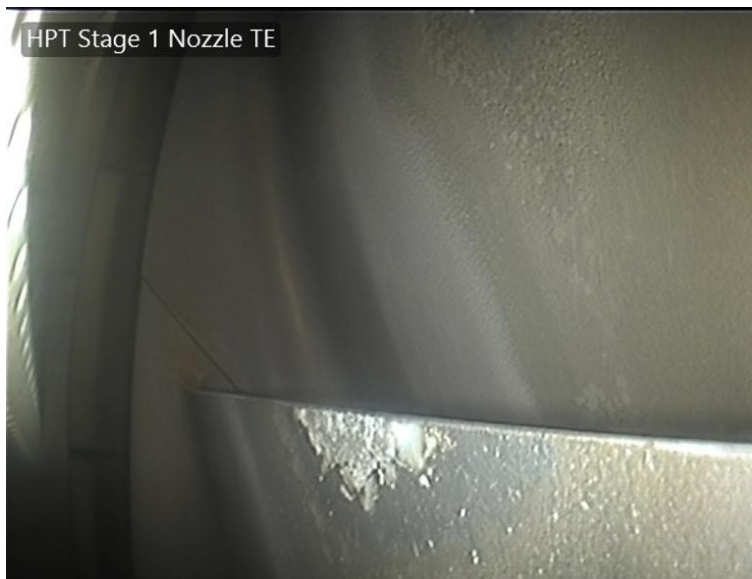
hpt\_stage\_1\_nozzle\_te006.jpg

| Defect | EROSION |
| <b>Erosion.</b> | |

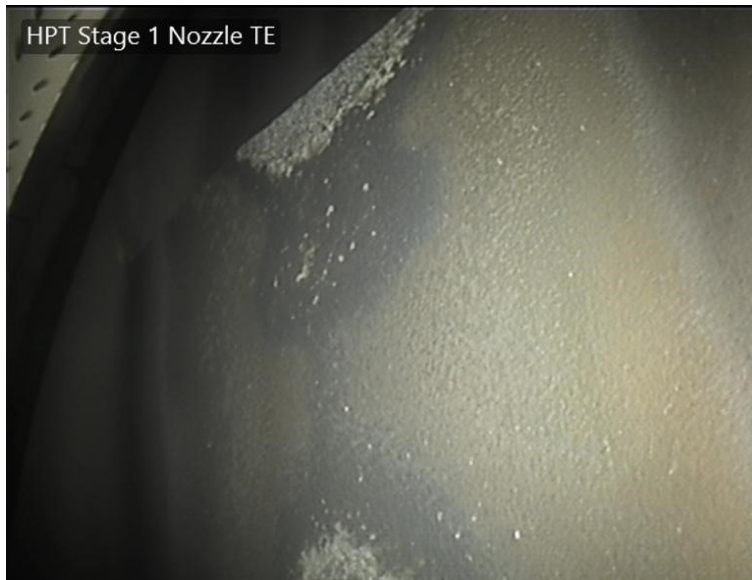
hpt\_stage\_1\_nozzle\_te009.jpg

| Defect | EROSION |
| <b>Comments:</b><br><br><b>Erosion.</b> | |

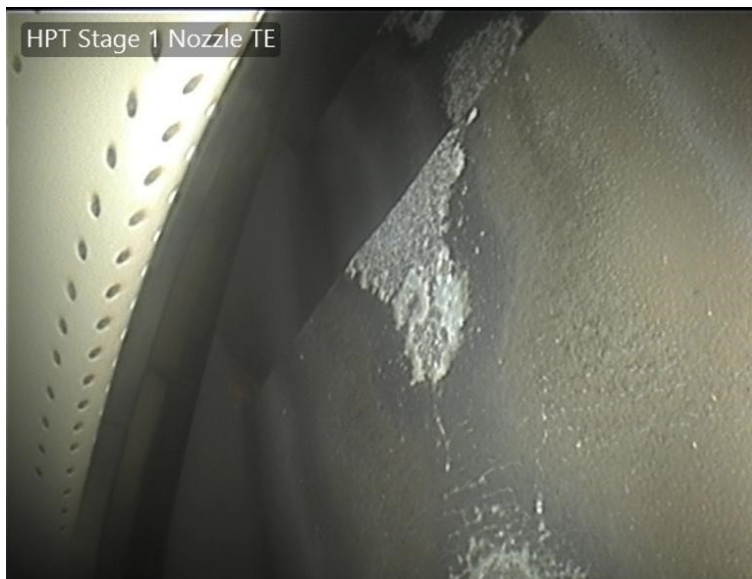
hpt\_stage\_1\_nozzle\_te008.jpg

| Defect | EROSION |
| <b>Comments:</b><br><br><b>Erosion.</b> | |

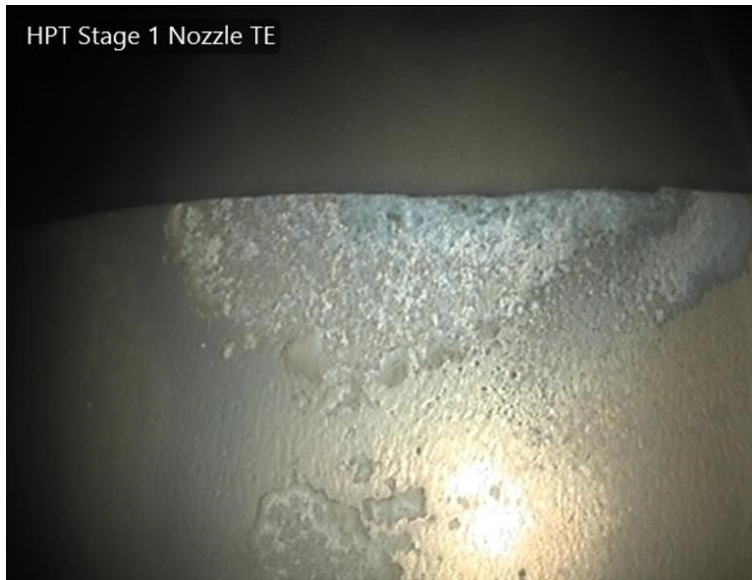
hpt\_stage\_1\_nozzle\_te010.jpg

| Defect | EROSION |
| <b>Comments:</b><br><br><b>Erosion.</b> | |

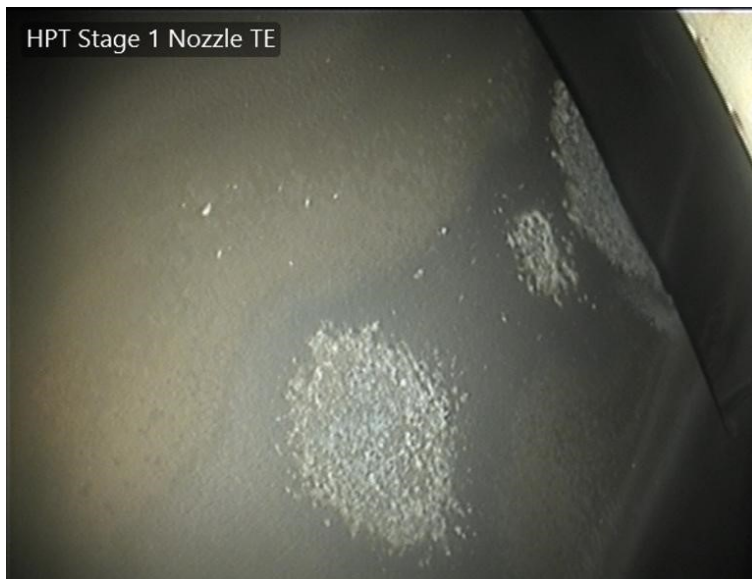
hpt\_stage\_1\_nozzle\_te011.jpg

| Defect | EROSION |
| <b>Comments:</b><br><br><b>Erosion.</b> | |

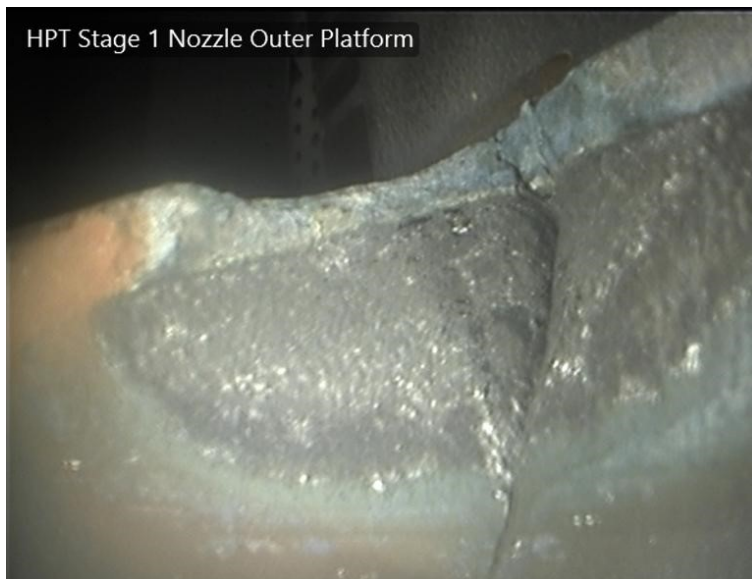
hpt\_stage\_1\_nozzle\_outer\_platform001.jpg

| Defect | CRACK |
| <b>Crack at borescope port hole (also found at last BSI)</b> | |

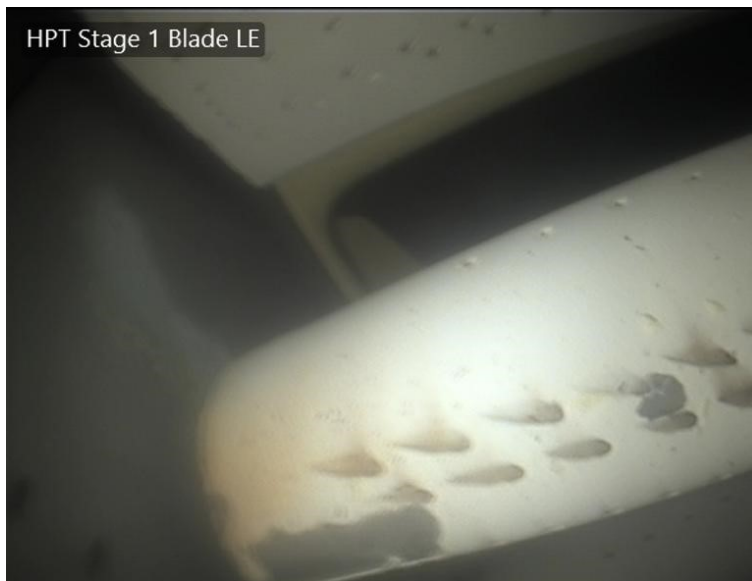
hpt\_stage\_1\_blade\_le003.jpg

| Defect | TBC LOSS |
| <b>TBS missing.</b> | |

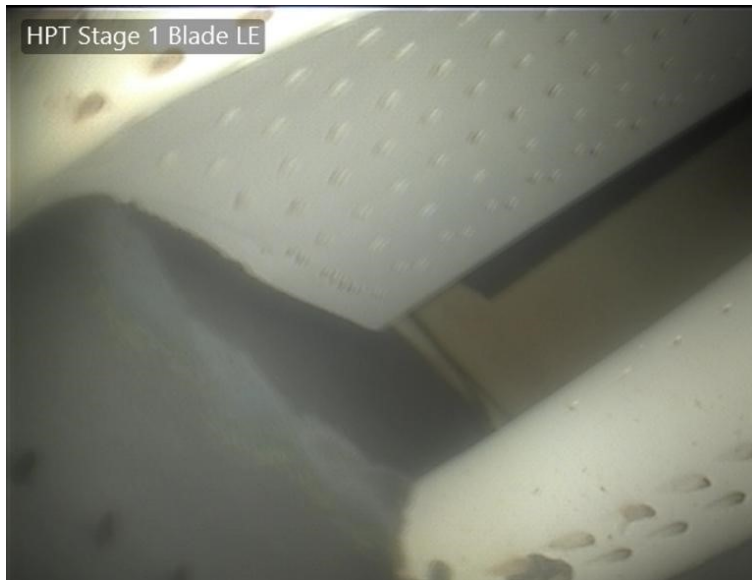
hpt\_stage\_1\_blade\_le002.jpg

| Defect | TBC LOSS |
| <b>Comments:</b><br><b>TBS missing.</b> | |

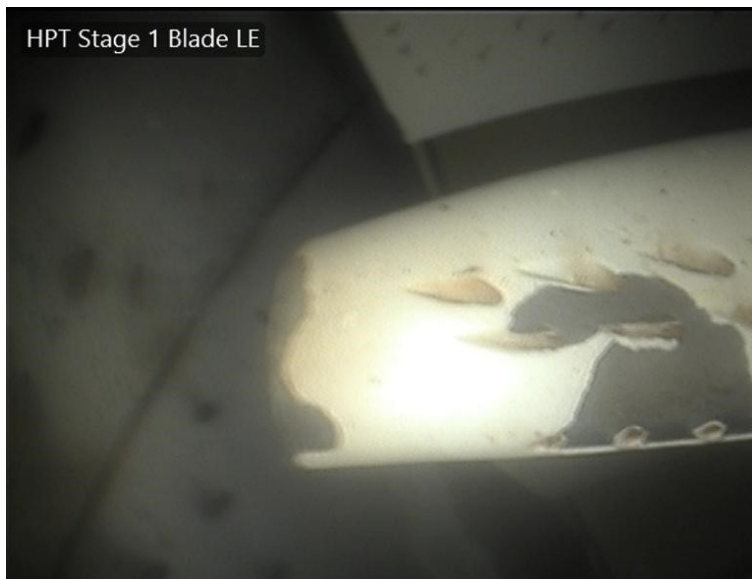
hpt\_stage\_1\_blade\_le004.jpg

| Defect | TBC LOSS |
| <b>Comments:</b><br><b>TBS missing.</b> | |

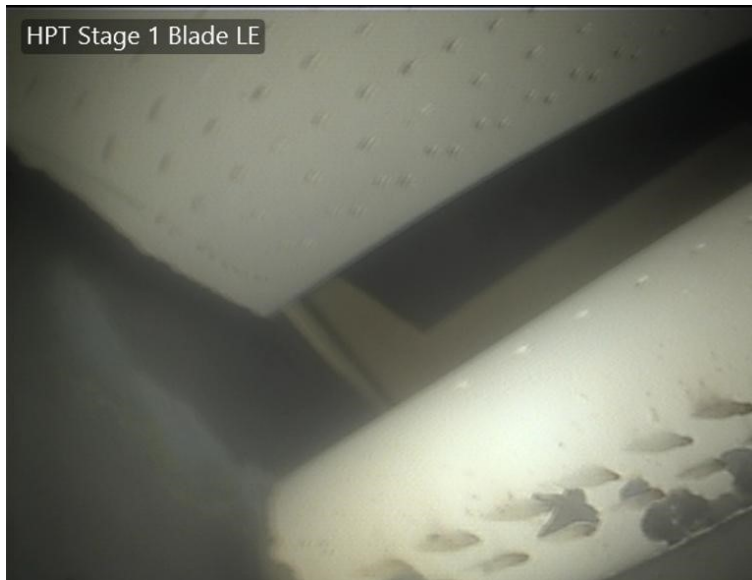
hpt\_stage\_1\_blade\_le005.jpg

| Defect | TBC LOSS |
| <b>Comments:</b><br><br><b>TBS missing.</b> | |

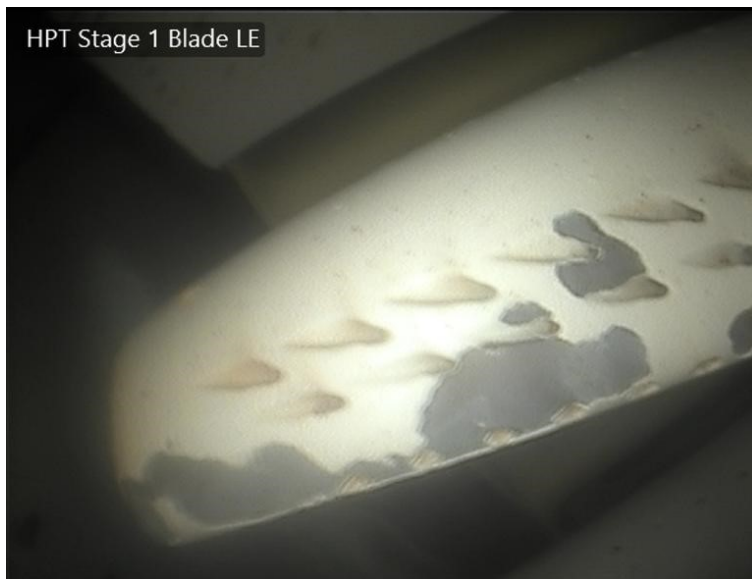
hpt\_stage\_1\_blade\_le006.jpg

| Defect | TBC LOSS |
| <b>Comments:</b><br><br><b>TBS missing.</b> | |

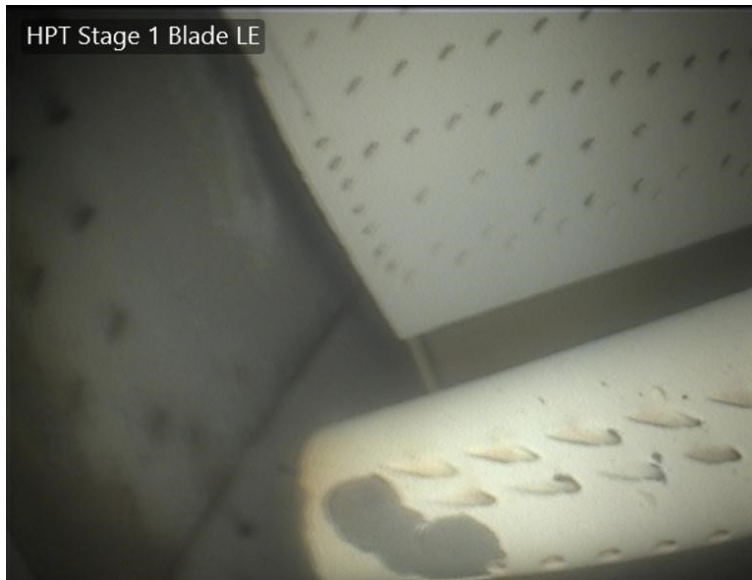
hpt\_stage\_1\_blade\_le009.jpg

| Defect | TBC LOSS |
| <b>Comments:</b><br><br><b>TBS missing.</b> | |

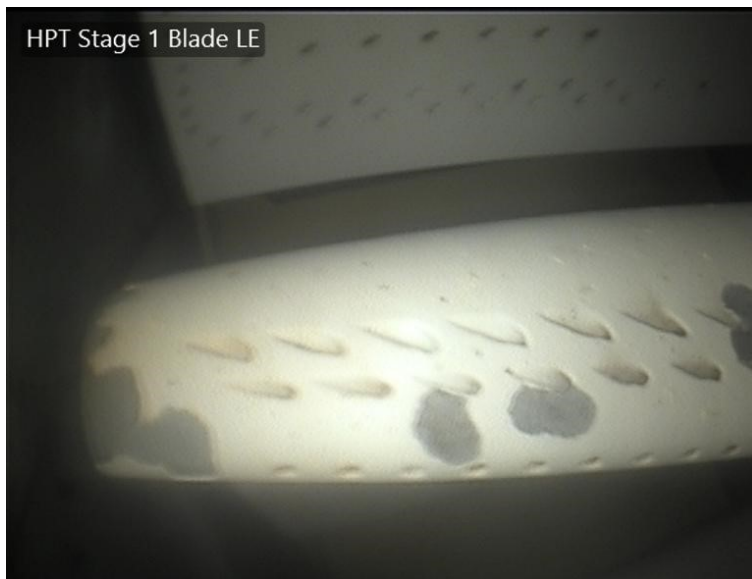
hpt\_stage\_1\_blade\_le010.jpg

| Defect | TBC LOSS |
| <b>Comments:</b><br><br><b>TBS missing.</b> | |

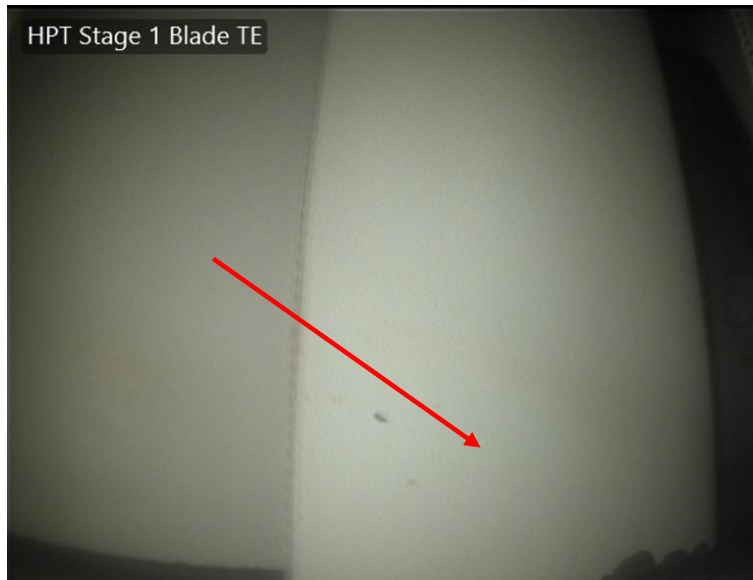
hpt\_stage\_1\_blade\_te001.jpg

| Defect | TBC LOSS |
| <b>Comments:</b><br><b>TBC missing.</b> | |

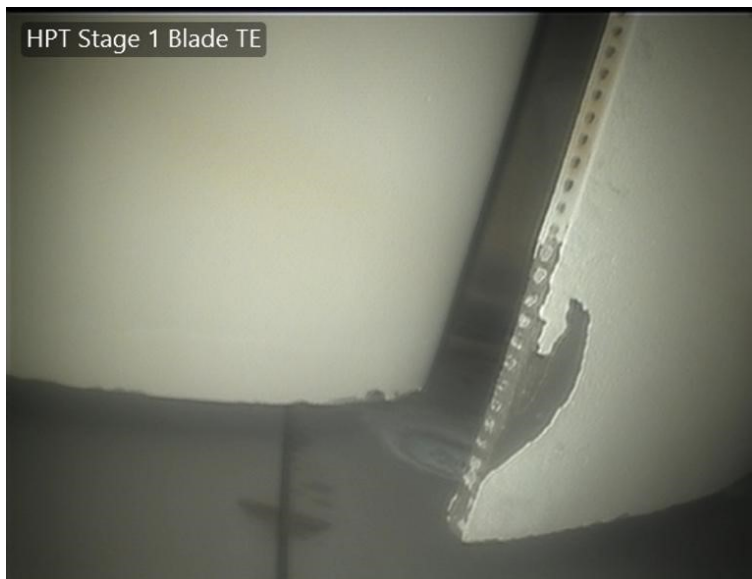
hpt\_stage\_1\_blade\_te008.jpg

| Defect | TBC LOSS |
| <b>TBC missing.</b> | |

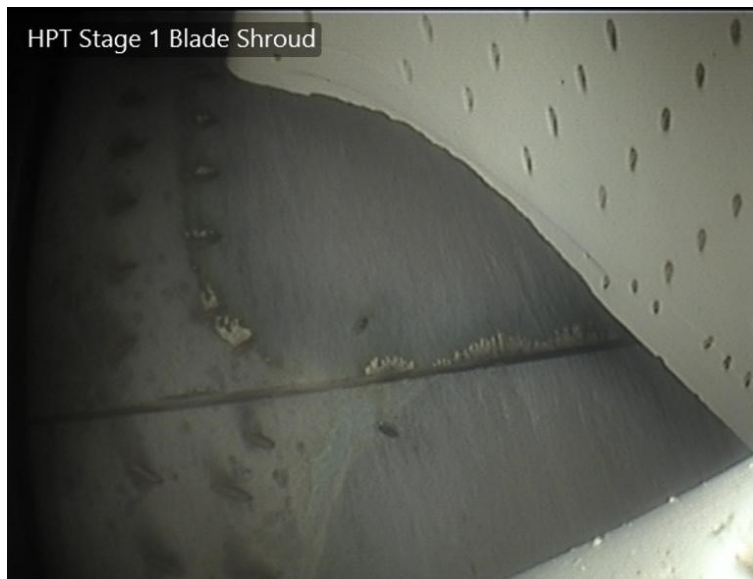
hpt\_stage\_1\_blade\_shroud001.jpg

| Defect | RUB |

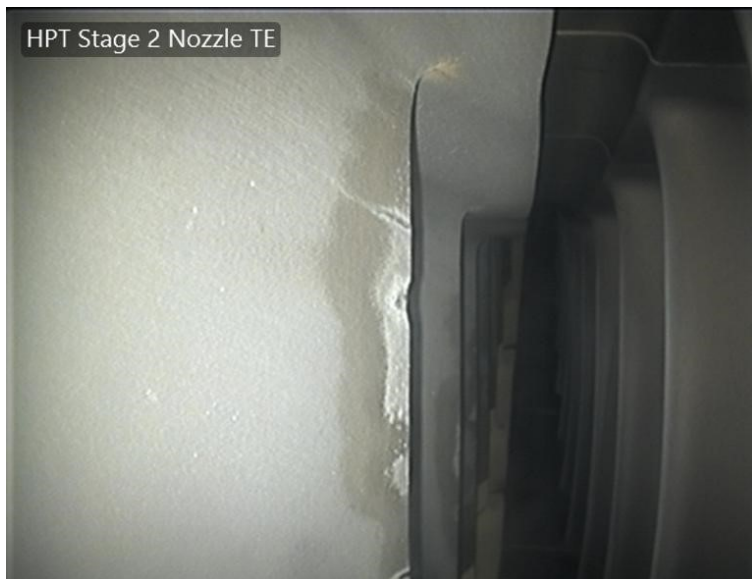
hpt\_stage\_2\_nozzle\_te004.jpg

| Defect | DENT |
| <b>Comments:</b><br><br><b>Crack at TE, serviceable.</b> | |

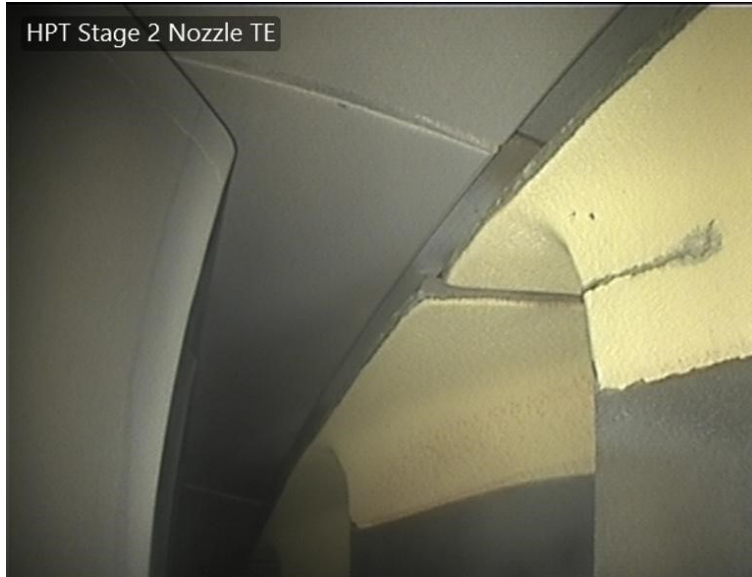
hpt\_stage\_2\_nozzle\_te007.jpg

| Defect | CRACK |
| <b>Comments:</b><br><br><b>Crack at TE, serviceable.</b> | |

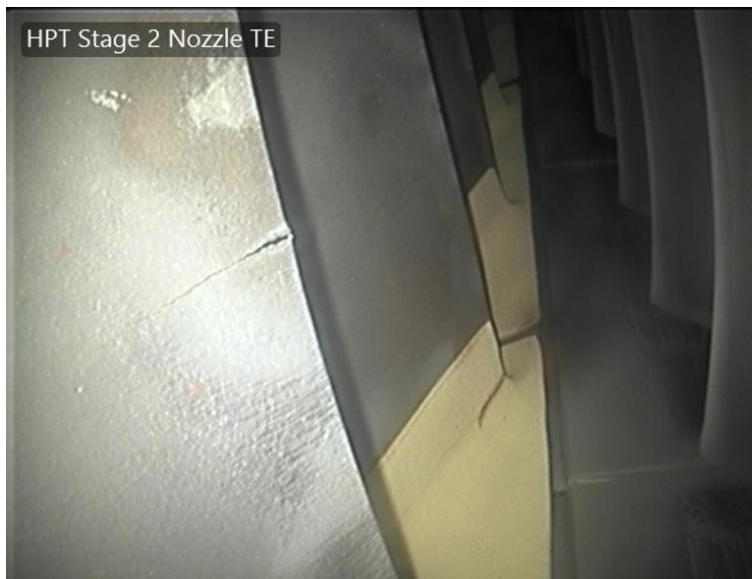
hpt\_stage\_2\_nozzle\_te005.jpg

| Defect | CRACK |
| <b>Comments:</b><br><br><b>Crack at TE, serviceable.</b> | |

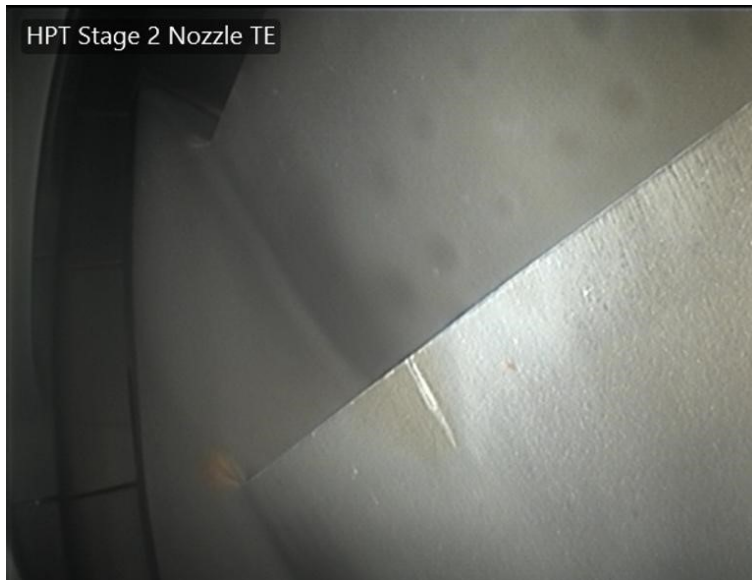
hpt\_stage\_2\_nozzle\_te010.jpg

| Defect | CRACK |
| <b>Comments:</b><br><br><b>Crack at TE, serviceable.</b> | |

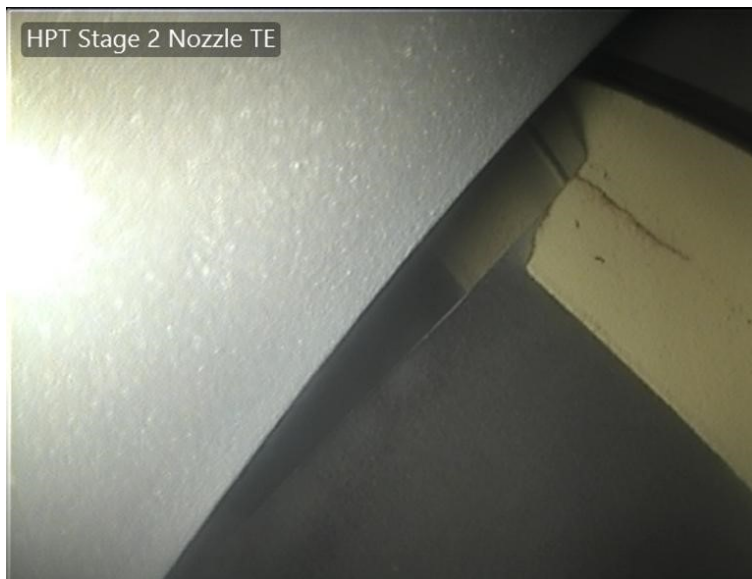
hpt\_stage\_2\_nozzle\_te011.jpg

| Defect | CRACK |
| <b>Comments:</b><br><br><b>Crack at TE, serviceable.</b> | |

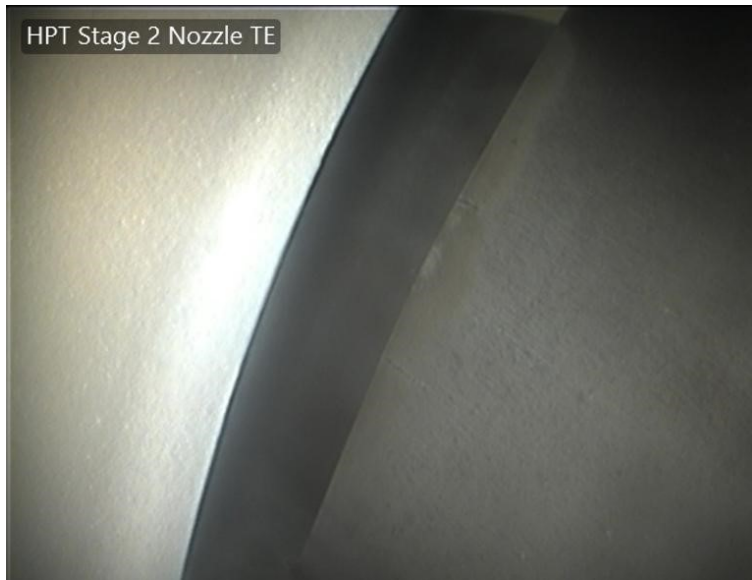
hpt\_stage\_2\_nozzle\_te012.jpg

| Defect | CRACK |

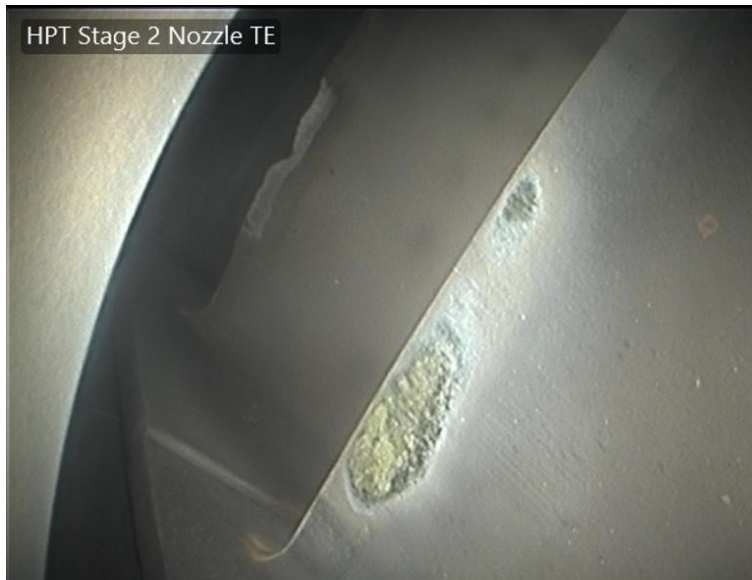
hpt\_stage\_2\_nozzle\_te013.jpg

| Defect | EROSION |
| <b>Comments:</b><br><br><b>Erosion and material missing, serviceable.</b> | |

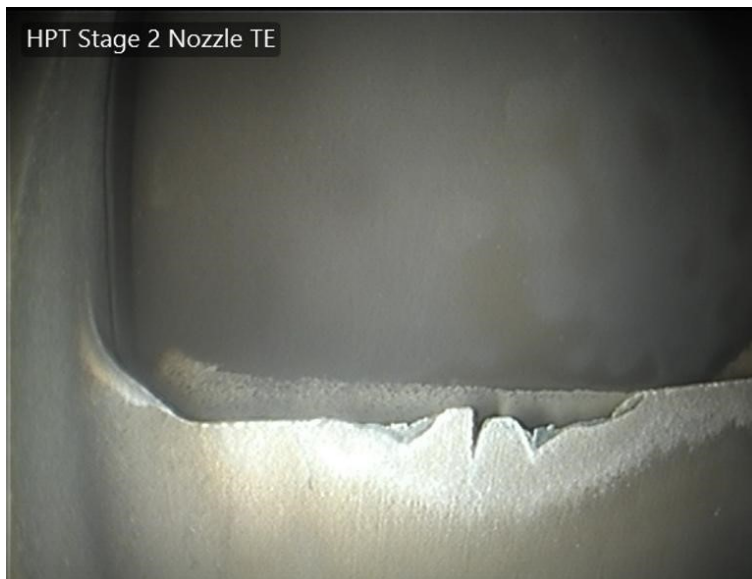
hpt\_stage\_2\_nozzle\_te014.jpg

| Defect | CRACK |
| <b>Comments:</b><br><br><b>Erosion and material missing, serviceable.</b> | |

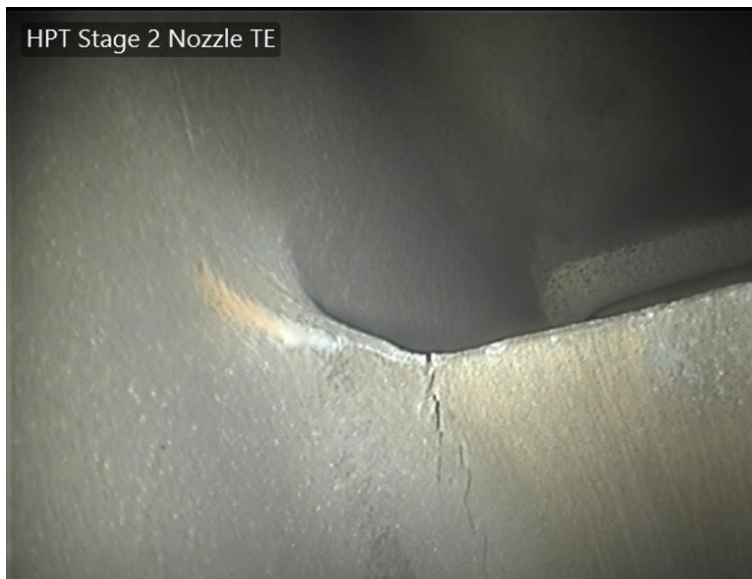
hpt\_stage\_2\_nozzle\_te016.jpg

| Defect | CRACK |
| <b>Comments:</b><br><br><b>Crack, serviceable.</b> | |

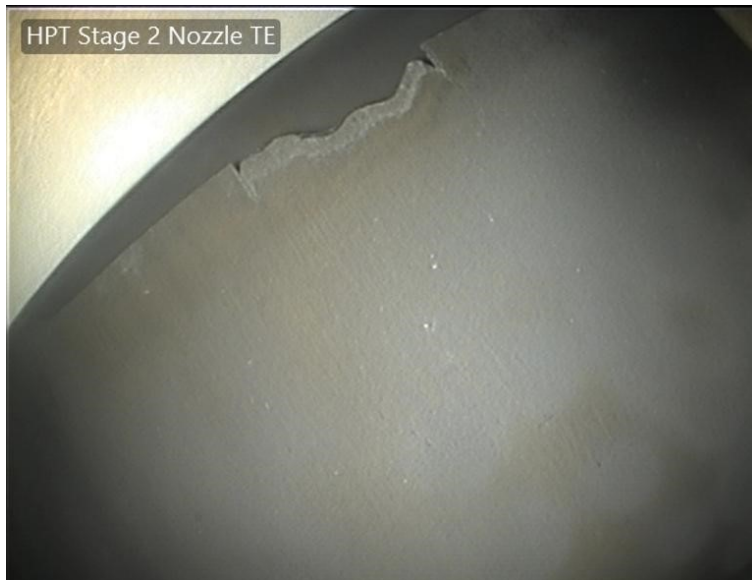
hpt\_stage\_2\_nozzle\_te017.jpg

| Defect | CRACK |
| <b>Comments:</b><br><br><b>Erosion and material missing, serviceable.</b> | |

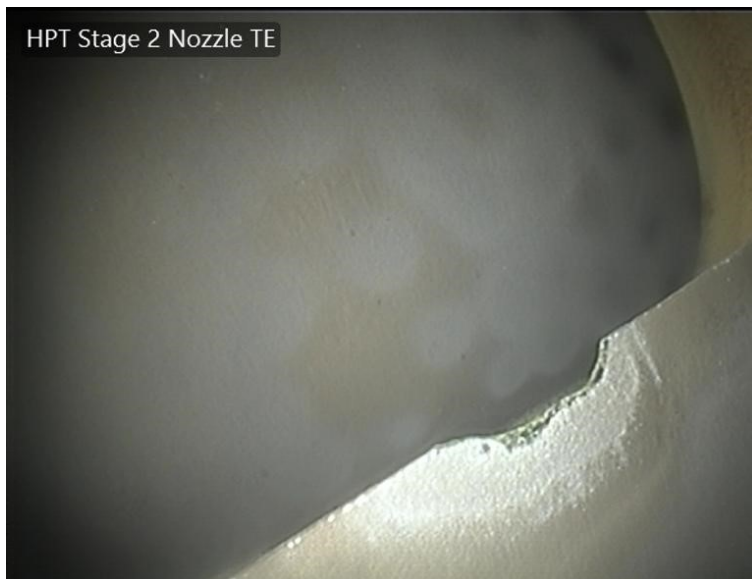
hpt\_stage\_2\_nozzle\_te018.jpg

| Defect | EROSION |
| <b>Comments:</b><br><br><b>Erosion and material missing, serviceable.</b> | |

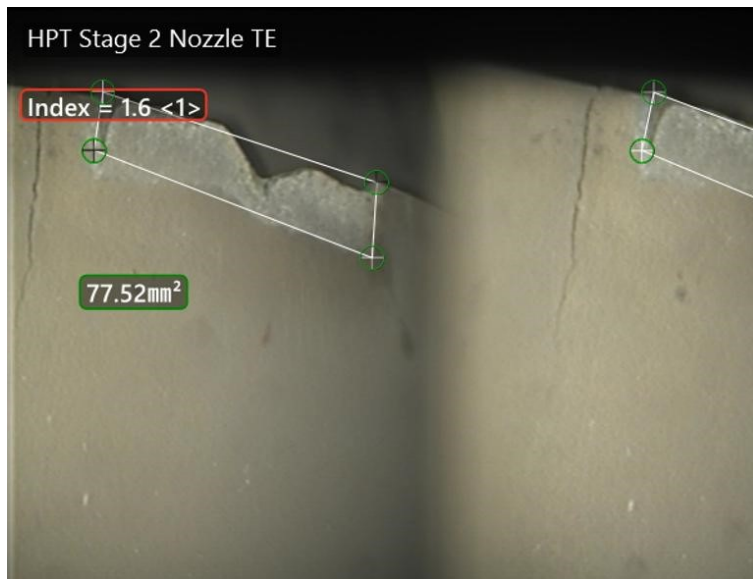
hpt\_stage\_2\_nozzle\_te027.jpg

| Defect | EROSION |

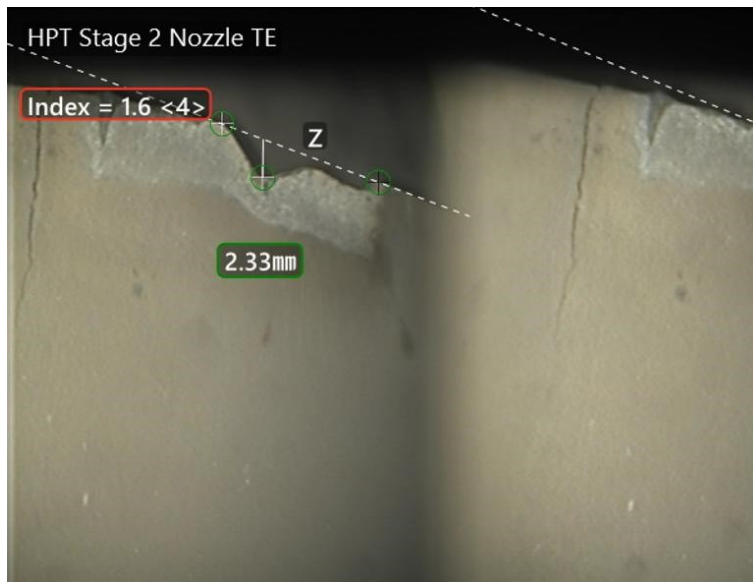
hpt\_stage\_2\_nozzle\_te026.jpg

| Defect | EROSION |

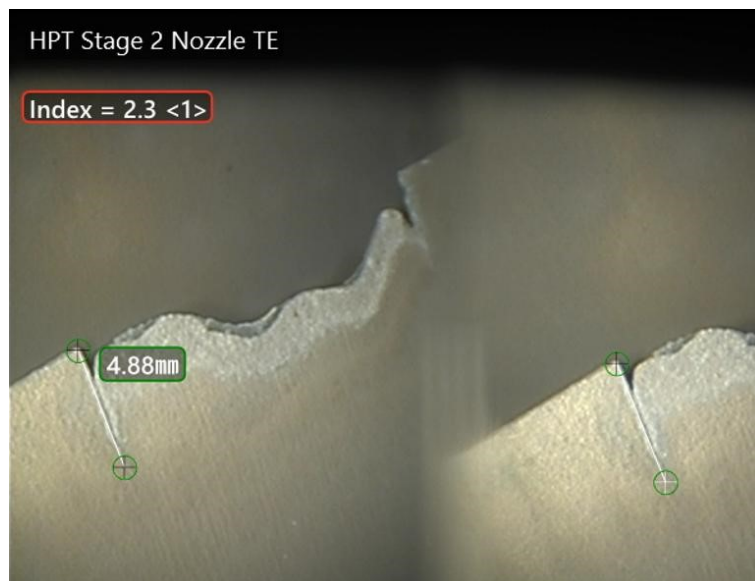
hpt\_stage\_2\_nozzle\_te031.jpg

| Defect | CRACK |

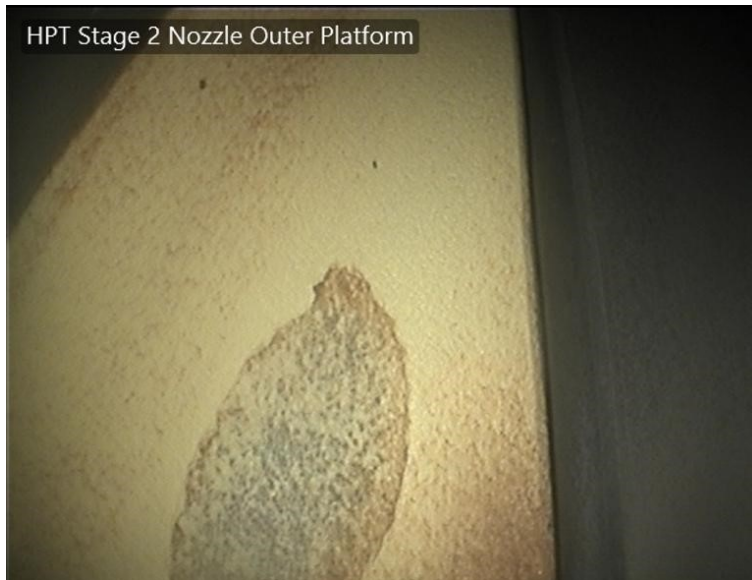
hpt\_stage\_2\_nozzle\_outer\_platform002.jpg

| Defect | TBC LOSS |
| <b>Comments:</b><br><br><b>TBS missing.</b> | |

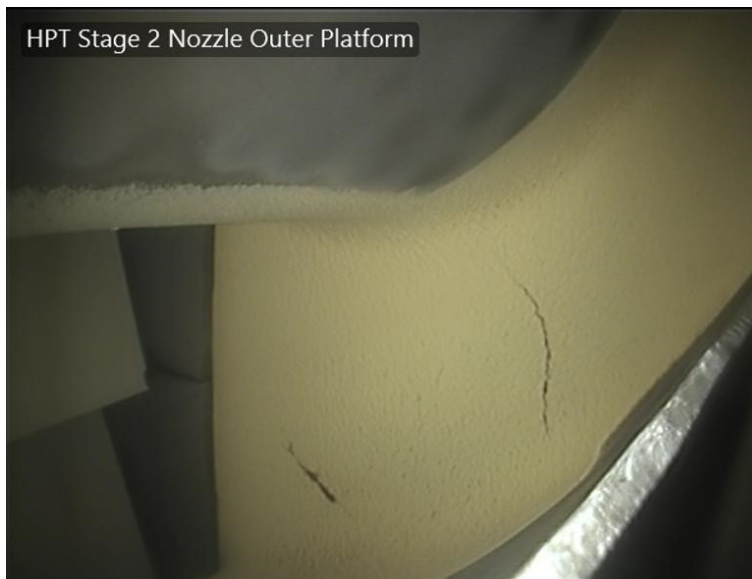
hpt\_stage\_2\_nozzle\_outer\_platform004.jpg

| Defect | CRACK |
| <b>Comments:</b><br><br><b>Cracks at Outer Platform<br/>between the Vanes.</b><br><br><b>Can't see if crack is only in the<br/>coating.</b><br><br><b>Aero case logged, AERO-<br/>20240704-0131.</b> | |

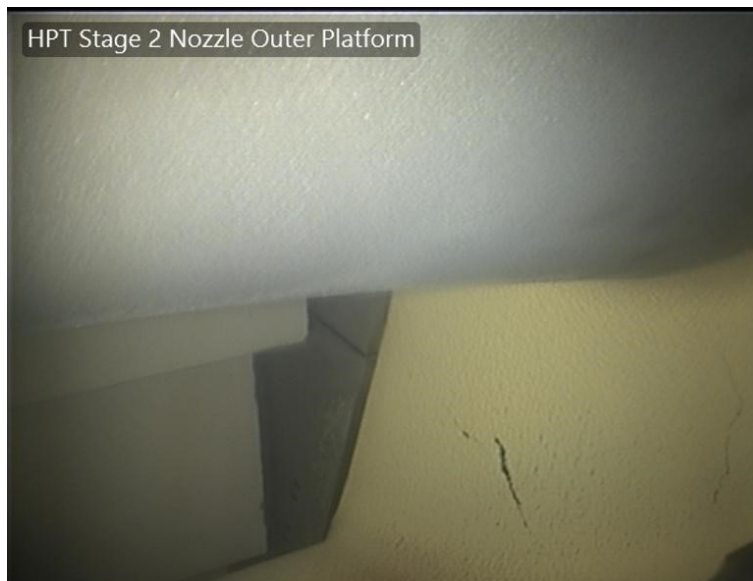
hpt\_stage\_2\_nozzle\_outer\_platform011.jpg

| Defect | CRACK |
| <b>Crack at Outer Platform between the Vanes.</b> | |
| <b>Can't see if crack is only in the coating.</b> | |

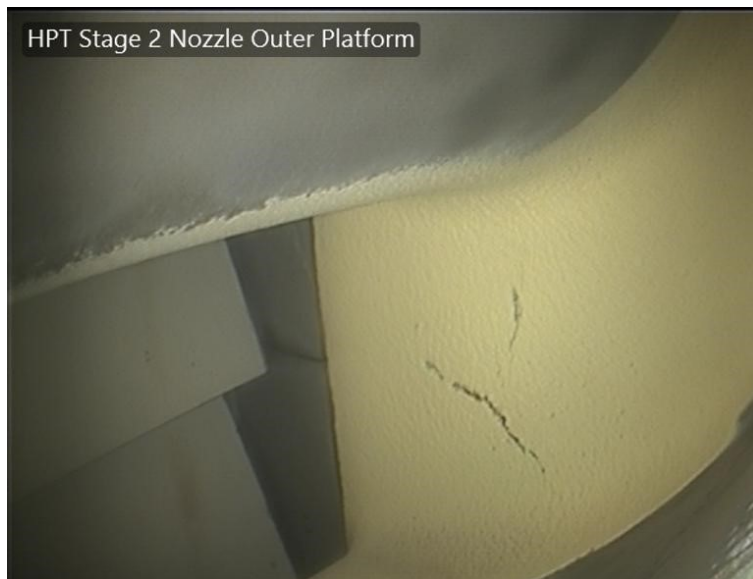
hpt\_stage\_2\_nozzle\_outer\_platform014.jpg

| Defect | CRACK |
| <b>Comments:</b><br><br><b>Cracks at Outer Platform between the Vanes.</b><br><br><b>Can't see if crack is only in the coating.</b><br><br><b>Aero case logged, AERO-20240704-0131.</b> | |

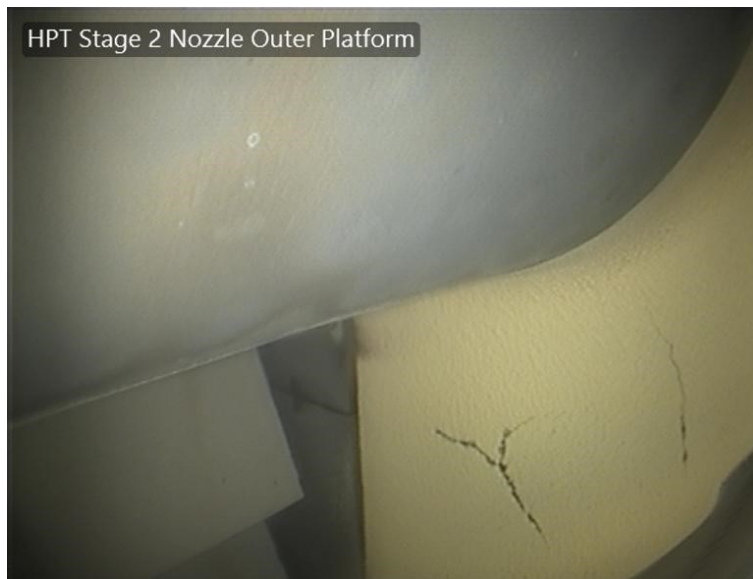
hpt\_stage\_2\_nozzle\_outer\_platform015.jpg

| Defect | CRACK |
| <b>Comments:</b><br><br><b>Cracks at Outer Platform between the Vanes.</b><br><br><b>Can't see if crack is only in the coating.</b><br><br><b>Aero case logged, AERO-20240704-0131.</b> | |

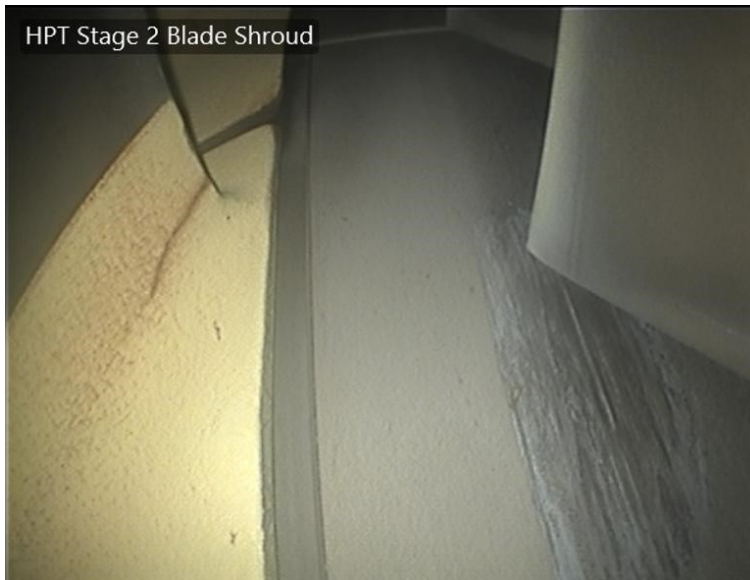
hpt\_stage\_2\_blade\_shroud002.jpg

| Defect | RUB |
| <b>Comments:</b><br><br><b>Rubbing.</b> | |

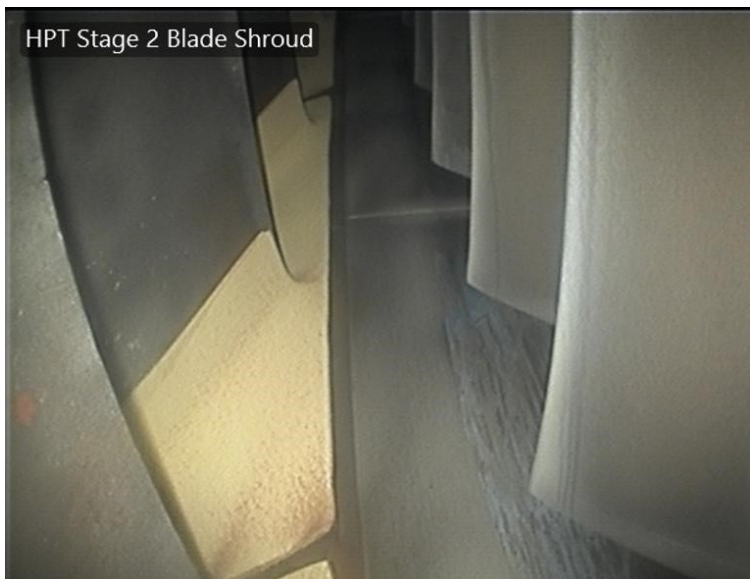
hpt\_stage\_2\_blade\_shroud003.jpg

| Defect | RUB |

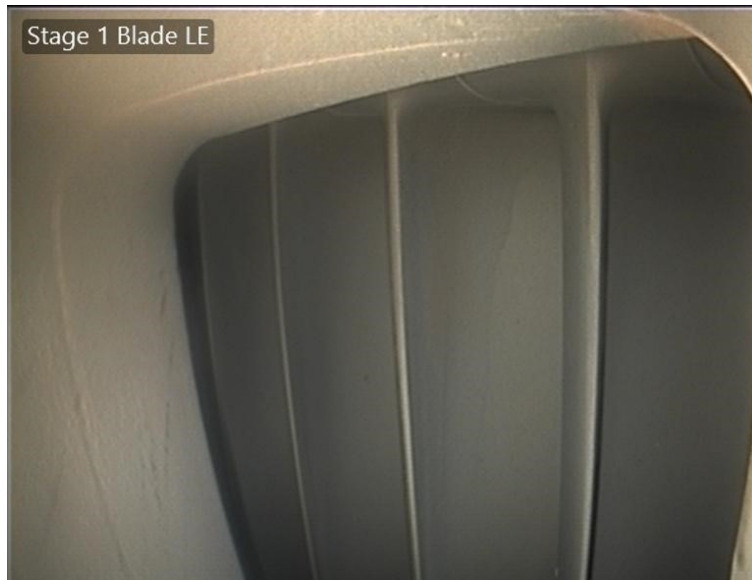
stage\_1\_blade\_le003.jpg

| Defect | NO DEFECT - SERVICEABLE |

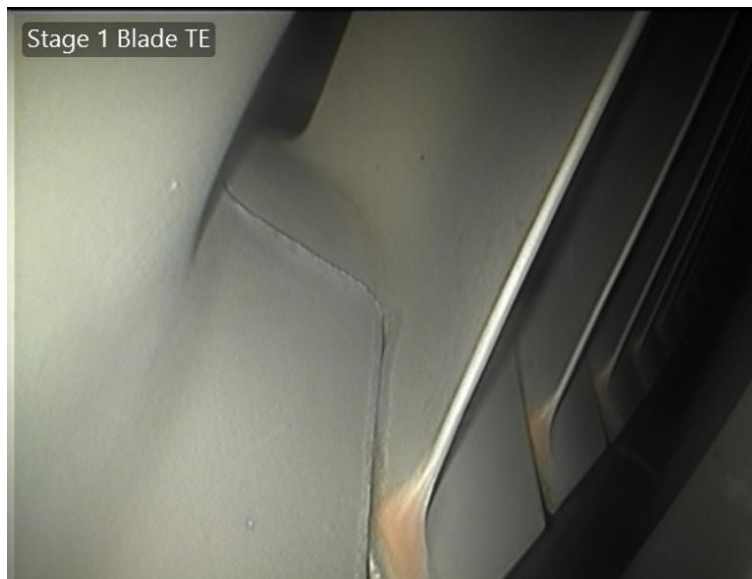
stage\_1\_blade\_te001.jpg

| Defect | NO DEFECT - SERVICEABLE |

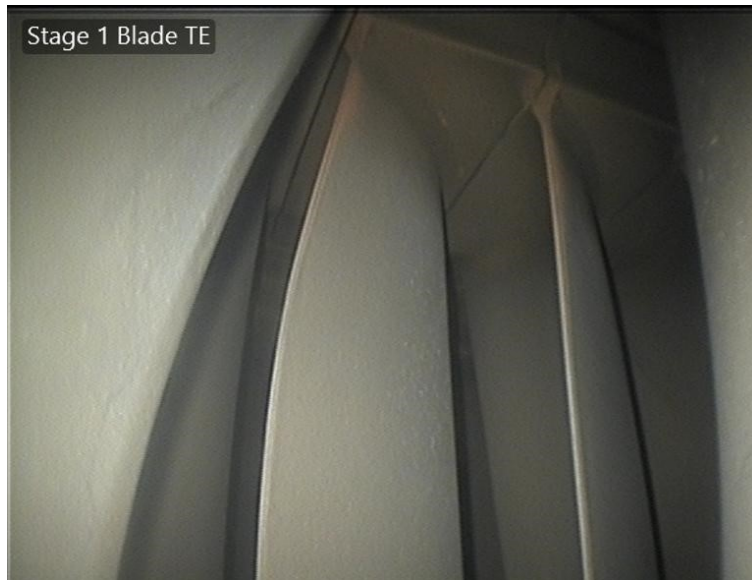
stage\_1\_blade\_te002.jpg

| Defect | NO DEFECT - SERVICEABLE |

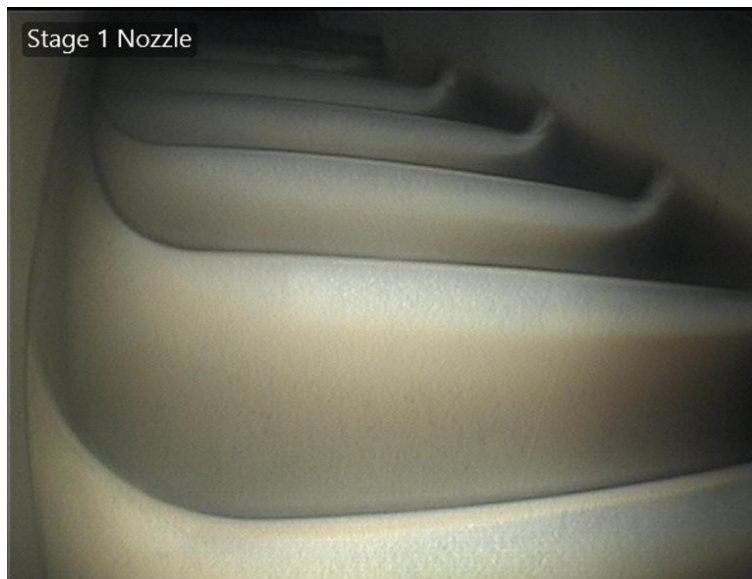
stage\_1\_nozzle001.jpg

| Defect | NO DEFECT - SERVICEABLE |
