# Borescope Inspection Report

July 3, 2024

**Unit 52**

**ESN 192-229**

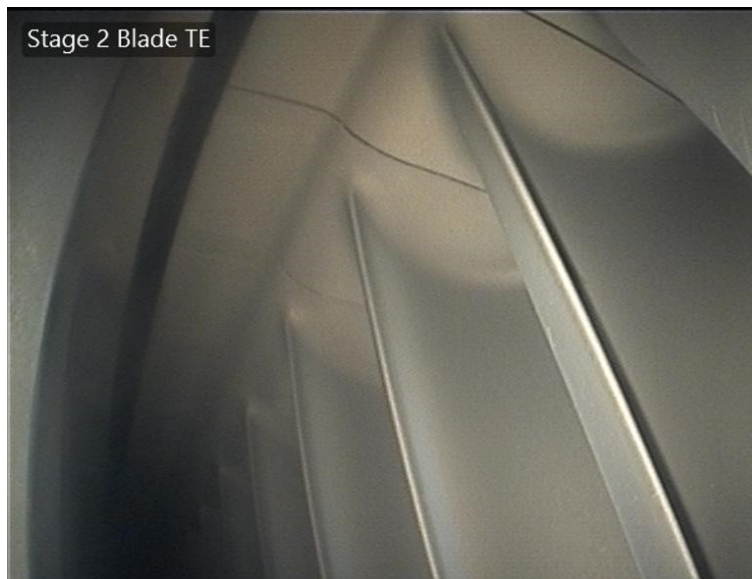
stage\_2\_blade\_te002.jpg

| Defect | NO DEFECT - SERVICEABLE |

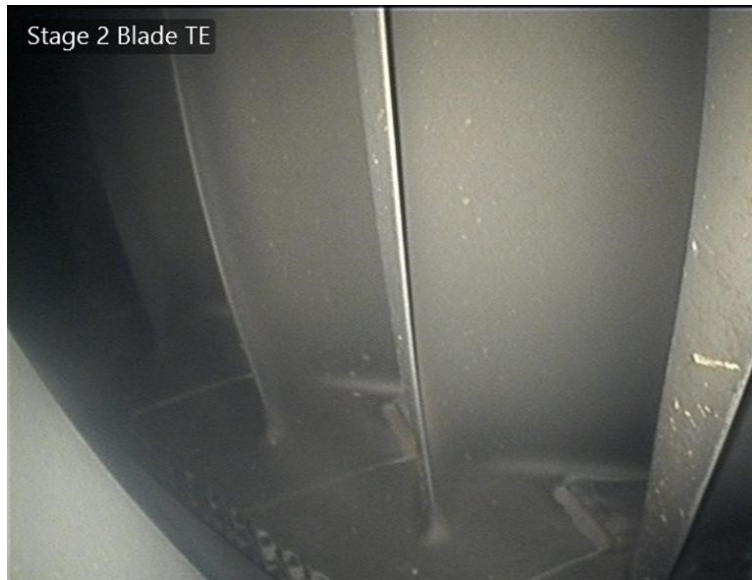
stage\_2\_blade\_te001.jpg

| Defect | NO DEFECT - SERVICEABLE |

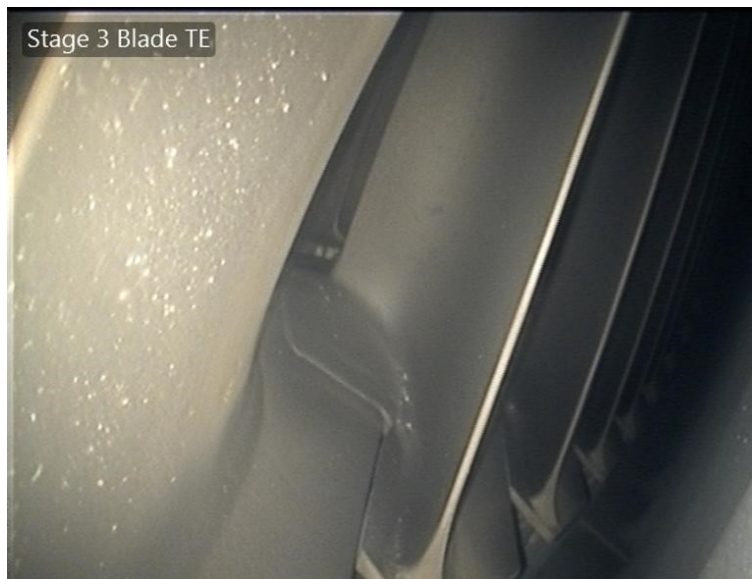
stage\_3\_blade\_te001.jpg

| Defect | NO DEFECT - SERVICEABLE |

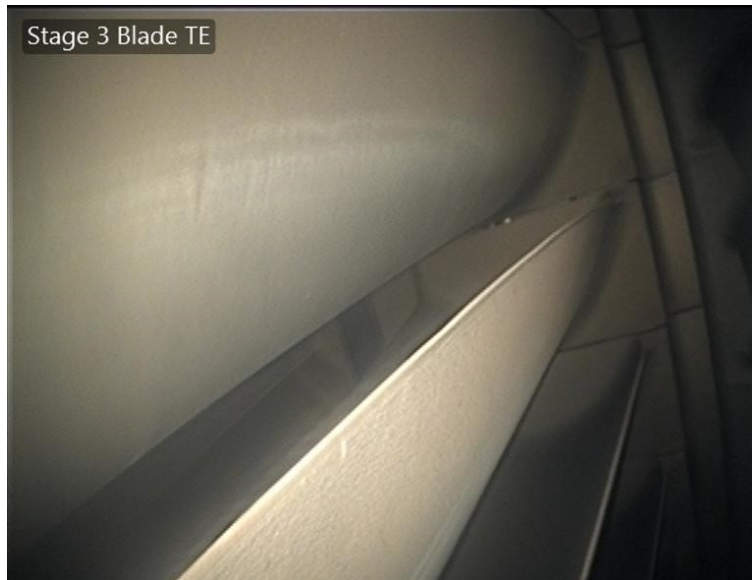
stage\_3\_blade\_te002.jpg

| Defect | NO DEFECT - SERVICEABLE |

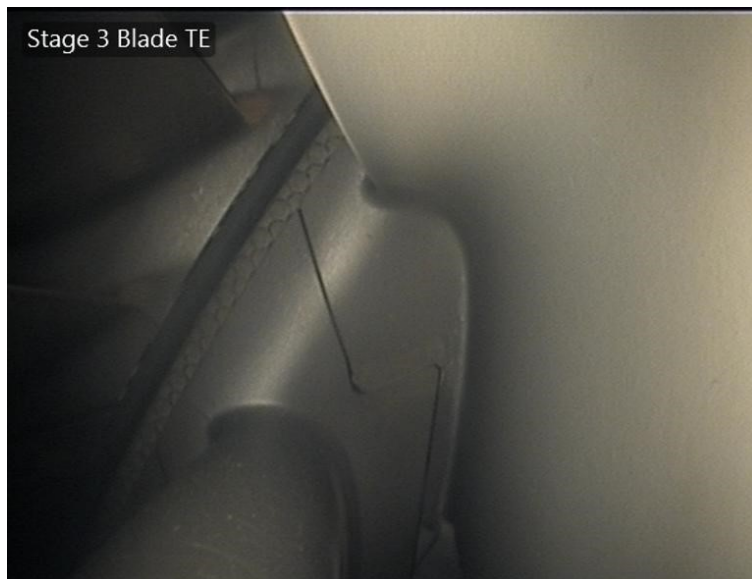
stage\_3\_blade\_te003.jpg

| Defect | NO DEFECT - SERVICEABLE |

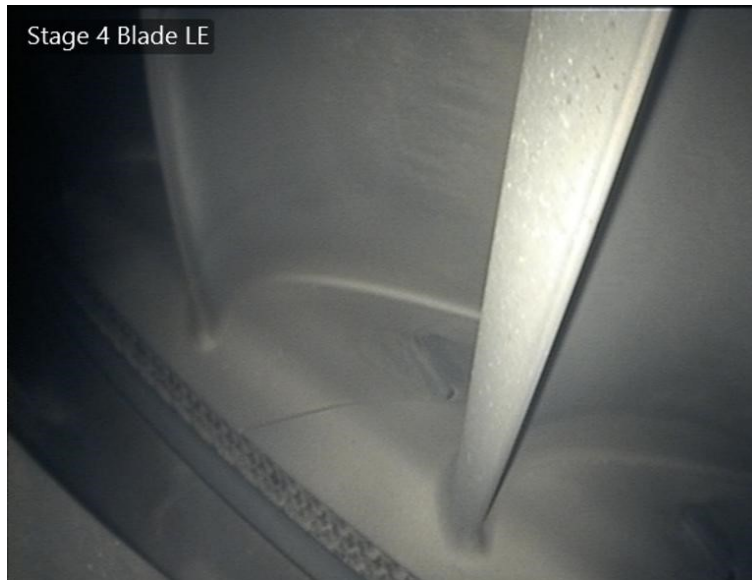
stage\_4\_blade\_le001.jpg

| Defect | NO DEFECT - SERVICEABLE |

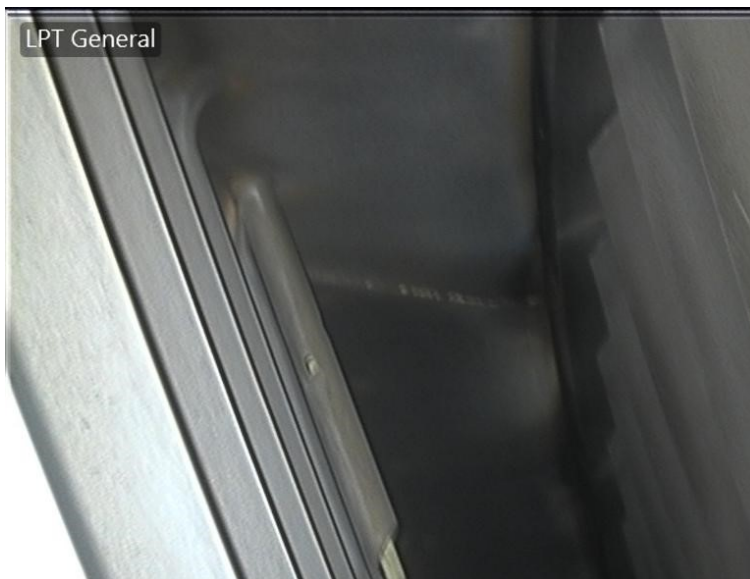
lpt\_general002.jpg

| Defect | NO DEFECT - SERVICEABLE |

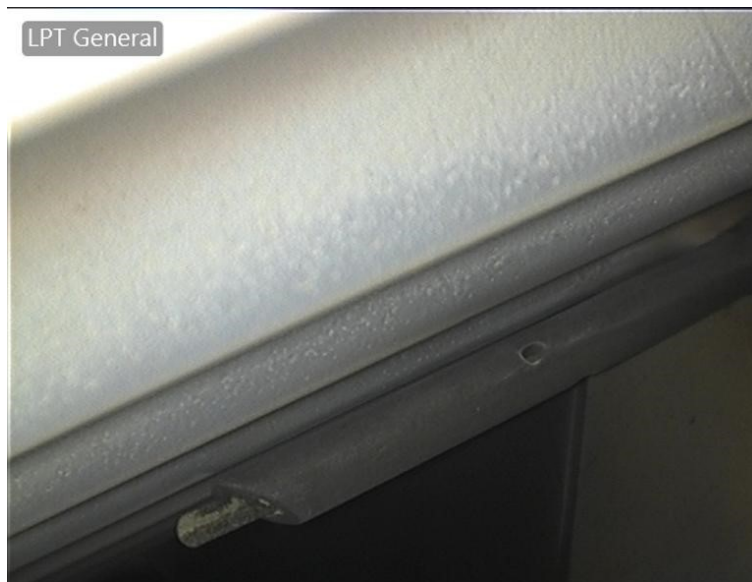
lpt\_general003.jpg

| Defect | NO DEFECT - SERVICEABLE |

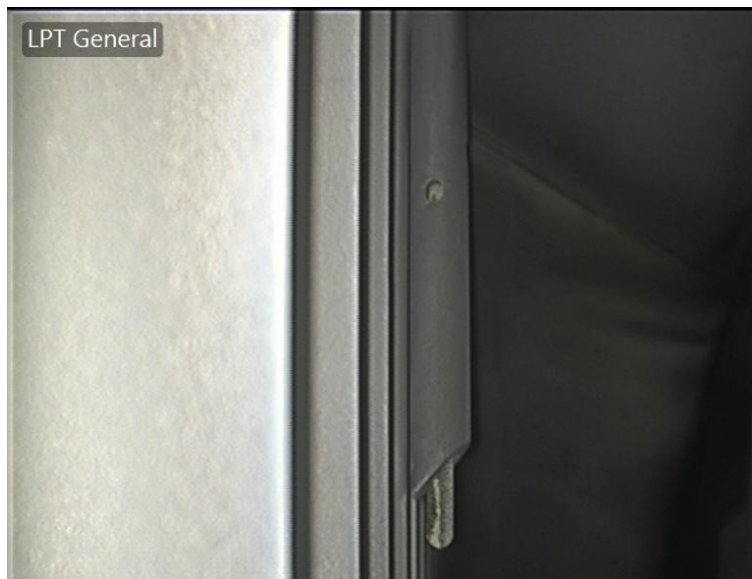
lpt\_general004.jpg

| Defect | NO DEFECT - SERVICEABLE |

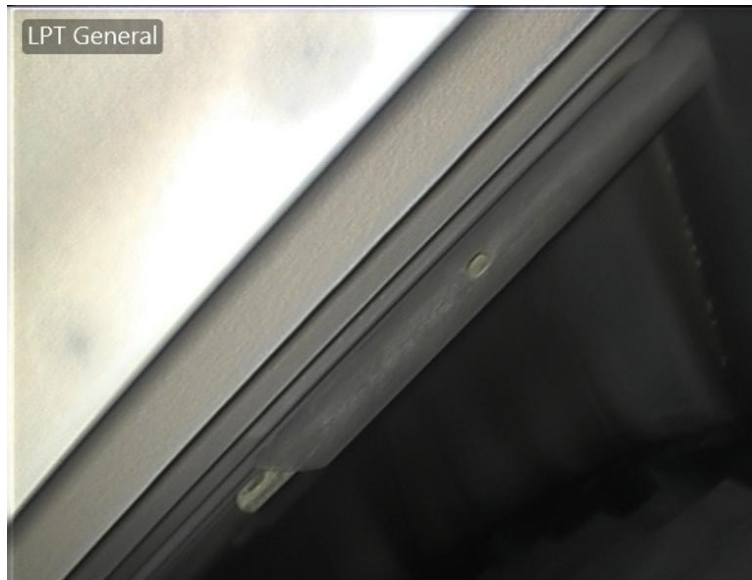
lpt\_general006.jpg

| Defect | NO DEFECT - SERVICEABLE |

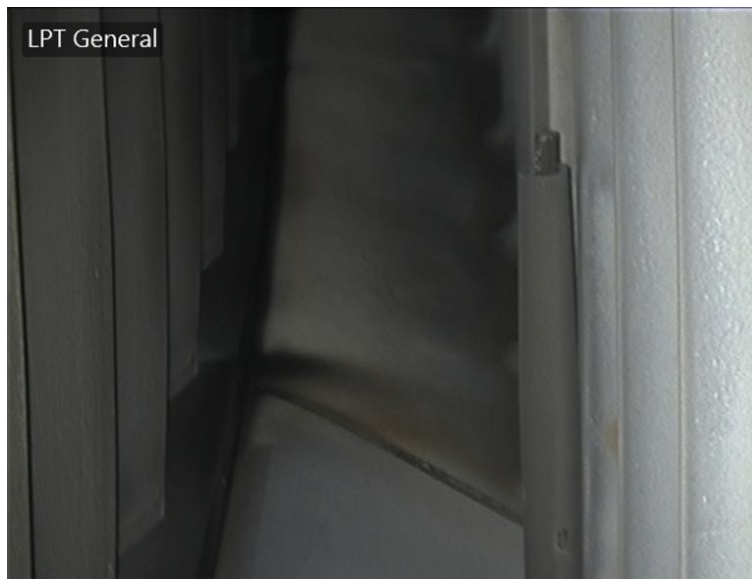
lpt\_general008.jpg

| Defect | NO DEFECT - SERVICEABLE |
